Report ULM A-013/2016

Accident involving an Evektor
EV-97 Eurostar aircraft, registration
EC-KTF, in San Ignacio del Viar
(Seville, Spain) on 20 May 2016

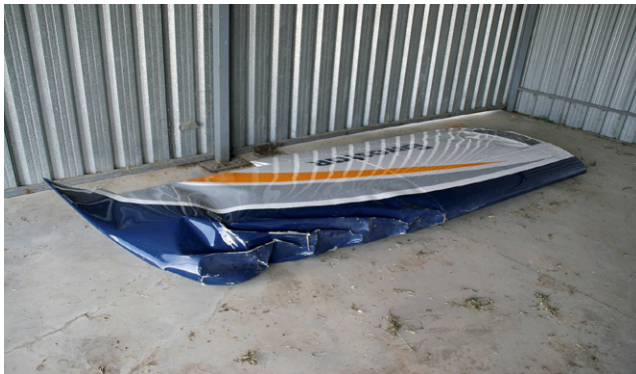
Figure 3. Right wing

The right wing exhibited compression damage on the outboard half of the leading edge. This damage started at the outer edge and continued in the direction of the wing root. There was also compression damage on the trailing edge, close to the root.

The right wing exhibited compression damage on the outboard half of the leading edge. This damage started at the outer edge and continued in the direction of the wing root, while the left wing only had compression damage on the leading edge, close to the root.

The damage to the right leading edge, combined with the deformation of the fuselage and the engine mount to the left, suggest that the propeller hub impacted the ground a few moments after the right wing.

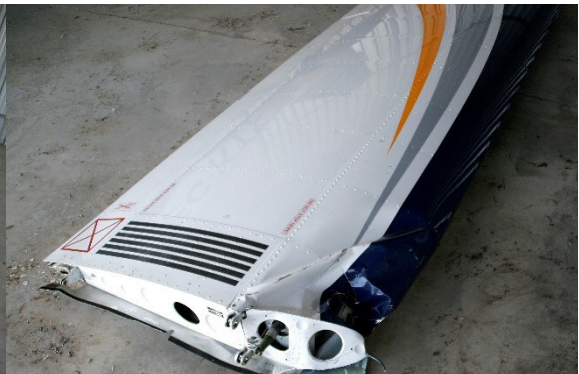
Figure 4. Left wing

The left wing had compression damage and fractures on the leading edge, close to the root. The rest of the wing was undamaged.

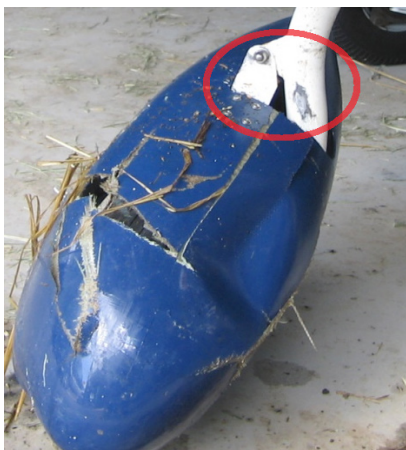
Figure 5. Marks on front gear

The main landing gear was not muddy and it did not exhibit any marks or apparent damage. The metal bar on the front landing gear showed signs of having scraped a metallic element. There were also marks on the top front of the fairing (see Figure 5). There was no dirt in the fairing, but there were wheat stalks.

The marks found on the front landing gear were caused by impacting the power line, which slid along the fairing to the bar. The aircraft must have then rotated about its axis to untangle itself from the power line, since it fell a short distance away from the line, which was at an approximate height of 32 meters.

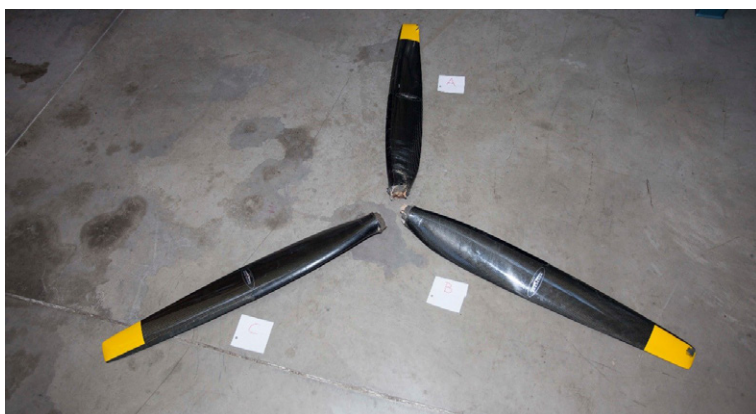
Figure 6. Propeller blades

The propeller cone was completely destroyed. The three blades were broken at the root, in the hub, and there was mud at the front of the hub. As for the wood fibers in the fractures, none were found to exhibit signs of twisting, which would have indicated the sudden stoppage of the engine, but there were fibers that had been crushed toward the root of the blade. The blades did not exhibit marks compatible with having struck the power line, or severe damage from impacting the ground, only minor drag marks. These marks were practically parallel to the direction of rotation (but without quite being concentric) in blade A, and at approximately a 45° angle from the direction of rotation in blade B. There were no marks on blade C.

Given the minimal damage exhibited by the blades, including the absence of cable marks, the possibility that they impacted the power lines is ruled out. The breaks in the blades did not exhibit fibers with signs of a rotational component, which would have indicated the sudden stoppage of the propeller. They were, however, crushed inward by the almost vertical impact of the nose against the ground. This suggests that the blades did not break in flight, but rather when the nose impacted the ground.

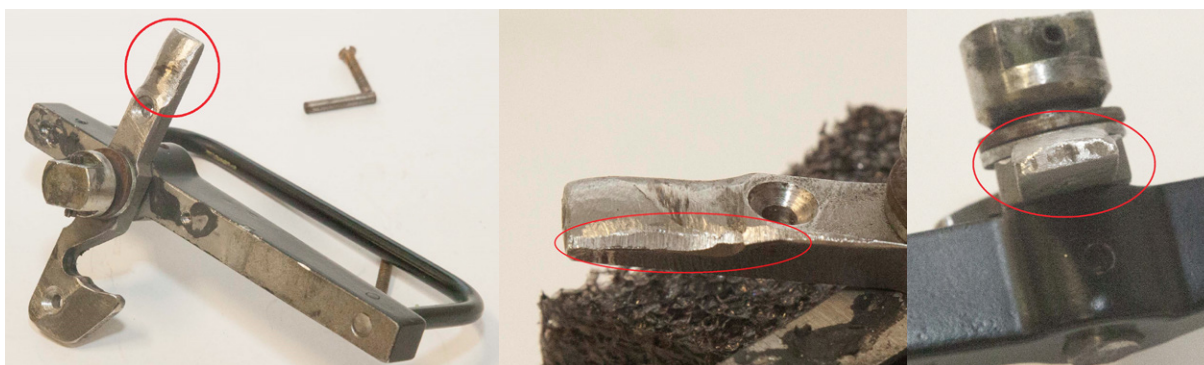
Figure 10. Modification to the canopy locking mechanism

During the accident investigation, the locking mechanism was fully disassembled and inspected. The hook had been filed down, which had reduced its thickness (Figure 10). This modification was only noticeable if the part was disassembled, since it was riveted to the structure. The aircraft manufacturer was asked about this, and it stated that it had not authorized the modification carried out on the locking system. The manufacturer explained that, as in other cases, the canopy had opened due to improper maintenance, since the hook had been filed down so the canopy could close easier. It stated that an overly gentle motion to open and close the canopy should be a warning sign, since in these conditions the possibility exists that the system will open accidentally.

When the canopy locking mechanism on aircraft EC-KTF was disassembled, it was noted that the hook attached to the handle had been thinned. The hook had been filed down and this caused the spring clip to offer less resistance, opening and closing easily.

The manufacturer confirmed that this tapering constituted an unauthorized modification of the locking system. It also underscored the importance of having owners ask the manufacturer about any anomaly in the aircraft, since an overly soft locking mechanism is indicative of inadequate maintenance, and in such cases the manufacturer can help identify the root cause of the problem.

The accident was caused by the reduced control of the aircraft, resulting from the involuntary opening of the canopy as a consequence of an unauthorized modification to its locking mechanism, which led to the aircraft impacting a high-voltage power line.

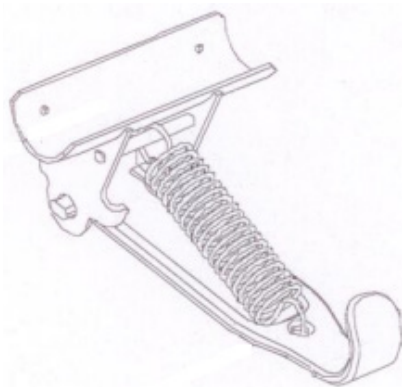
Figure 11. Canopy catch

Figure 11 shows the catch. The SB also includes various pages to replace in the pilot's operating handbook, one of which modifies the Before Takeoff checklist by replacing the line "Cockpit closed" by "Cockpit locked and secured by the catch".

This catch, which would have kept the canopy from opening more than a few centimeters, instead of the 55 to 57 cm that the manufacturer's study found when gliding with the engine at idle, had not been installed on aircraft EC-KTF. This would have minimized disruptions to the air flow and the vibrations in the elevator, which would have made the aircraft much more controllable than in the accident scenario, thus reducing the likelihood of its occurrence.

In November 2015, Evektor-Aerotechnik issued service bulletin EV97-033a, classified by the manufacturer as mandatory and applicable to all Eurostar and Sportstar aircraft with a metal frame around the canopy. The reason for the bulletin stated that as a consequence of not following procedures, in certain circumstances the lock in the cockpit could be released in flight, causing the canopy to open. The SB states to install a mechanical catch on the canopy frame to act as an additional securing element and prevent the canopy from opening even if its locking mechanism failed (it would only open a few centimeters). The material is provided by the manufacturer at the owner's request, the latter being responsible for the associated costs.
