## **Report ULM A-008/2017**

Accident involving a Capella XSX TD aircraft,  
registration EC-ZCS, 2 km south of  
Carmona (Seville, Spain) on 3 May 2017

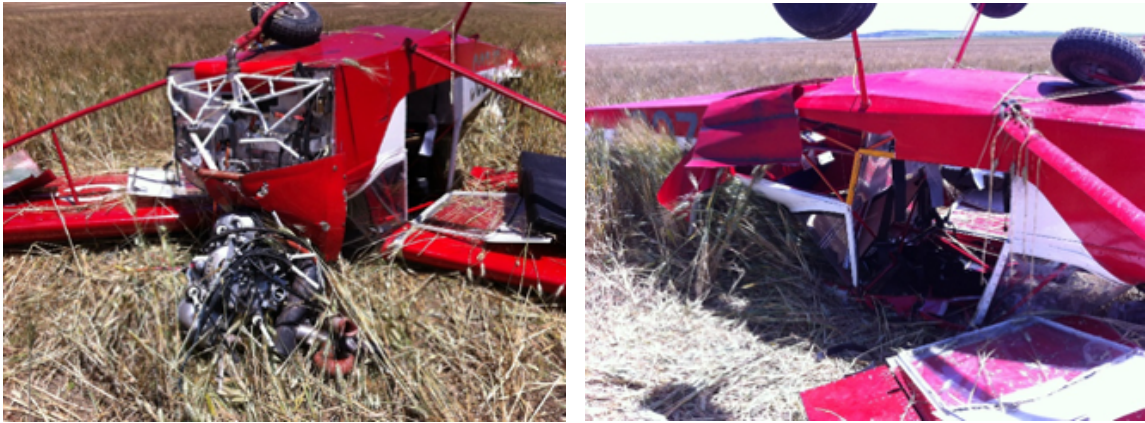
**Figure 2.** Aircraft on wheat field after accident

There were barely any marks on the field. No wheat stalks were found to have been cut by the propeller. The marks on the field revealed that the initial contact had been by the main gear followed by the nose gear and the main gear again. The nose gear eventually collapsed.

The engine was on the ground, detached from its mount. The wings had no significant damage. The cockpit had retained its integrity. The seatbelts worked properly and the pilot stated they were fastened, which had undoubtedly prevented major injuries. One of the pedals was broken. The pilot stated that he had probably broken it when he exited the aircraft. He also said that they certainly would have moved levers and other aircraft components when exiting the aircraft.

There was a smell of leaked fuel.

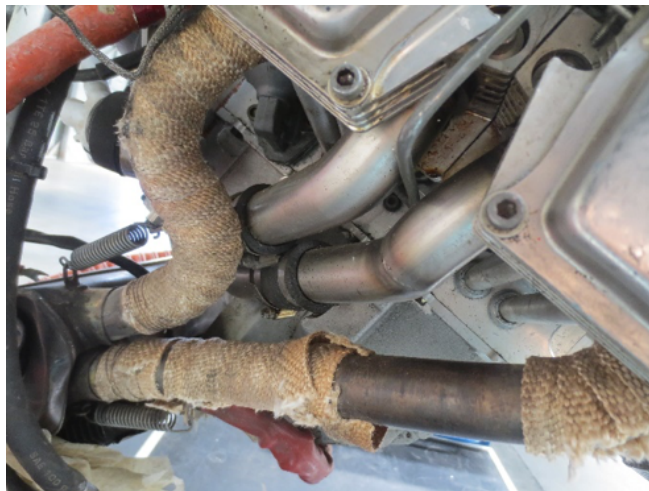
The external inspection revealed that the exhaust pipes were covered in an insulating fabric that hampered heat dissipation. The engine manufacturer, Jabiru, which was consulted following the engine inspection, did not approve taping the exhaust pipe.

**Figure 3.** Close-up of taped exhaust pipe

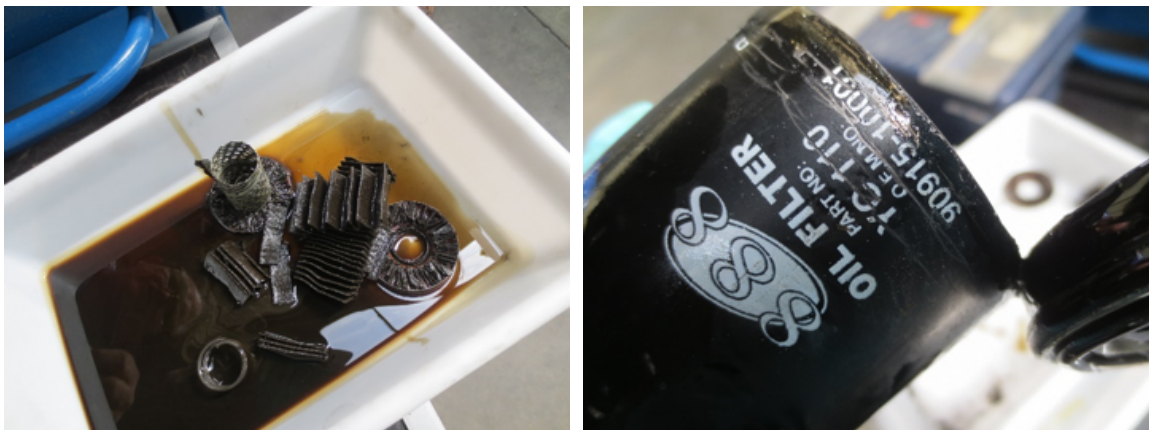
The oil was then drained from the engine and a sample drawn for analysis<sup>11</sup>. The oil was dark and had metal particles.

The oil filter was removed and cut to inspect the paper filter element. The pleats in the paper gave way on contact. The paper had no consistency, it was brittle and fragile. This may have been due to being very old, being in use for an excessive length of time or to being stored in bad conditions. Moreover, the filter recommended by the manufacturer (P/N PG10162N in the Jabiru Engine Parts Book) was not the one installed in the engine.

**Figure 4.** Close-up of oil and oil filter

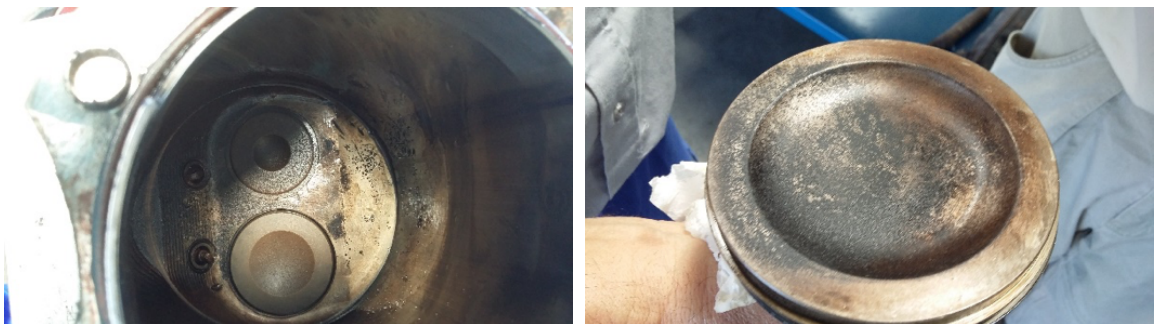
1. The pushrod for the intake valve was corroded and had silicone applied to it. Valve pushrods do not normally corrode while in use because they are covered in oil. The engine manufacturer, Jabiru, thus suspected that they had been removed from the engine and exposed to the air.
2. There was also corrosion inside the cylinder. This may have been due to periods of inactivity with inadequate or no preservation.

The plungers and rings on the piston were inspected. It was noticed that the rings did not have their respective openings shifted 120° between one ring and the adjacent ring. The color of the plunger under the rings indicated flashing due to the undesired escape of gases from the combustion chamber. This happens when the rings do not provide adequate sealing, which would cause the temperature in the cylinder/engine to rise.

**Figure 5.** Close-up of cylinder and piston exhibiting corrosion

- The iron (Fe) content could have come from the corrosion of the steel cylinders.

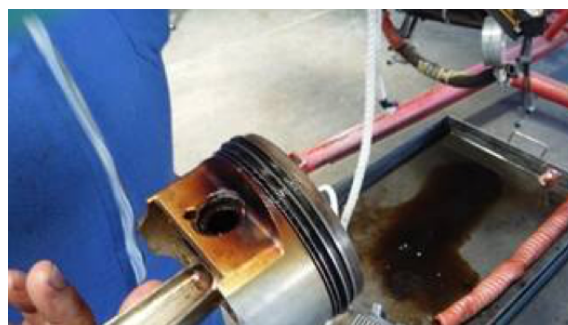
**Figure 6.** Close-up of piston with signs of overheating

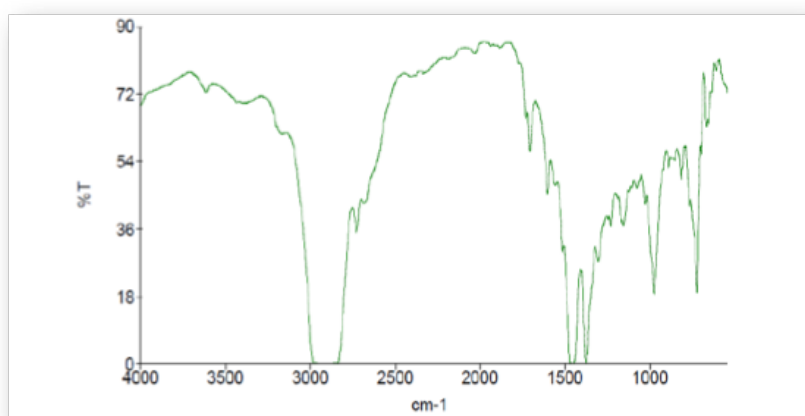
**Figure 7.** Infrared spectrum for the oil sample taken from the engine

Test	Standard	Results
Kinematic viscosity test	ASTM D-445	94,32 cst
Total Acid Number (TAN)	ASTM D 664 o 974	3,01 mg KOH/g
Wear metals	ASTM D 5185	Fe Cu Mo Pb Sn Cr Al Ni B Na (ppm) 67 25 0 373 4 6 21 3 69 1
Additive elements	ASTM D 5185	P Zn Ca Mg Li (ppm) 1749 1809 2791 13 0
Metal contaminants	ASTM D 5185	Si (ppm) 66
Oxidation	/	3 A/0,1 mm
Water content	UNE EN ISO 12937	<0,1%

4 – Subsequently, on 30 April 2017, an oil leak was noticed on the engine’s distribution cap and the oil was changed. The oil that was used was automotive oil, and not the one recommended by the manufacturer, Jabiru, as the analysis of the engine oil sample concluded.
