Report ULM IN-012/2017

Incident involving an ELA-07 R-115 aircraft,
registration EC-GA5, in Las Rozas
(Madrid, Spain) on 16 June 2017

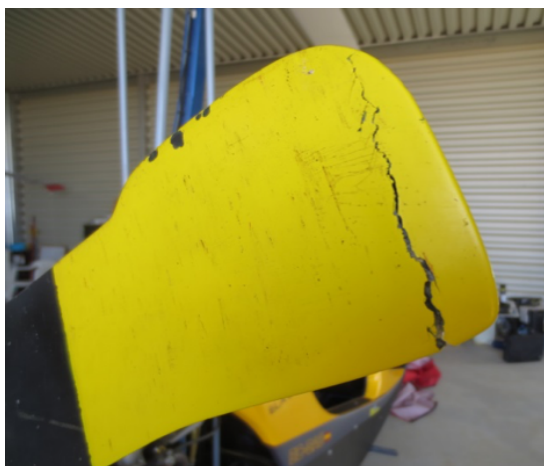
At 20:00, he landed in Robledillo without incident. He was then able to confirm visually that two of the three blades on the propeller were damaged: blade #3 had a fissure, while blade #2 had developed a considerable crack.

Figure 2. Close-up blade #2

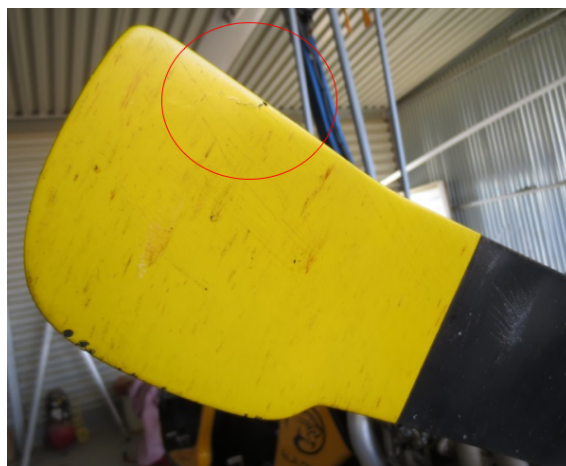
Figure 3. close-up blade #3

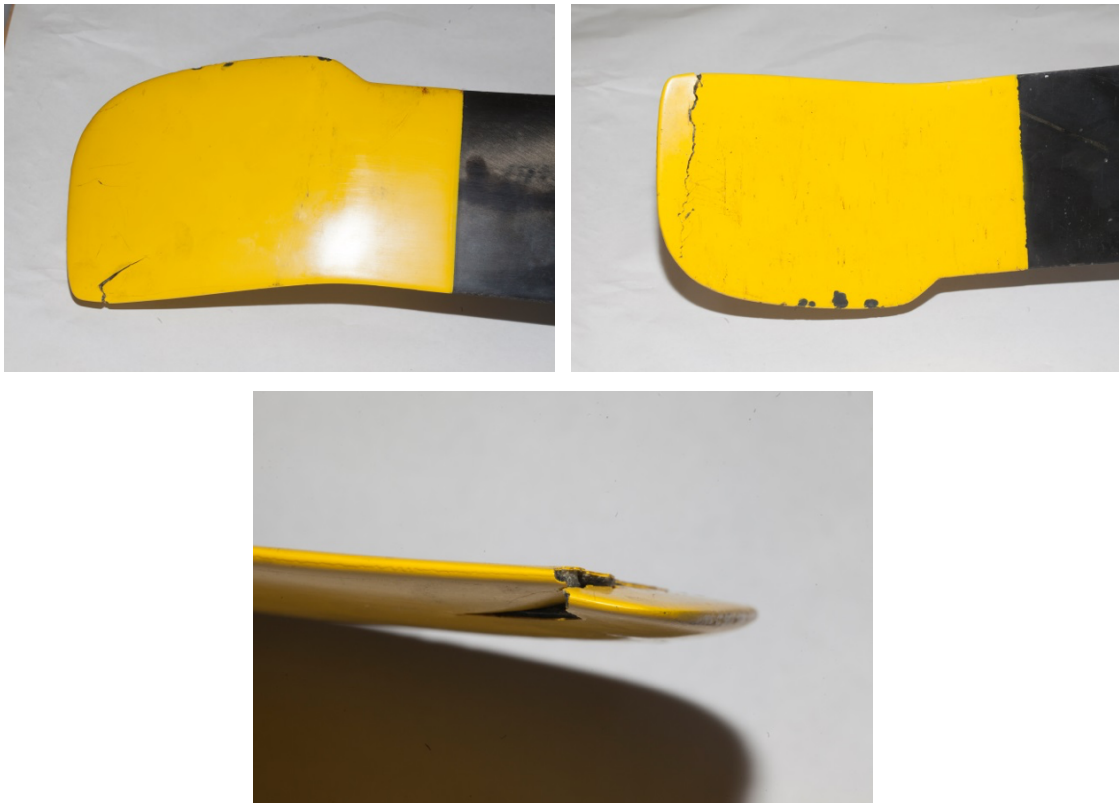
Blade number 1 exhibited no visible damage, blade 2 showed considerable damage near the tip, parallel to the chord, and blade 3 also showed damage (to a lesser extent) along its leading edge. The figures below show a close-up of the damage to blade 2.

Figures 6, 7 and 8. Close-up of the damage to blade 2.

In fact, the area where the crack occurred (so close to the blade tip and parallel to the chord) is an area where such cracks do not typically form due to the low mass⁴ between the crack and the blade tip. One possible explanation for this fact is that when the curvature of the blade tip was modified, it weakened the area, which is where the fissure eventually formed and progressed until it grew into a crack.

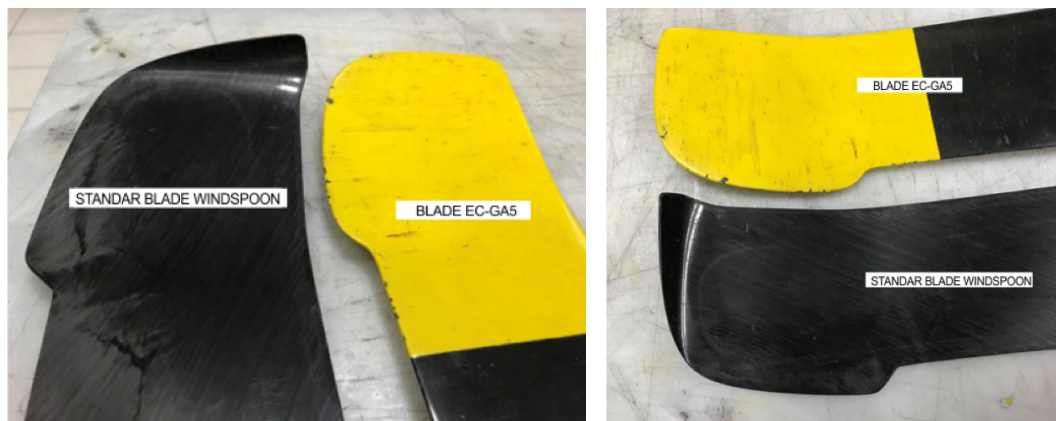
1. The three blades were manufactured by DUC in France.
2. All three blades are of the Windspoon model, but their shape, weight and paint were modified in a way that does not conform to any approved procedure.
3. The blade tips were modified in terms of both their planform and curvature (specifically, it is apparent to the naked eye that the curvature of the tips is practically gone from the blades on EC-GA5). Figures 9 and 10 show a comparison between a blade from EC-GA5 and a production blade.

Figures 9 and 10. Close-up comparison of blade tips on EC-GA5 and a standard blade

4. A crack parallel to the chord so close to the blade tip is very unusual. In this case it may have resulted from weakening of the area after the modification.
5. The three blades were painted black and the tips yellow. The blades that leave the factory are not painted.
6. The DUC logo that was applied to the blades on EC-GA5 is not the factory original; rather, it was a facsimile unlike any of the logos that DUC puts on its blades.
7. On one of the blades, it is apparent that repairs were made to its leading edge, but not to the area where the damage is located on blade 2.
8. The serial numbers of the blades could not be determined since the stickers containing this information had been removed.

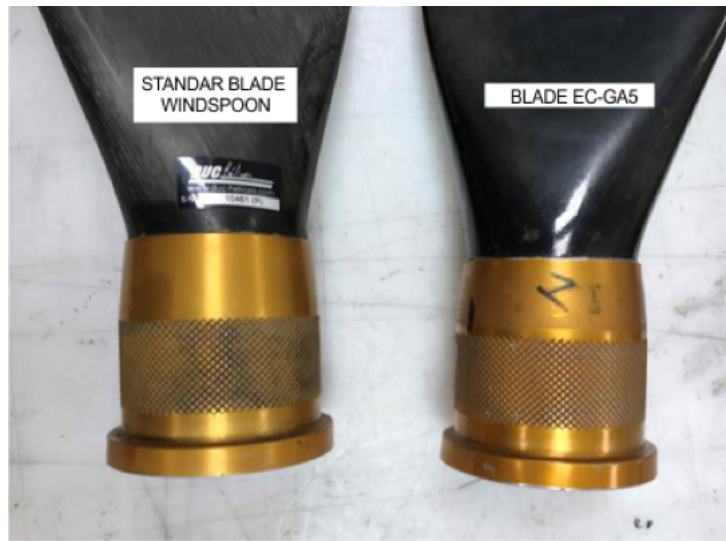
Figure 11. Sticker with serial number.

In August 2016, the previously repaired blade was again worked on, and all three blades were painted black and their tips yellow. The stickers bearing each blade's serial number were obstructed (or removed, it is not known which), and a logo similar (but not identical) to DUC's was affixed to each blade. None of these actions was approved by the manufacturer.
