## **Report ULM A-025/2016**

Accident involving a Mainair Gemini  
Flash 2A aircraft, registration EC-ILC,  
in Malgrat de Mar (Barcelona, Spain)  
on 1 December 2016

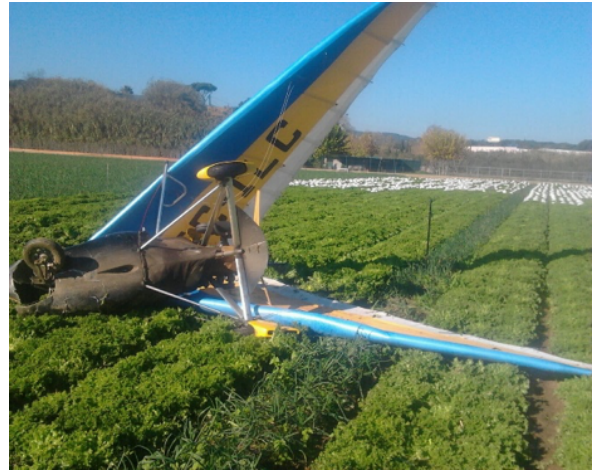
**Figure 1.** Condition of aircraft after impact

The front landing gear collapse, and did a hole in the front of the fuselage. The flight controls were broken, as were the flight instruments in the cockpit. One propeller blade was also broken. At the accident site, the pilot noticed that the fuel valve was selected to draw from the front tank.

In landings of this type, the correct technique is to land in the direction of the furrows, as this makes it easier to taxi. Landing perpendicular to the furrows increases the odds that the wheels will dig into the ground and collapse, causing the airplane to overturn, as happened in this case.

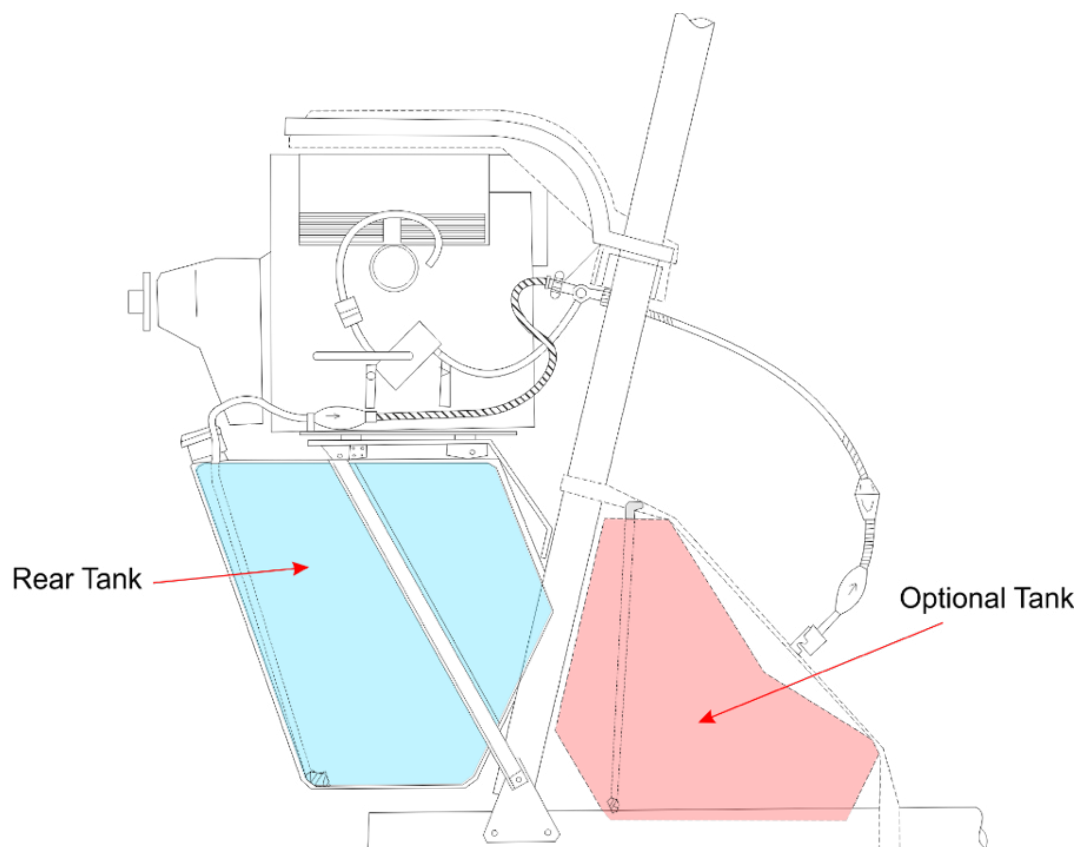
The fuel system has a tank located under the engine, and is thus behind the occupants' seats.

It also has an optional tank located under the occupants' seats.

A selector valve can be used to select the tank that is supplying fuel to the engine.

**Figure 2.** Diagram of fuel system

The aircraft manual instructs to check the position of the fuel valve during the pre-flight inspection.

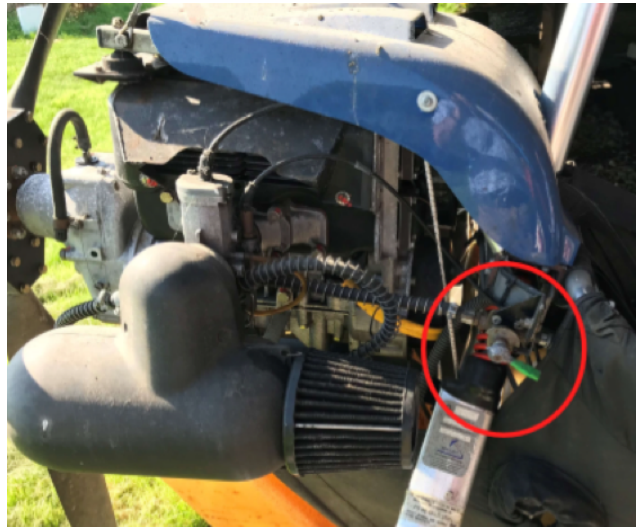
**Figure 3.** Fuel selector valve

As he stated, after transferring the fuel, he made the mistake of leaving the fuel selector valve to supply fuel from the front tank.

The aircraft manual clearly states that the position of the fuel valve must be checked during the pre-flight inspection. In this case, as the pilot himself recognized, he either did not check it or did not realize that he had not left it in the desired position, that is, supplying the engine from the rear tank. In other words, he had a mental lapse and made an involuntary mistake that results from an error or oversight.

He did not realize it during the flight, but even if he had noticed his mistake, the position of the valve makes it hard to operate while airborne.
