**COMISIÓN DE
INVESTIGACIÓN
DE ACCIDENTES
E INCIDENTES DE
AVIACIÓN CIVIL**

Report ULM A-006/2017

Accident involving a Tecnam P96
G 100 aircraft, registration
EC-ZGK, in the vicinity of the
Loring airfield (El Molar, Madrid,
Spain) on 31 March 2017

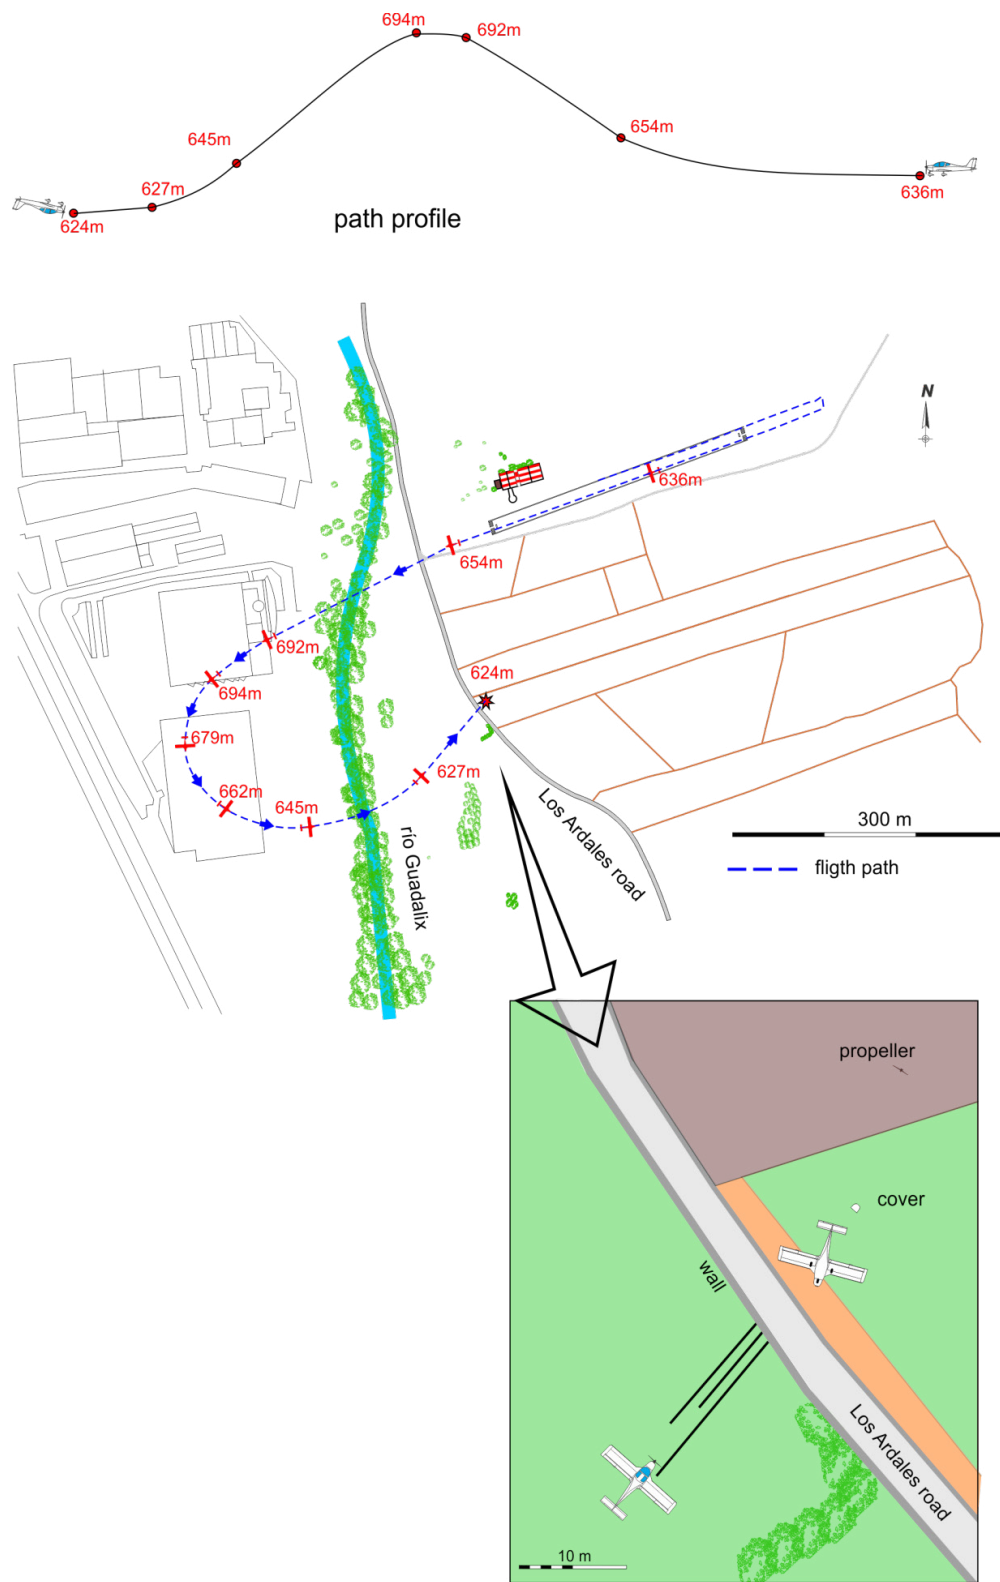
Fig. 1 – Diagram showing location of aircraft wreckage and flight path

The aircraft wreckage was located some 200 m away from the runway 06 threshold, next to the Los Ardales road (no street number), at coordinates 40° 39' 28.4" N 3° 35' 48" W and an elevation of 624 m.

It is a broad, irregularly shaped area located south of the airfield. To the west of this area runs the Guadalix River from north to south, and to the east it is crossed from practically northwest to southeast by the Los Ardales road. Although the area is flat and used to plant crops, there are also parts covered by trees, especially all along the river, with scattered trees between the river and the road (see Fig. 1).

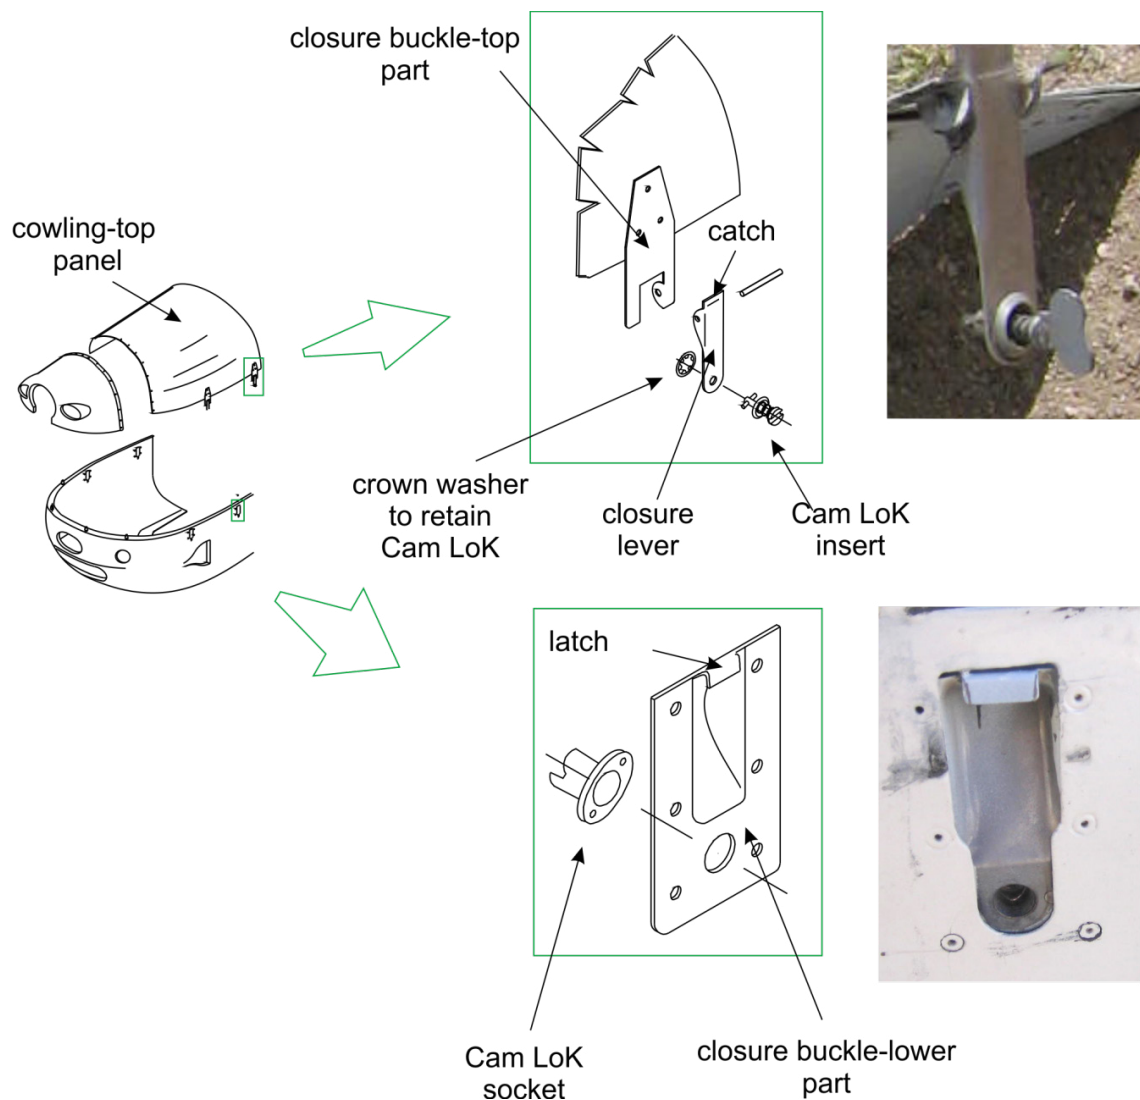
Fig. 2 – Close-up of engine cover closing and opening system

The system for closing and opening the engine cover features four latches situated symmetrically on both sides of the cover. Each latch has a top and bottom locking buckle. The top locking buckle contains the moving part of the locking lever, at the top of which there is a catch that must be inserted into the tab located on the bottom buckle, such that it is locked by means of a cam lock that runs across it and is housed in a collar plate in the latching crown.

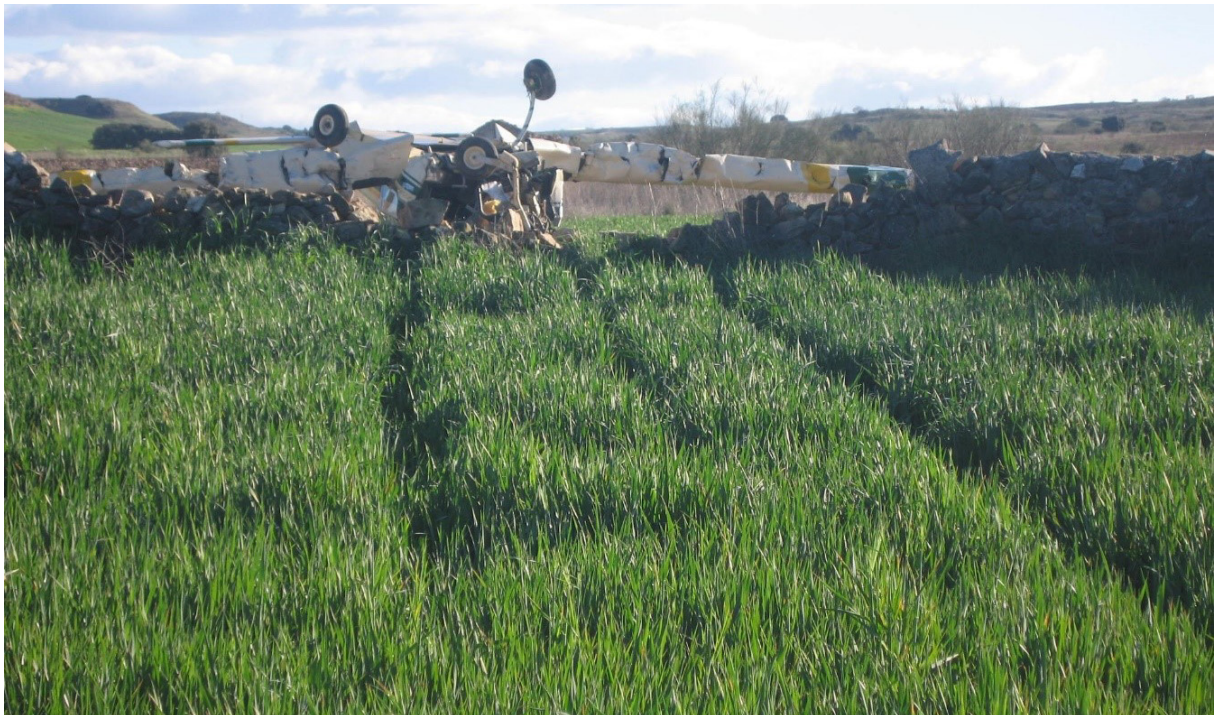
Figure 3: Tracks on the ground and hole created in the wall

Three tracks of different lengths were found in this plot, indicating the path taken by the landing gear as the aircraft traveled on the ground before reaching the stone wall. The stones had been knocked loose from this wall in an irregular pattern over a section of wall approximately 6 m long.

An inspection of the wreckage shows that the aircraft traveled just over 16 m on the ground, which indicates that it landed very close to the wall.

The 6-m section of wall affected is slightly shorter than the 8.7-m wingspan of the aircraft, which indicates that the impact did not occur with the wings level.

Using the direction of the landing gear tracks on the ground as a reference, there was more damage to the left side of the wall than the right. This, combined with the fact that the left main gear leg was visibly bent more than the right leg, and that the left wing was also bent backward more than the right wing, indicates that the aircraft impacted the wall with a slight left bank attitude.

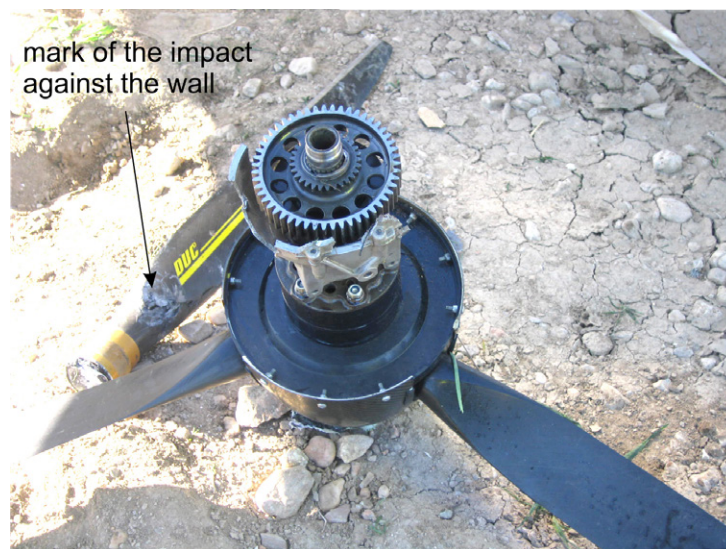
Fig. 4 – Close-up of propeller assembly and detached blade

All of the wreckage was confined to one point, with the exception of the engine cover, which was behind the tail of the airplane, and the propeller and hub assembly, which was 18.40 m away from the nose, toward the airfield. One of the propeller blades, which had a large dent, had in turn detached from the propeller assembly.

It was the front bottom part of the aircraft that impacted the wall, as demonstrated by the fact that the detached propeller blade exhibited a severe impact mark near the root, possibly caused when the blade impacted a rock in the wall, and by the impact marks and dents on the leading edges of the wings and on the bottom front of the engine area.

The damage to the propeller blades and hub was consistent with a direct impact against the wall, but with the propeller not turning, thus corroborating the pilot's statement that he had cut the engine.

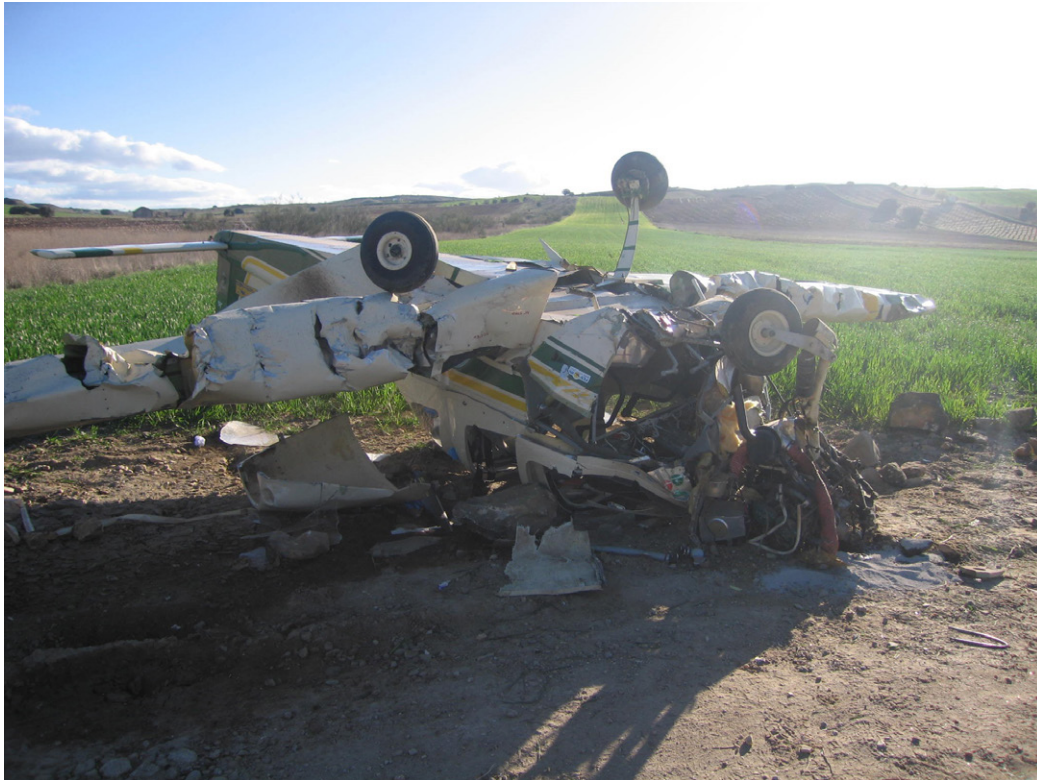
Figure 5: Main wreckage of the accident aircraft

The accident aircraft had flipped over and was upside down and practically destroyed, with the exception of the tail empennage. Almost all of the damage was caused by the impact itself.

There was fuel remaining in the aircraft, part of which spilled onto the road.

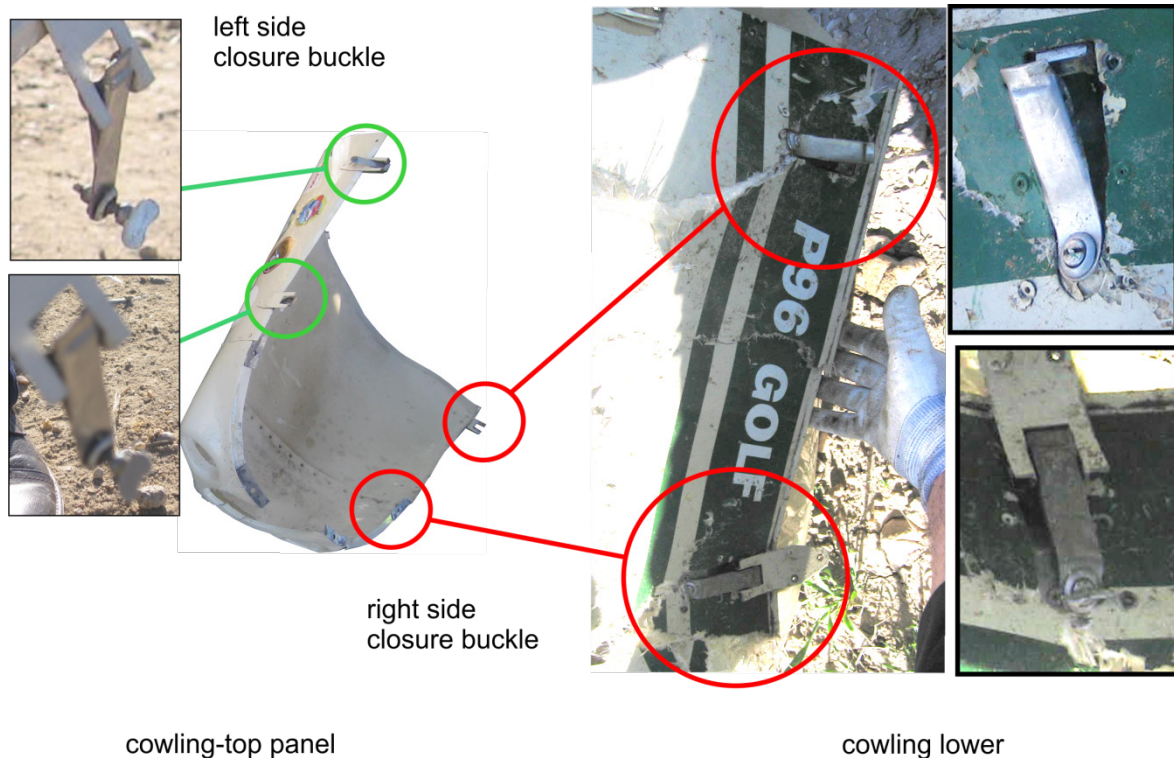
Fig. 6 – Close-up of the engine cover locking latches

As for the locking latches on the engine cover, both of the latches on the right side had the moving part of the locking lever locked. On the rear latch, the locking buckle had detached, and on the front latch, the top part of the locking buckle was torn from its housing.

As for the buckles on the left side, they were in good condition and the moving part of the locking levers was released.

As concerns the locking latches on the engine cover, those on the left side were in good condition, with the moving part of the locking levers released. As for the latches on the right side, the front one had its top locking buckle ripped from its housing, and the locking lever on the rear latch had detached from the locking buckle. In both cases the moving part of the locking lever was closed and locked.

Based on its condition, the investigators determined that the left side cover opened under the influence of the air current generated by the propeller, since its latches were not closed and locked. The cover remained attached to the aircraft thanks to the right-side latches, which were bent or detached after the impact, even though the closing lever remained locked. The pilot's statement confirms the fact that the left-side engine cover opened first.

The accident occurred as a result of initiating a flight after failing to properly close and lock the left-side locking latches on the engine cover at the conclusion of the pre-flight inspection.
