Report ULM A-017/2017

Accident involving an AEROPRAKT A-22 aircraft, registration EC-GU4, operated by the Binissalem aeroclub, in the municipality of Escorca (Mallorca, Balearic Islands, Spain) on 8 October 2017

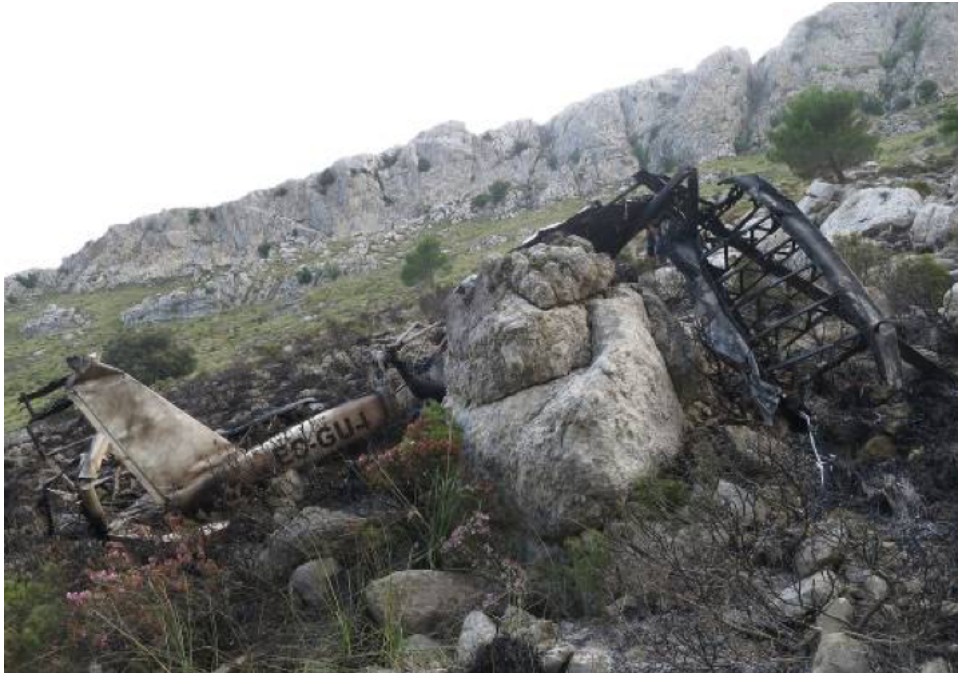
Figure 1. Photograph of the aircraft at the crashsite

The airplane had collided directly with the terrain, with the bottom front of the fuselage impacting first, since there was no significant damage to the landing gear.

The propeller detached and remained at the impact site. The aircraft later caught fire and the rest of the fuselage slid downhill. There were no drag marks or marks of any other kind on the main wreckage or propeller. There were shards of glass from

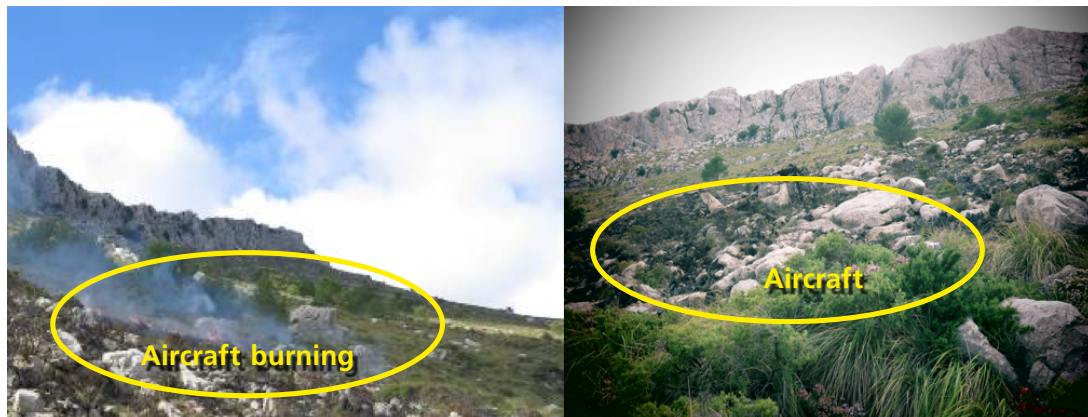
The photographs taken by the rescue team that reported to the site shortly after the impact show clouds in the nearby summits.

Figurea 3. Photographs from rescue personnel after the accident

However, the information provided by the people who were near the accident site, along with the statements and some photographs taken by the rescue team that reported to the site a short time later, which clearly show some clouds at a low altitude, leave open the possibility that the visibility at the accident site may have been partially lost.

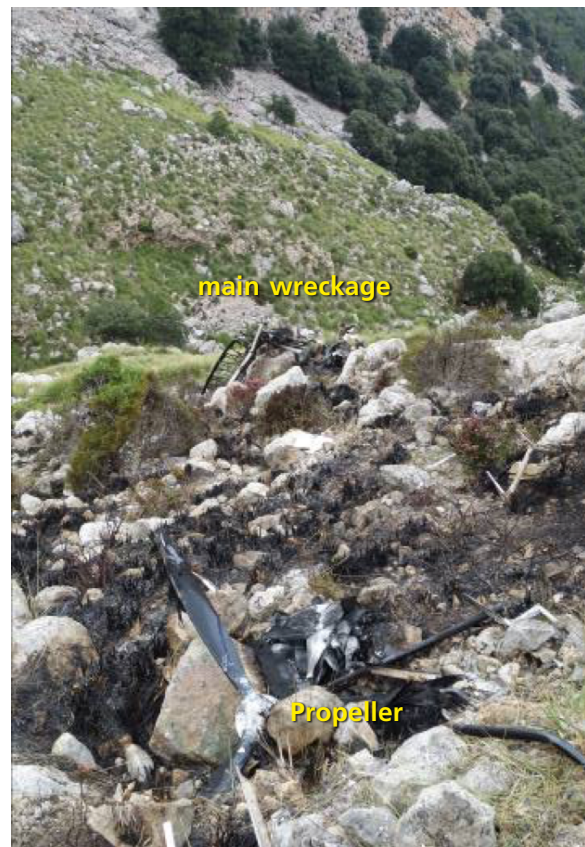
The fuselage was some 45 m downhill, creating a 320° angle with respect to magnetic north. All of the remaining components of the aircraft were grouped together.

Two of the propeller blades showed damage from the fire, but not from the impact. The third blade was broken.

The airplane came to a stop between two large rocks. The outer skin was still present on the tail, except on the rudders, but on the rest of the aircraft this skin had mostly been burned by the fire, especially in the wing, where only the structure remained. The two main beams had been bent downward by the effects of the heat.

Figure 4. Airplane wreckage
