REPORT IN-017/2006

Date and time	Thursday, 6 April 2006; 09:37 UTC (11:37 local time)		
Site	Girona Airport (LEGE)		
AIRCRAFT			
Registration	EC-IPO		
Type and model	CESSNA 421-B		
Operator	Private		
Engines			
Type and model	TELEDYNE CONTINENTA	L GTSIO-520-H	
Number	2		
LKEVV	Dilot in commented	Ca l	~ +
4.00		Student pilo	JL
Age			1
Licence		CPL(A)	
	2,700 n	2,075 n	
	50 11	140 11	
NJURIES	Fatal	Serious	Minor/None
Crew			2
Passengers			
Third persons			
DAMAGE			
Aircraft	Minor		
Third parties	Minor damage to the ru	nway	
Operation	General aviation – Flight	t training – Dual	
Phase of flight	Landing run		
REPORT

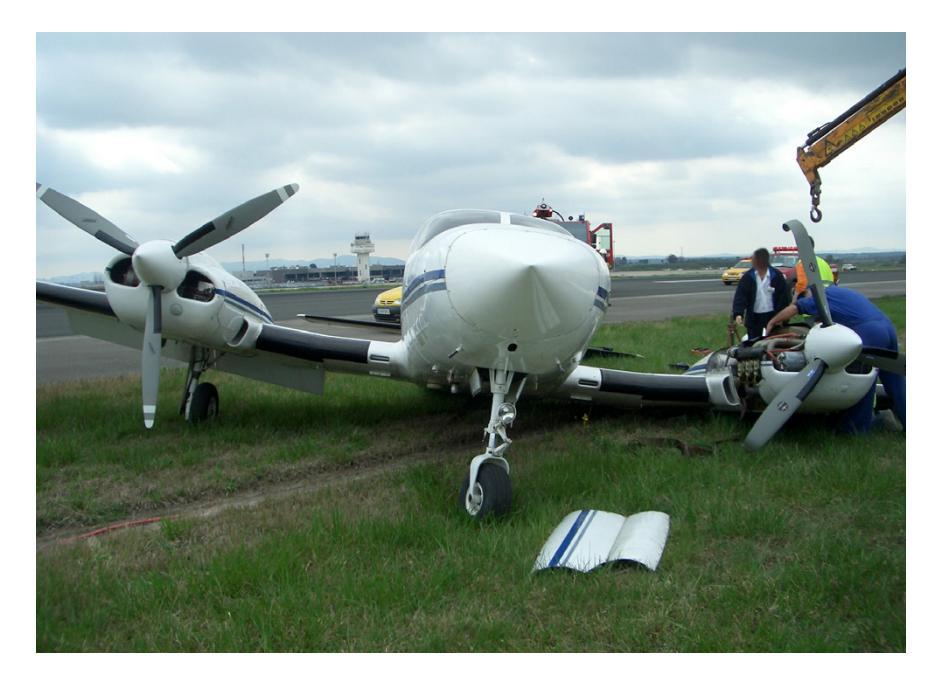
Figure 1. Aircraft following the incident

During a visual inspection of the aircraft performed at the incident site, it was noted that the left main landing gear leg was almost completely retracted inside the wheel

well, and that some pieces had broken off its actuating mechanism. Consequently, the aircraft had fallen toward that side, resulting in scratches along the bottom of the fuselage and left wing, especially the left flap, as well as in a bent left wingtip.

It was also noted that the tips of the left propeller blades were bent and worn by abrasion, indicative of having struck the runway several times. The trailing edge of the left-side flap and some components from the left wingtip were also scraped.

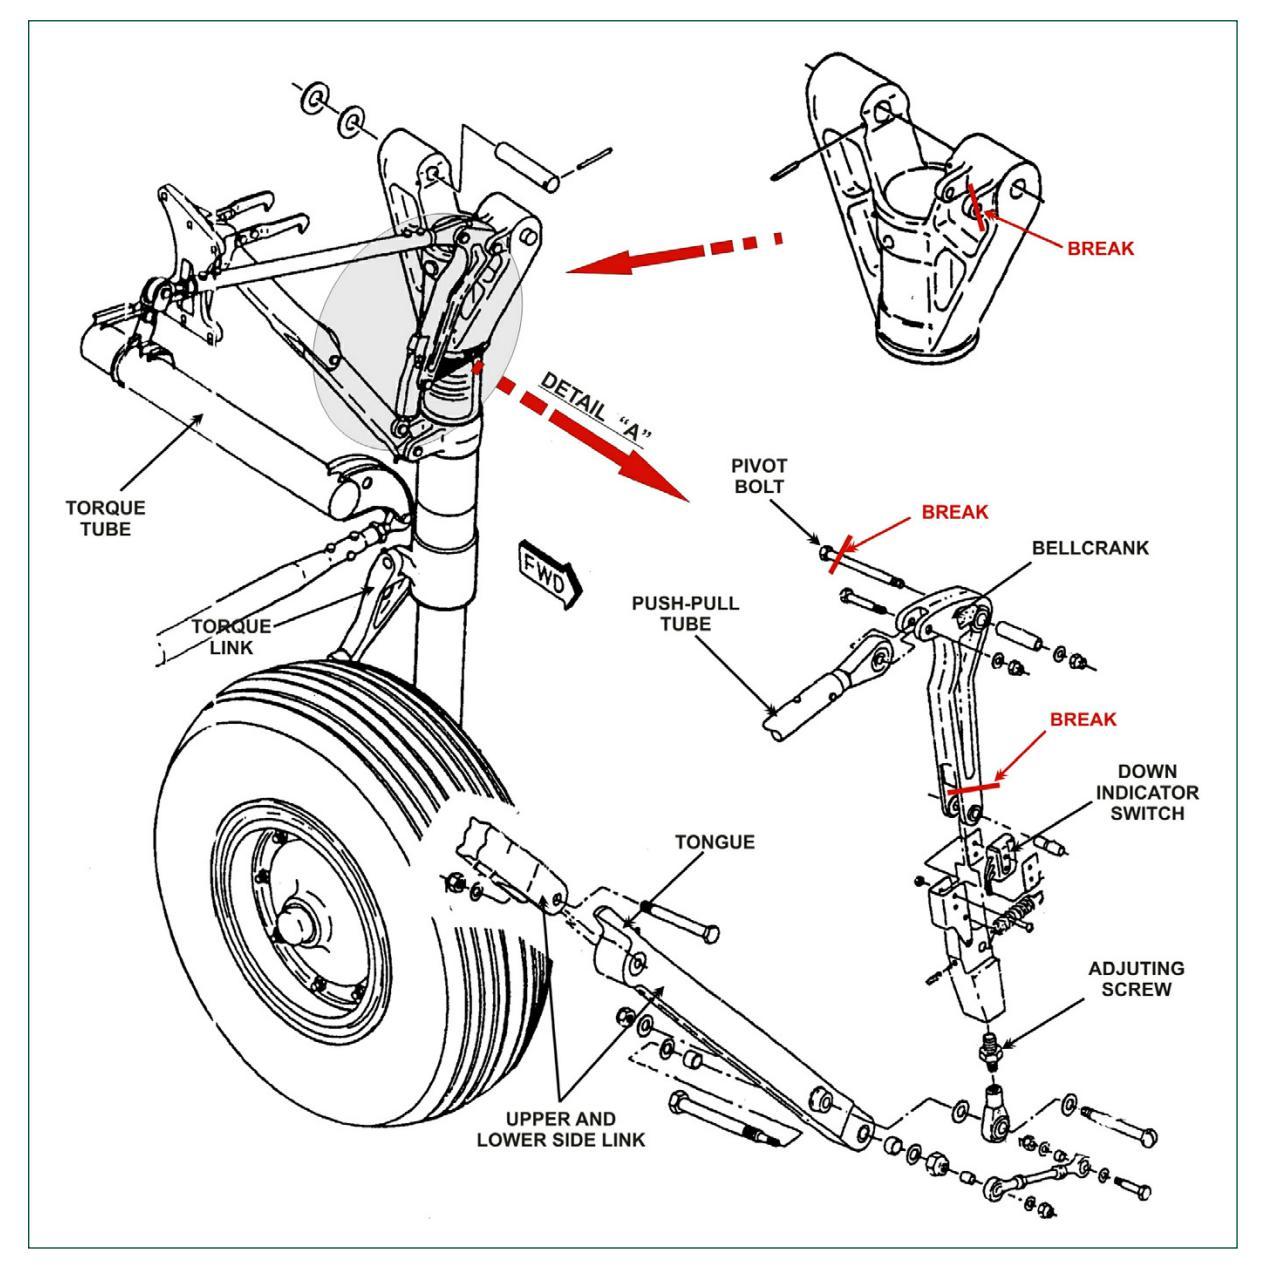
Figure 2 shows a diagram of the left landing gear leg in its extended position. Also shown in the figure is a detailed view of the leg's mechanism with the names of those components most relevant to this incident and, in red, the breaks discovered, to be addressed later.

Figure 2. Diagram of the left gear leg

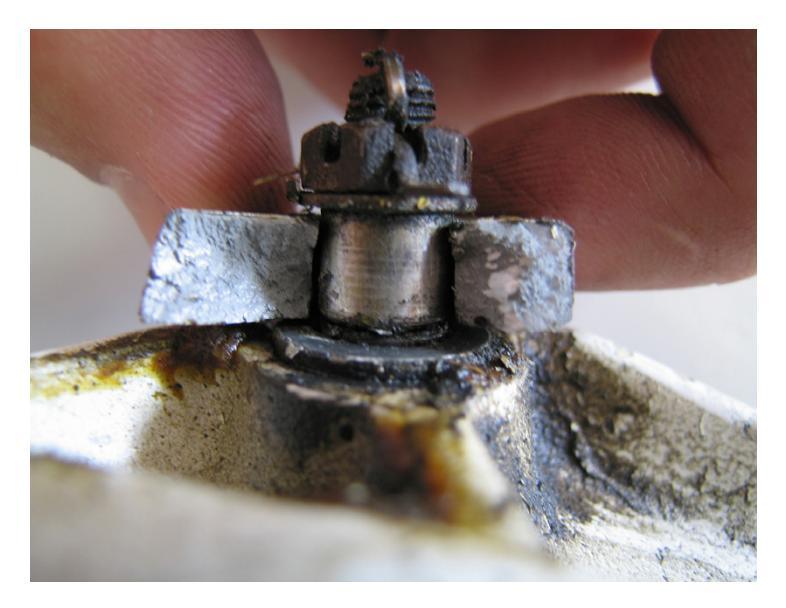
- The right lug fitting as seen from the wing root (that is, the one in the front) which supports the pivot bolt in the truss assembly was broken at the hole for the pivot bolt. The detached piece from the lug was later found. The break is shown in Figure 2, and Figure 3 shows the lug piece superimposed on the bellcrank. This superposition revealed that the pivot bolt hole was slightly ovalized.
- The pivot bolt (NAS 464P4-26) also broke between the left lug of the aforementioned fitting, which was intact, and the bellcrank, as shown in Figure 2.
- The lower right lug on the bellcrank was fractured in the section where the thickness begins to increase and which corresponds with the limit switch for the leg. As shown in Figure 4, this break involved a bending component toward the outside of the bellcrank (front of the aircraft) and also affected the lug bushing.

Figure 3. Break of the bellcrank lug

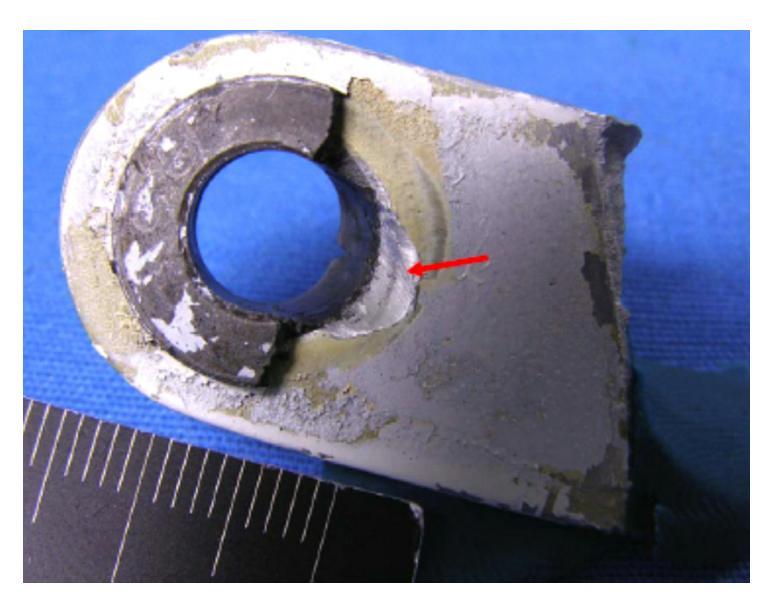
Figure 4. Break of the lower bellcrank lug

exceeding the mechanical limits of the materials involved. An existing plastic deformation was found in the break of the lower bellcrank lug, while the bushing had suffered a brittle fracture.

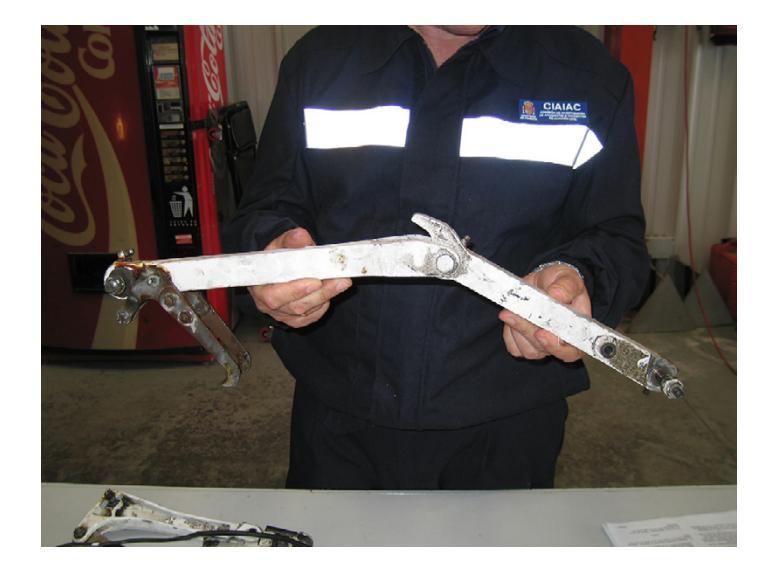
- Slight play was noted in the LH torque link. This was the result, and not the cause, of the incident. The lower front part of the torque link was also fretted from making contact with the ground. Friction marks from the ground were also noted on the outer wheel rim.
- There were no signs of lateral slippage on the left gear tire. Such signs were noted on the right.
- Lastly, there were no deformations or stress marks on the hinge tab between the two parts of the side link assembly (Fig. 5).

Figure 5. Condition of the lower side link following the accident

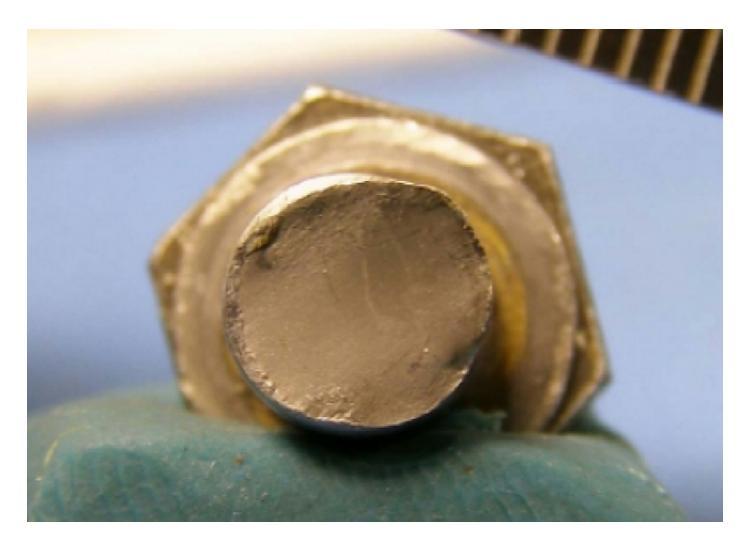
Specifically, for the pivot bolt (NAS 464P4-26), an analysis was performed to compare the pivot bolt sheared in the incident and the undamaged pivot bolt from the right gear. This analysis showed that though both bolts were of the same type, their chemical compositions were slightly different, resulting in different breaking loads, the one for the sheared bolt being greater (129.78 kg/mm², versus 123 kg/mm²). Both were near or above

Figure 6. Fracture of pivot bolt NAS 464P4-26

the specification required for the bolt type (112/126 Kg/mm²). It should be noted that these results were obtained through a hardness test, and are thus for information purposes only.

A fractographic analysis of the fracture surface on the pivot revealed a smooth appearance (Figure 6) and a certain degree of plastic deformation. The break is of a ductile nature, there being no signs of a pre-existing flaw or crack.

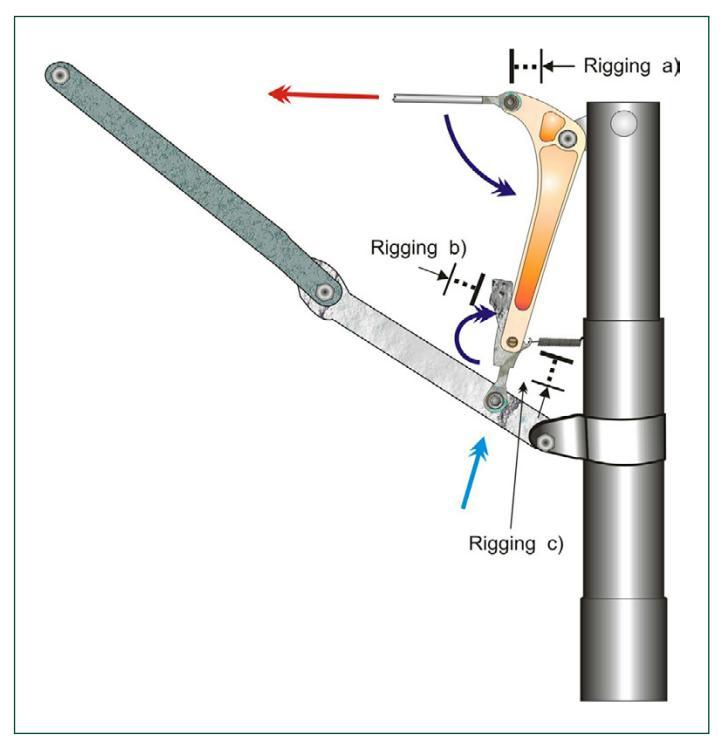
Figure 7. Possible adjustments

position (down and locked) and the tests performed by varying the above-mentioned adjustments led to the identification of the two ways in which the bellcrank can be subjected to excess loads and outside operating parameters.

- I With adjustment a), the cutoff switch for the motor when extending, beyond its appropriate position, tension is placed on the push-pull tube, and therefore on the upper bellcrank arm. If at the same time the length of the lower bellcrank arm is made excessive using adjustment c), this places a compressive load on the lower bellcrank arm. As a result of either or both loads, the pivot bolt is conditioned for a shear fracture at an intermediate angle between the two arms of the bellcrank.

- II A setting contrary to that mentioned above for adjustment c) leaves the lower side link or overcenter with enough clearance at its mechanical stop to allow for the appearance of an oscillatory motion around a neutral axis as a consequence of lateral loads on the leg. This clearance may result from an adjustment of a) as mentioned in the previous paragraph, which would take the gear down switch (adjustment b) to the stop without a fault indication. This oscillatory motion of the overcenter induces loads on the bellcrank, and therefore on the pivot bolt, with results similar to those above and with larger absolute values due to the geometry of the mechanism.

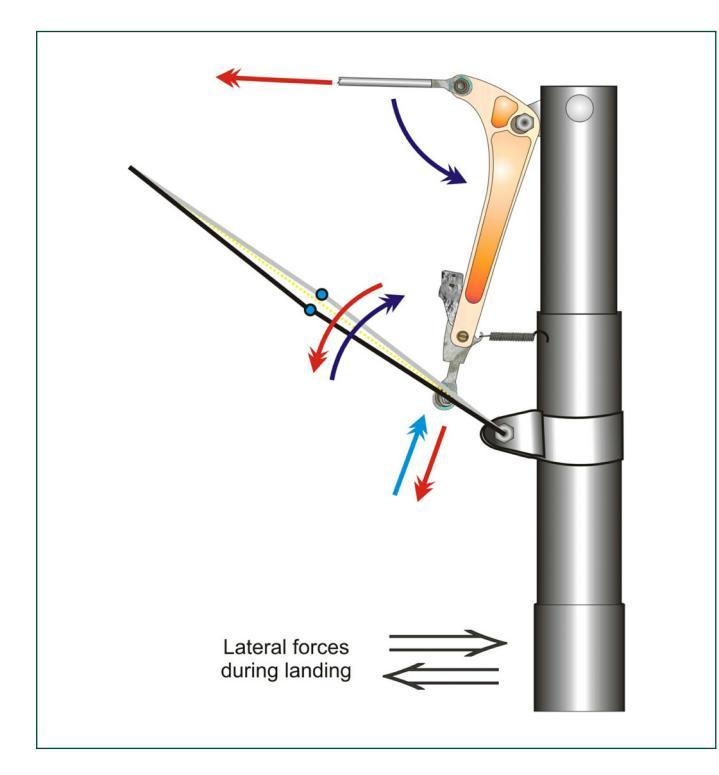
The mechanism must be properly adjusted or calibrated if it is to maintain a suitable geometry in all its configurations and an adequate load distribution within design criteria, without bending and imparting loads on relatively weak components which were designed

Figure 8. Diagram showing forces on the mechanism

to move the mechanism and not to absorb landing forces.
