COMISIÓN DE INVESTIGACIÓN DE ACCIDENTES E INCIDENTES DE AVIACIÓN CIVIL

Report IN-029/2006

Wake turbulence encounter in high-level air space involving an AIRBUS A320 aircraft, registration EC-JDK, operated by Vueling, in route between Barcelona and Santiago de Compostela on 28 May 2006

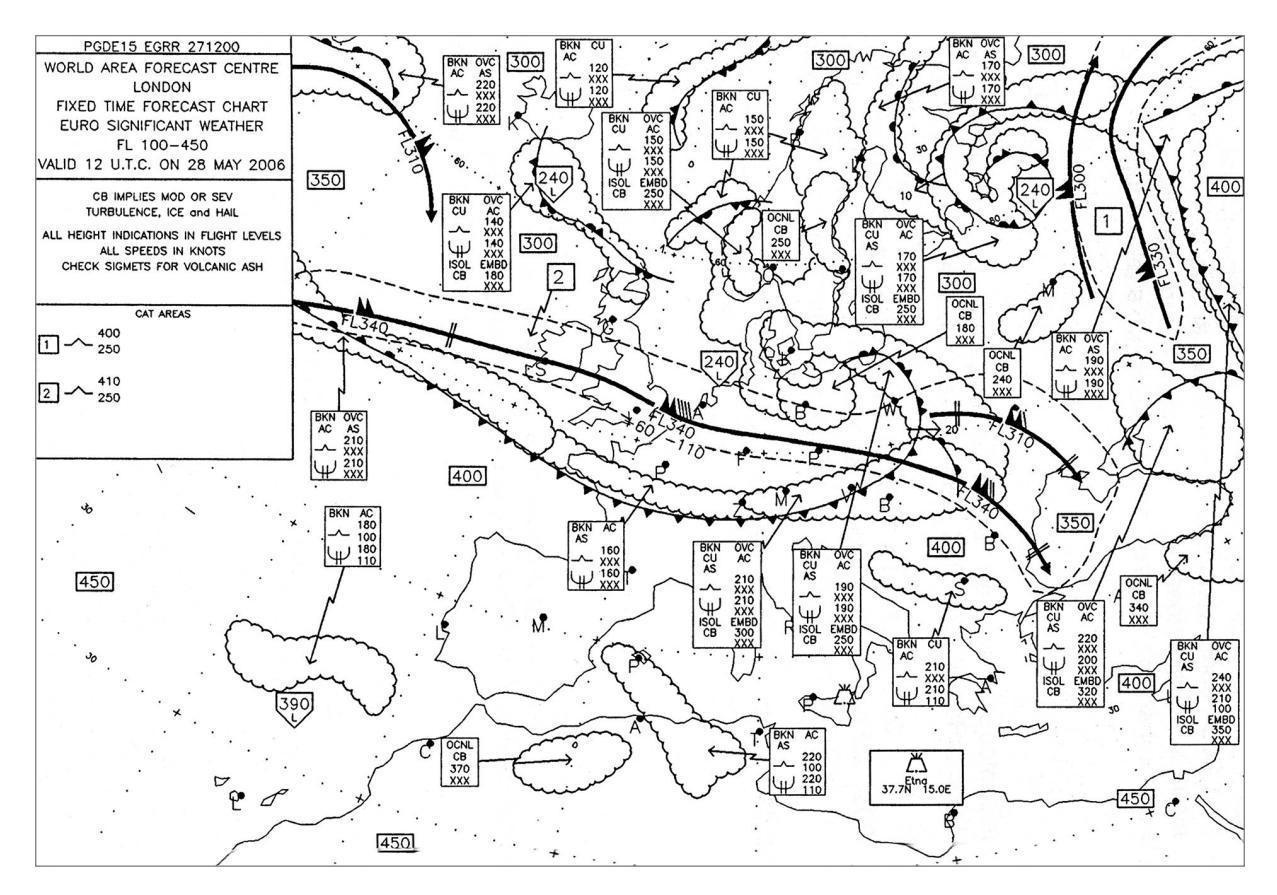
Figure 3. Chart issued by the World Area Forecast Centre

There was no record of any temperature anomalies, clear air turbulence, mountain waves, wind shifts or any other phenomenon that could be related with this incident between altitudes of 34,000 and 37,000 ft.

An analysis of the weather information reveals that the general situation in the area at the time of the incident did not contribute to the turbulence encountered, though the atmospheric stability and the low, steady winds were conducive to preserving the wake turbulence conditions.

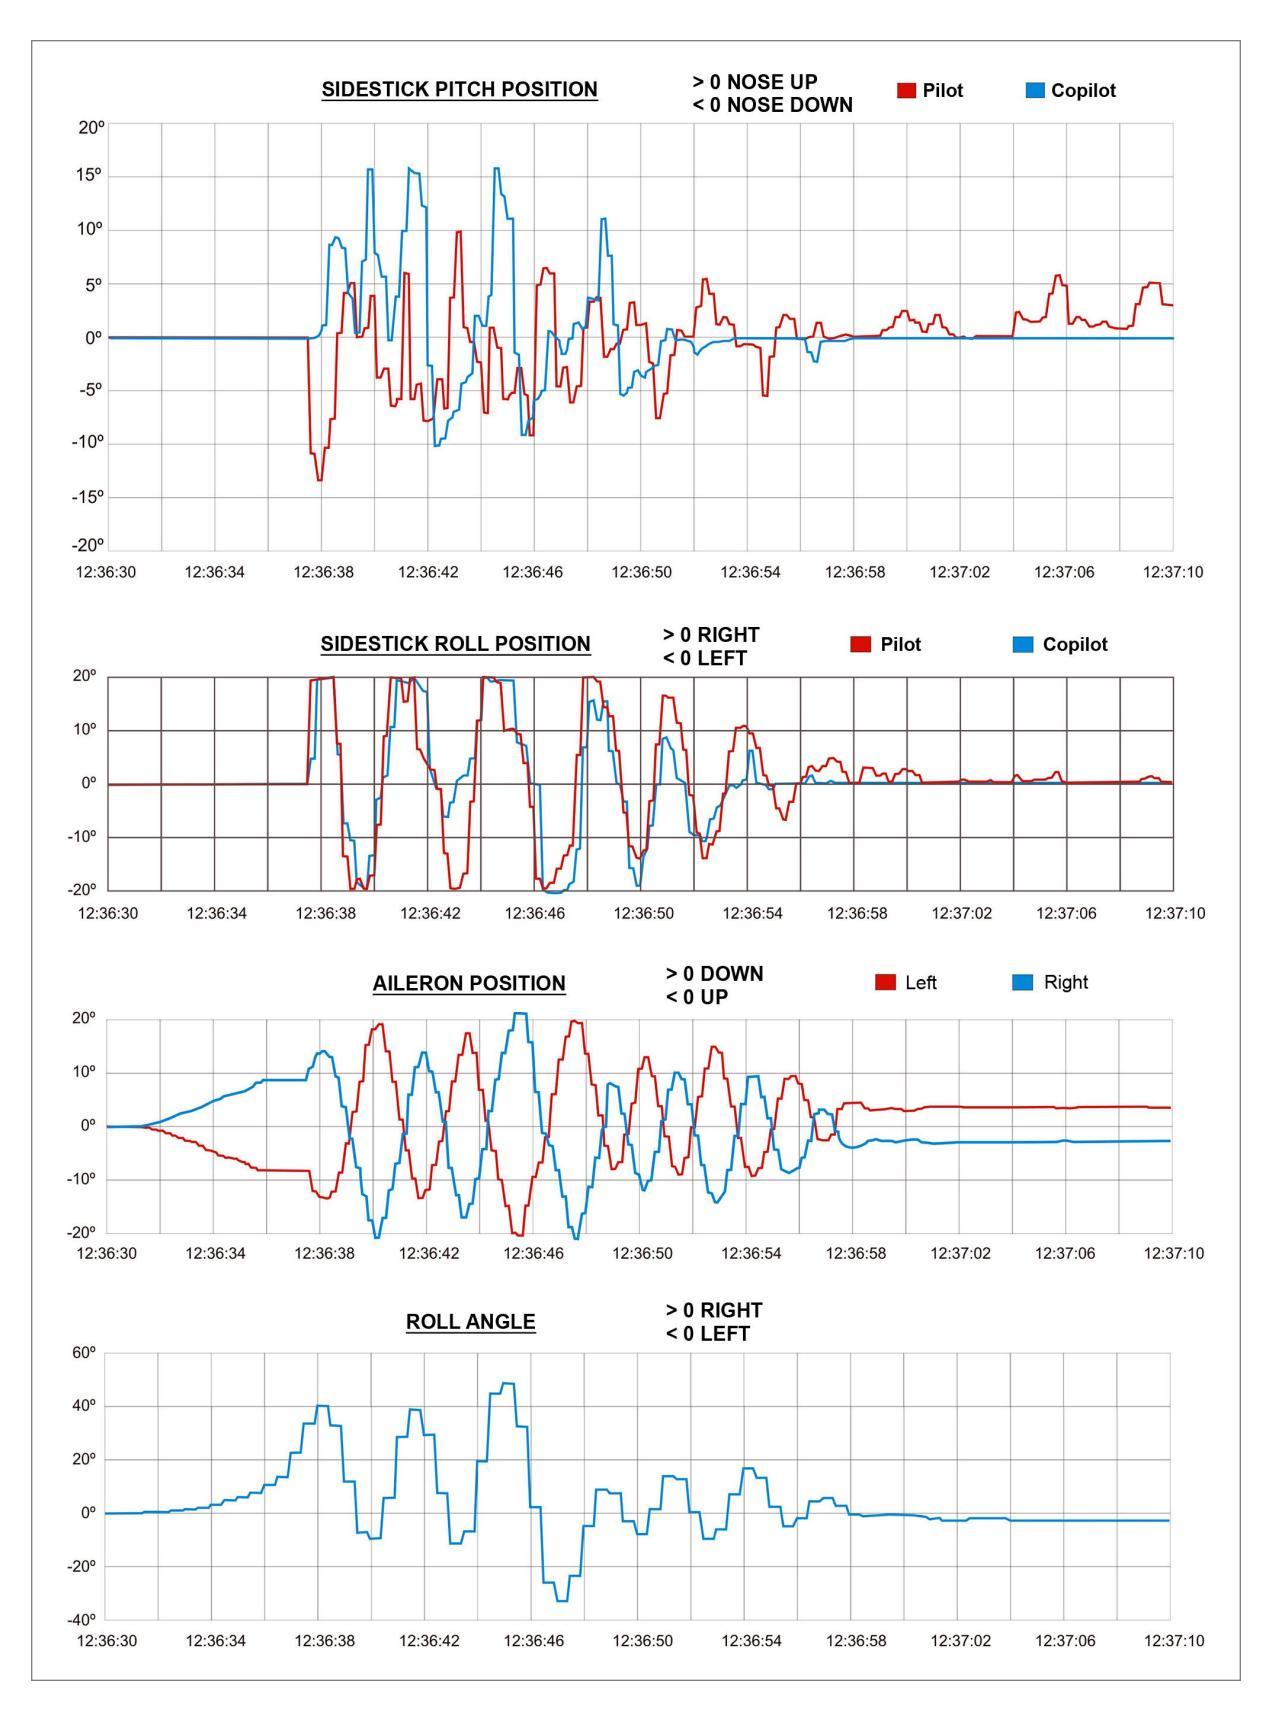
Figure 4. Positions of flight controls, ailerons and roll angle

One second later, at 12:36:39, both sidesticks were positioned full to the right, the left pedal displacement was reduced to 1.7° and the rudder deflection was 0.6° right, which resulted in a decrease in roll angle to -9.1° (negative values indicate a left bank).

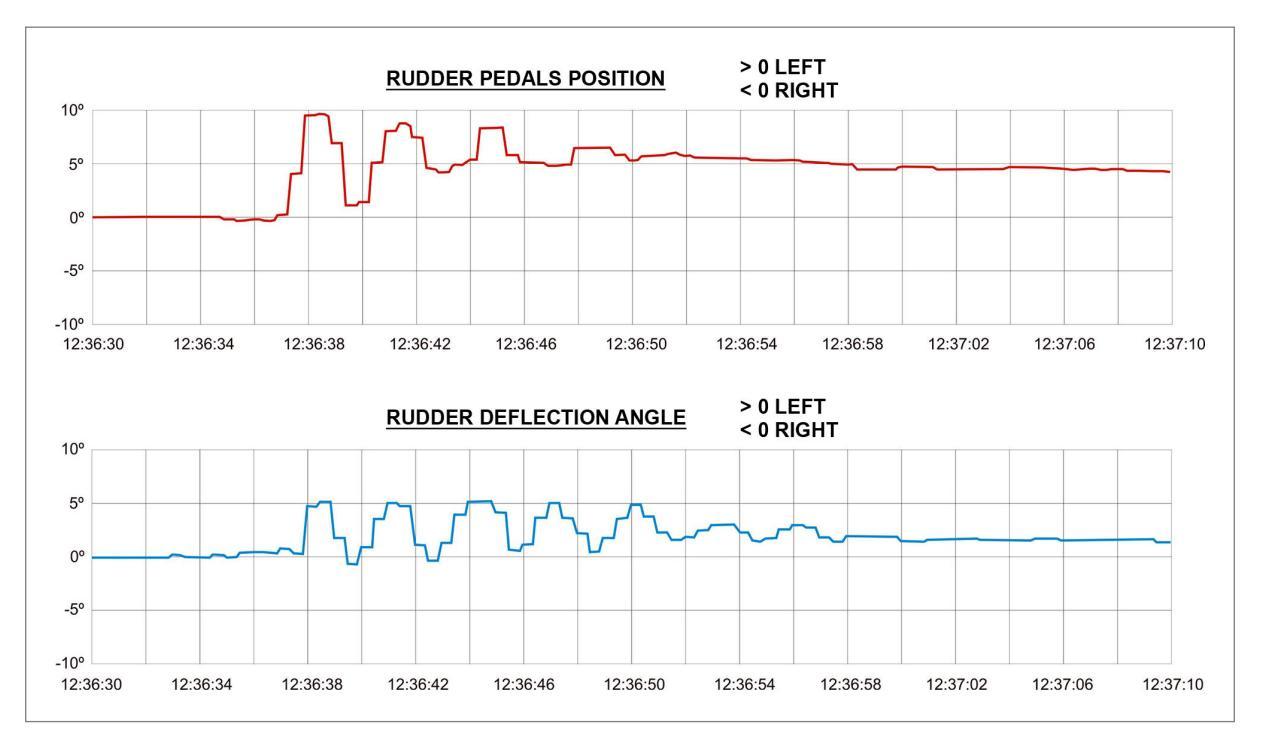
Figure 5. Rudder pedal position and rudder deflection angle

An evaluation of the lateral loads confirmed that the vertical stabilizer and rudder had been subjected to loads of 125% of the limit load value. The maximum theoretical resistance of the tail prior to failure is 150% of the limit load.

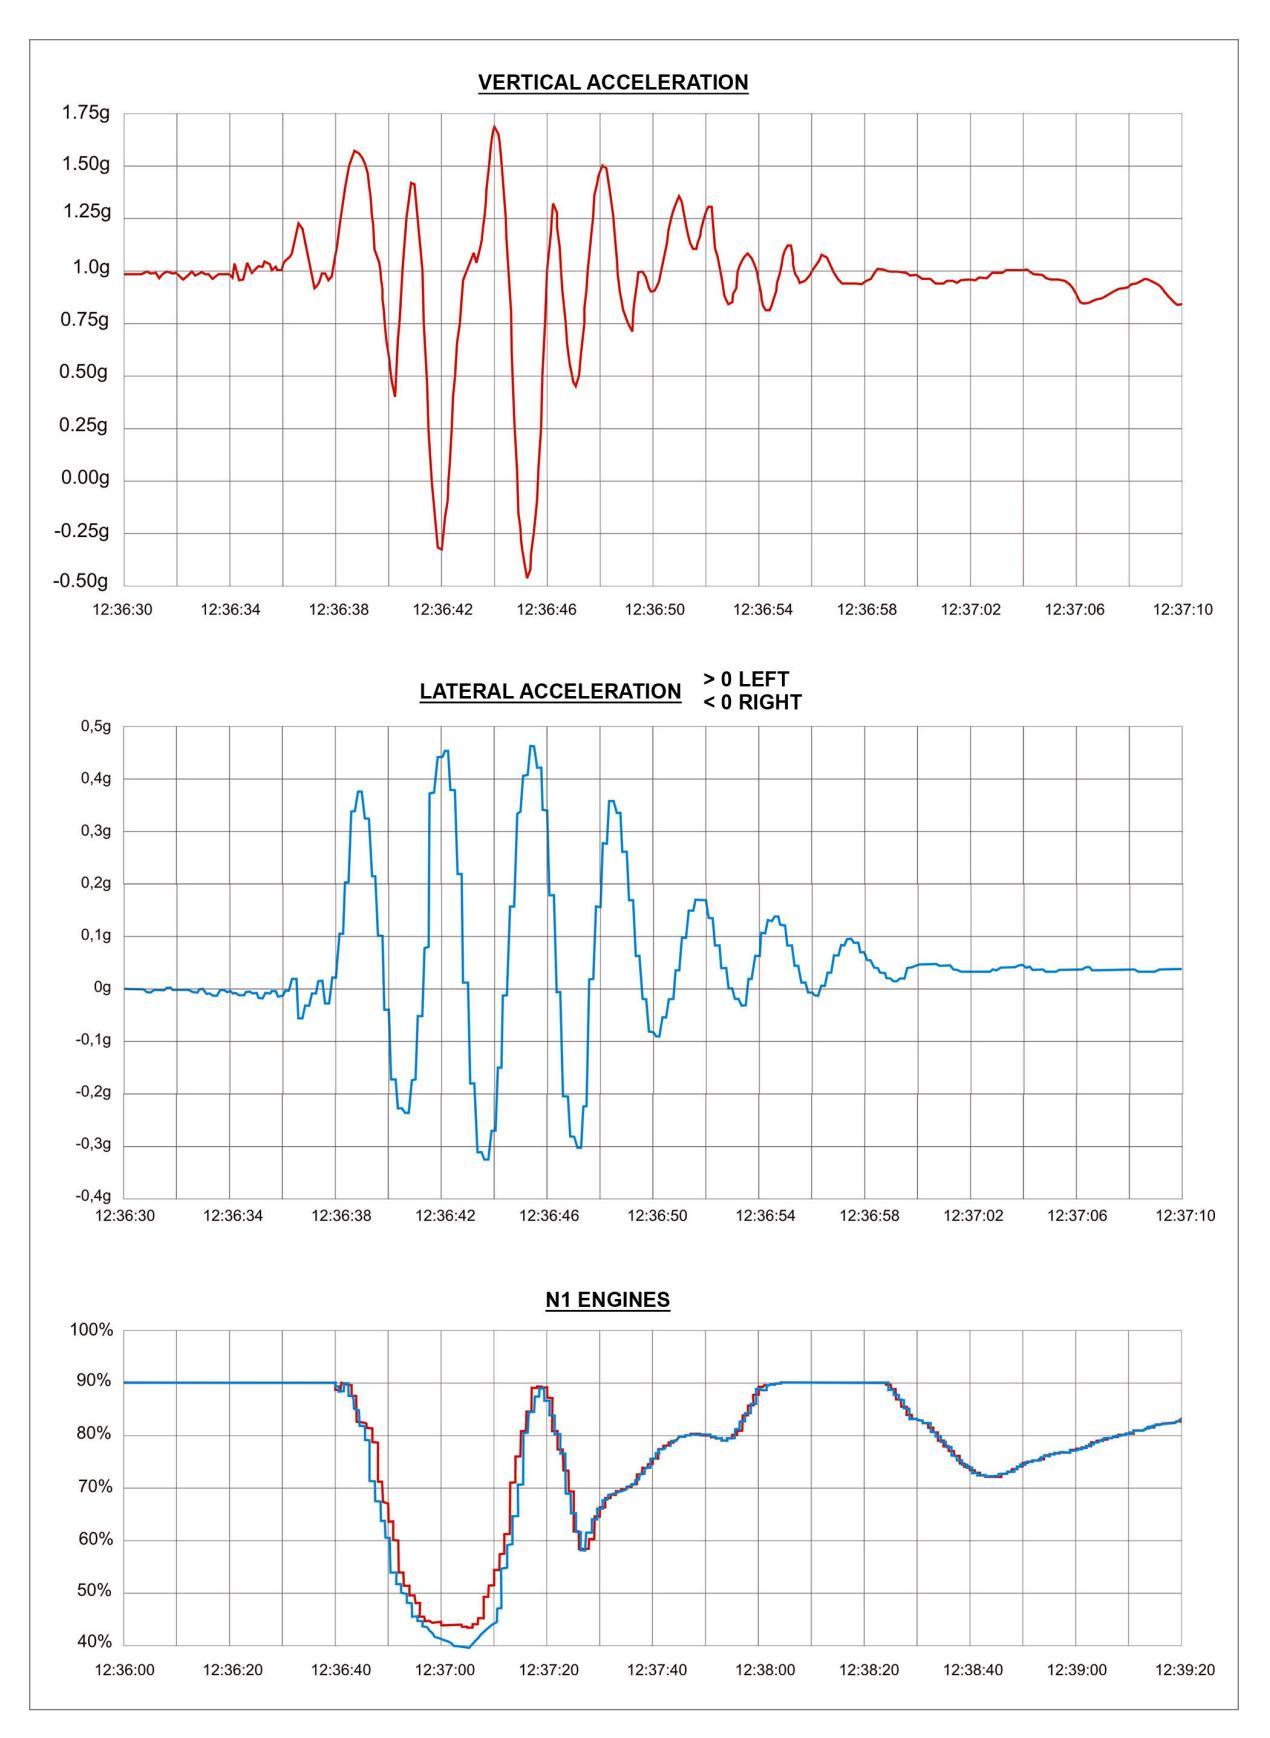
Figure 6. Vertical and lateral accelerations and engines N1

In this specific case, this inspection was conducted at Santiago de Compostela airport and did not reveal any damage. The maximum vertical acceleration values to which the aircraft was subjected during the event were 1.69 g and -0.45 g, which are below the thresholds specified in the maintenance manual, above which an aircraft inspection is required.

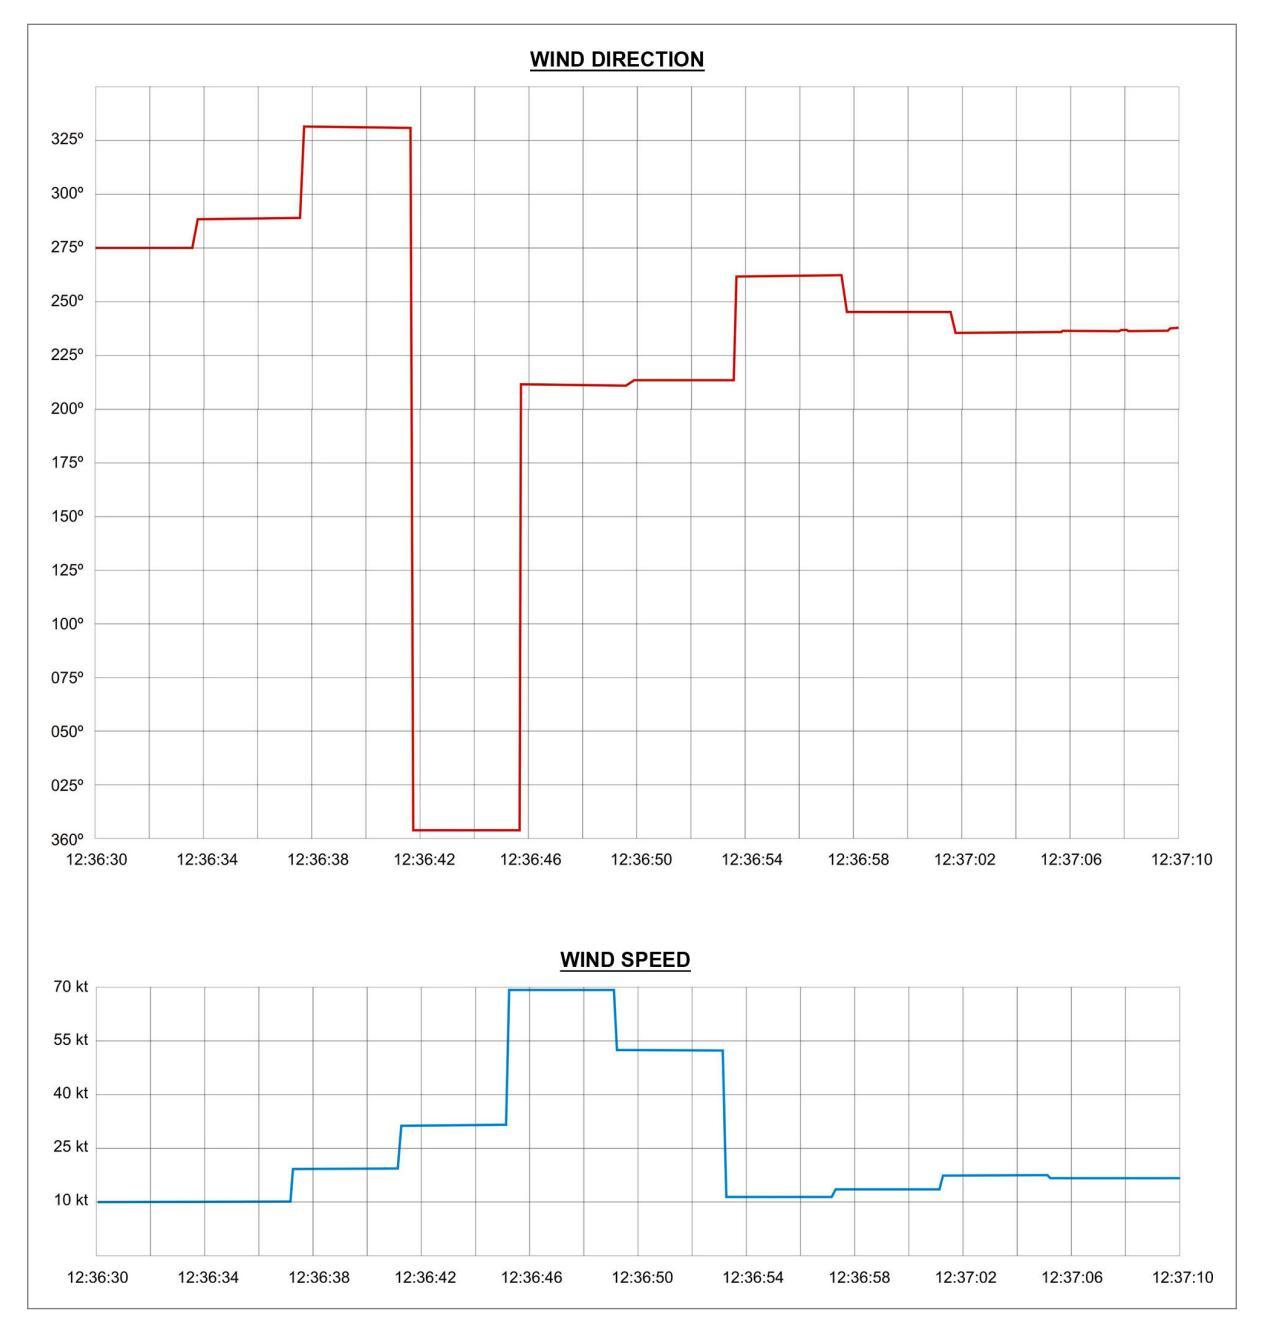
Figure 7. Wind direction and speed

The relative wind (as felt by the aircraft) varied in direction from 272° initially to 285° and finally to 318°, with the speed increasing from 10 kt to 19 kt.
