REPORT IN-003/2010

Date and time	Saturday, 30 January 2010; 09:25 UTC ¹		
Site	Malaga Airport (LEMG)		
AIRCRAFT			
Registration	EC-IJI		
Type and model	PIPER PA-28-R 200 "Cherokee Arrow II"		
Operator	Private		
Engines			
Type and model	LYCOMING IO-360-C1C		
Number	1		
LICENCE	CPL		
Pilot in command			
Licence	CPL		
	1,911.35 h		
Total flight hours	1,911.35 h		
Total flight hours Flight hours on the type	1,911.35 h 758.83 h		
Total flight hours Flight hours on the type NJURIES	1,911.35 h 758.83 h Fatal	Serious	Minor/None
Total flight hours Flight hours on the type NJURIES Crew	1,911.35 h 758.83 h Fatal	Serious	Minor/None 1
Total flight hours Flight hours on the type INJURIES Crew Passengers	1,911.35 h 758.83 h Fatal	Serious	Minor/None 1 1
Total flight hours Flight hours on the type NJURIES Crew Passengers Third persons	1,911.35 h 758.83 h Fatal	Serious	Minor/None 1 1
Total flight hours Flight hours on the type NJURIES Crew Passengers Third persons DAMAGE	1,911.35 h 758.83 h Fatal	Serious	Minor/None 1 1

1.1. Description of event

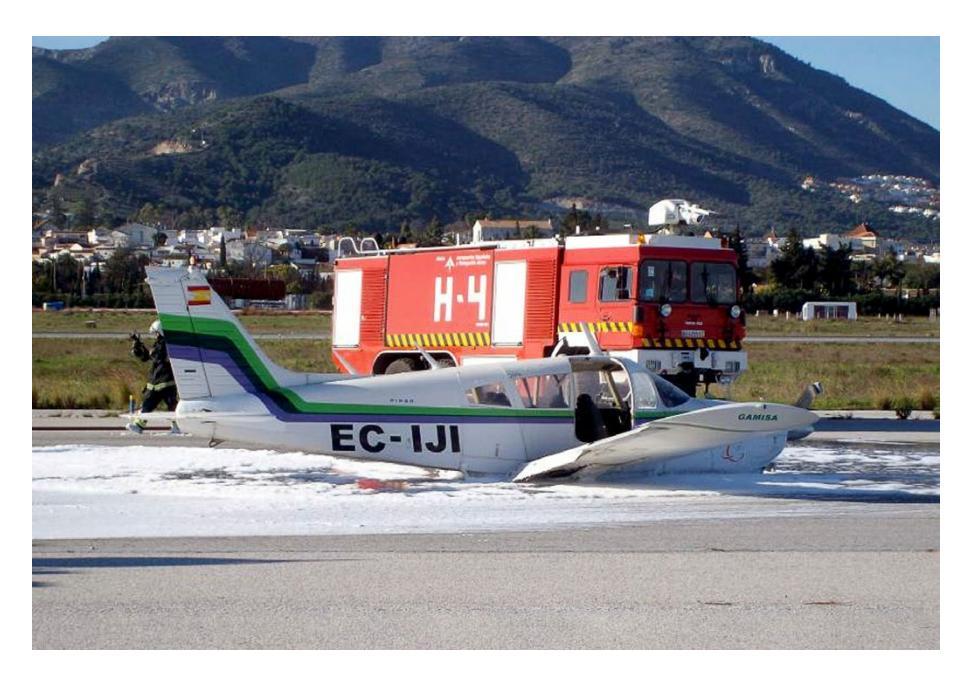
During the approach phase, the pilot realized that the landing gear was not fully locked. He informed the control tower and made a go-around maneuver. After making several fly-bys of the tower, several controllers informed the pilot that the front gear leg was fully retracted and that the main gear legs were between 30 and 45° from the horizontal. The pilot then decided to proceed to point E1 of the CTR, where he performed the emergency procedure for lowering the gear. After several failed attempts, he decided to remain airborne to burn fuel and then, after declaring an emergency to the control tower, proceeded to land on the taxiway, as proposed by air traffic control. Neither the pilot nor the passenger were injured. The underside of the fuselage, landing gear doors and propeller blade tips were damaged.

Figure 1. Photograph of aircraft after the incident

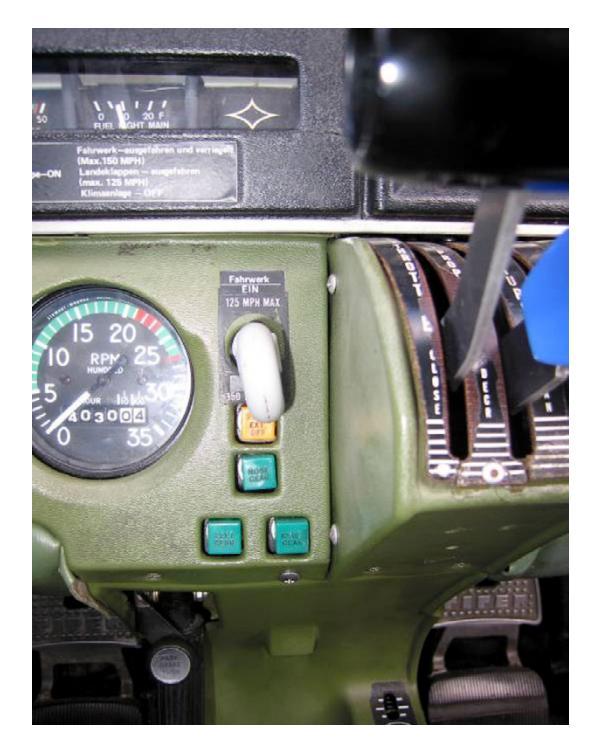
The retractable landing gear is hydraulically operated by an electrical reversible pump. There is an actuating lever on the instrument panel to the left of the control quadrant that is used to select the gear to the UP or DOWN position. The different gear positions are indicated by way of three green lights underneath the gear actuating lever for the "gear down and locked" position. There is a yellow light situated at the top of the instrument panel for the "gear in transit" position, whether up or down. There is no light to indicate that the gear is fully retracted, the only such indication being that all of the other lights are off (see Figure 2).

Figure 2. Photo of gear lever and associated lights

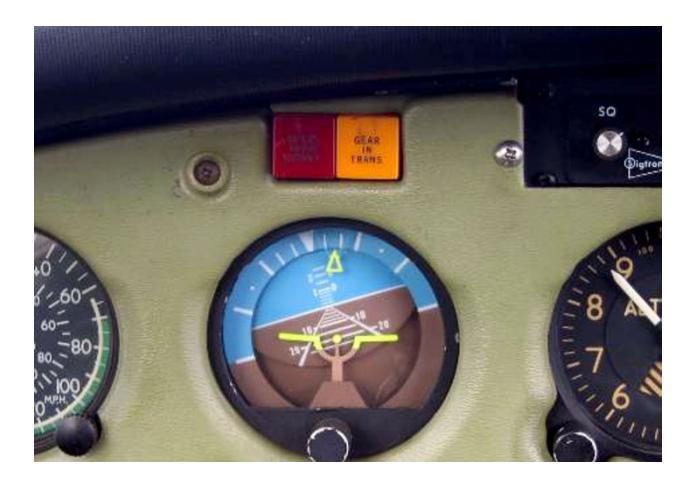
There is a red warning light to the left of the yellow one (see Figure 3) that operates in conjunction with an aural warning and has a dual purpose: to warn when thrust is reduced below approximately 14 inches of intake pressure and the gear is not down and locked; and to warn that the gear lever is in the UP position with the aircraft on the ground or at a speed below that required to close the hydraulic valve and the switch for the backup gear extender (BGE) pump (see Section 1.3.3).

Figure 3. Photo of the gear in transit lights (yellow) and gear unsafe light (red)

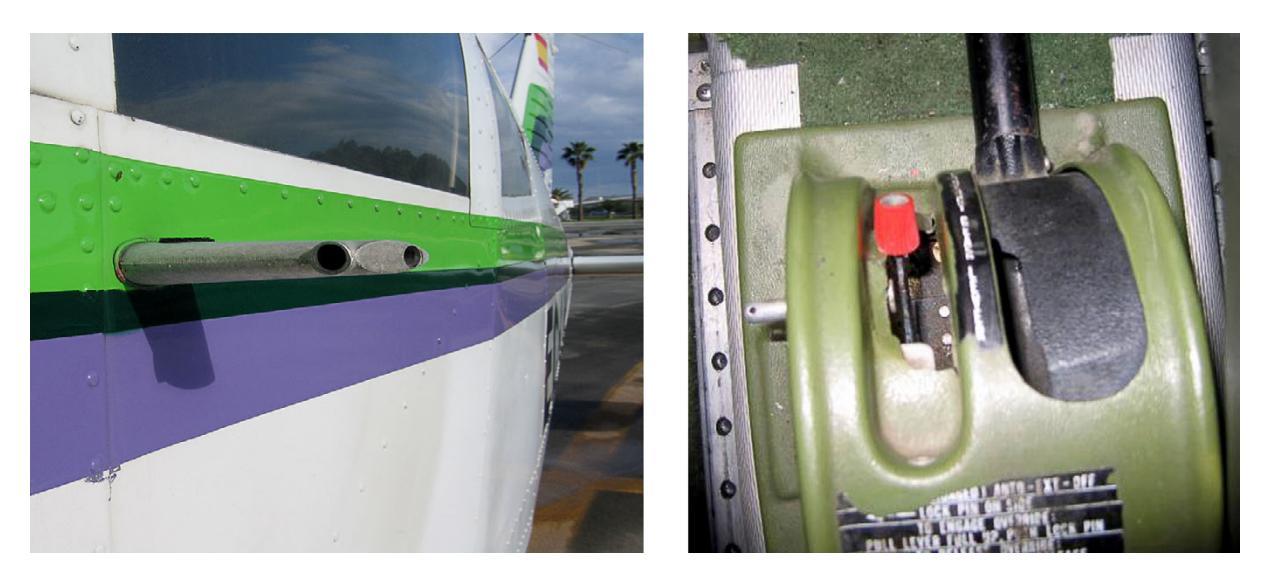
As described in the Pilot's Operating Handbook, the system is controlled using the difference in air pressure across a diaphragm that is mechanically linked to an electronic valve and to an electronic switch that turns the electrically powered hydraulic pump pump on. The system that provides information on the static and ram pressure at the diaphragm is located in the left part of the fuselage above the wing (see Figure 4). Any obstruction of the ports could cause the gear to lower.

Figure 4. View of the pitot/static tube that supplies information to the BGE. Emergency gear lever

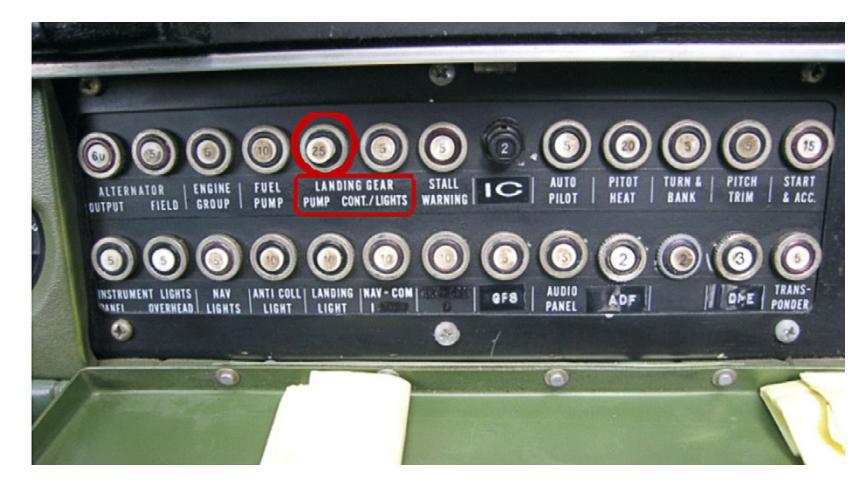
The aircraft was taken to the apron and inspected a few days later. It was resting on the bottom of the fuselage and had been cordoned off by the Civil Guard. After conducting a visual inspection of the outside and taking some initial photographs, the cockpit was inspected before any other actions were taken with the aircraft. Inside the cockpit it was noted that the flaps lever was in the flaps retracted position (though information provided during the investigation confirmed that at least one notch of flaps was used during the landing), the gear lever was down, and the emergency lever in AUTO. The circuit breaker panel situated at the right of the cockpit was not visible to the naked eye and was protected by a cosmetic lid like that used for a glove box. When opened, it was noticed that the breaker for the landing gear pump was open (see Figure 6).

Figure 6. Close-up of the position of the landing gear pump breaker

During the inspection of the aircraft a week later, it was noted that in the breaker panel located in the right side of the cockpit and shielded by a cover, breaker 25 A (CB), associated with the landing gear pump, was tripped. The pilot did not mention having reset this breaker, though he did make reference during his statements that he had carried out the emergency procedure. Item 2 in this procedure requires a check of the condition of the breakers, though it should be noted that in an emergency, this check cannot be made quickly without first removing the cover that hides the breakers and which is located on the side of the cockpit opposite the pilot's seat.

- The dimensions and condition of the taxiway were suited for landing an aircraft of these characteristics.
- Breaker 25A, associated with the gear pump, was found in a tripped position.

- **REC 56/11.** It is recommended that the CAMO, SINMA Aviación, establish a system for two-way communications with operators so as to be informed in real time of any anomaly or discrepancy affecting an aircraft for which it is responsible.
- **REC 57/11.** It is recommended that Spain's State Aviation Safety Agency (AESA) establish the procedures and means necessary for ensuring that approved CAMOs establish a system for two-way communications with operators so as to be informed in real time of any anomaly or discrepancy affecting an aircraft for which it is responsible.
- **REC 58/11.** It is recommended that PIPER evaluate the possibility of modifying the design of the cover that shields the breakers in the Piper PA-28R-200 aircraft so as to allow for greater visibility when checking the status of these breakers, especially in emergency situations.
