REPORT IN-037/2012

Date and time	Friday, 21 September 2012; 19:16 UTC ¹					
Site	On approach to runway 06 at the Ibiza Airport (LEIB) (Spain)					
AIRCRAFT						
Registration	EC-JIL			CS-DNP		
Type and model	BOMBARDIER Inc. BD-700-1A10			DASSAULT FALCON 2000		
Operator	Punto-FA, S.L.			Netjets Europe		
Engines						
Type and model	ROLLS & R	OYCE BR70	0-710A2-20	HONEYWEI	L CFE 738-	1-1B
Number	2			2		
CREVV	Cantain	First	officer	Cantain	First	officer
Δαρ	38	46	omeer	48	38	onneer
Licence	ΔΤΡΙ	CPI			CPI	
Total flight hours	6.600 h	3.600	h	7.570 h	5.000	h
Flight hours on the type	2,900 h	1,900	h	1,767 h	1,000	h
	Fatal	Serious	Minor/None	Fatal	Serious	Minor/None
Crew			2			3
Passengers			9			/
Inird persons						
DAMAGE						
Aircraft	None			None		
Third parties	None			None		
FLIGHT DATA						
Tipo de operación	General aviation – Business Commercial Air Transport – Charter –			rt – Charter – r		
Phase of flight	Approach			Approach	i i ussenge

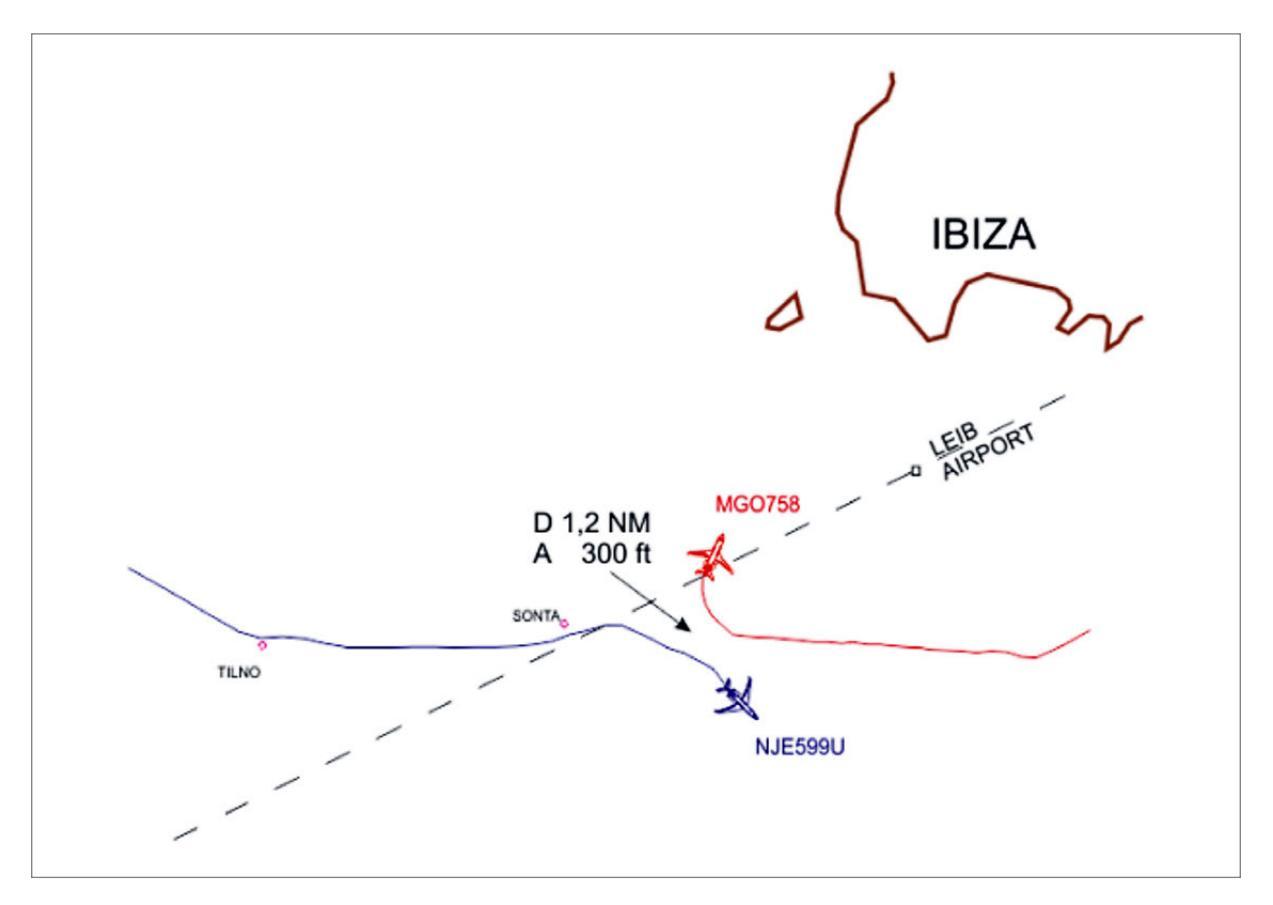
Figure 1. Aircraft flight paths

At 19:16:38, both aircraft notified ATC⁷ that they had received a TCAS RA⁸. Aircraft CS-DNP was established at 3,000 ft and had passed the runway 06 localizer, on a heading opposite that being flown by EC-JIL, which was descending to 2,500 ft as authorized. The two aircraft flew within 1.2 NM horizontally and 300 ft vertically of each other.

The incident, then, can be deemed to have been caused when the flight paths of EC-JIL and CS-DNP converged as Ibiza APP was vectoring them for the approach to runway 06 at LEIB, resulting in a violation of the prescribed minimum radar separation distances.

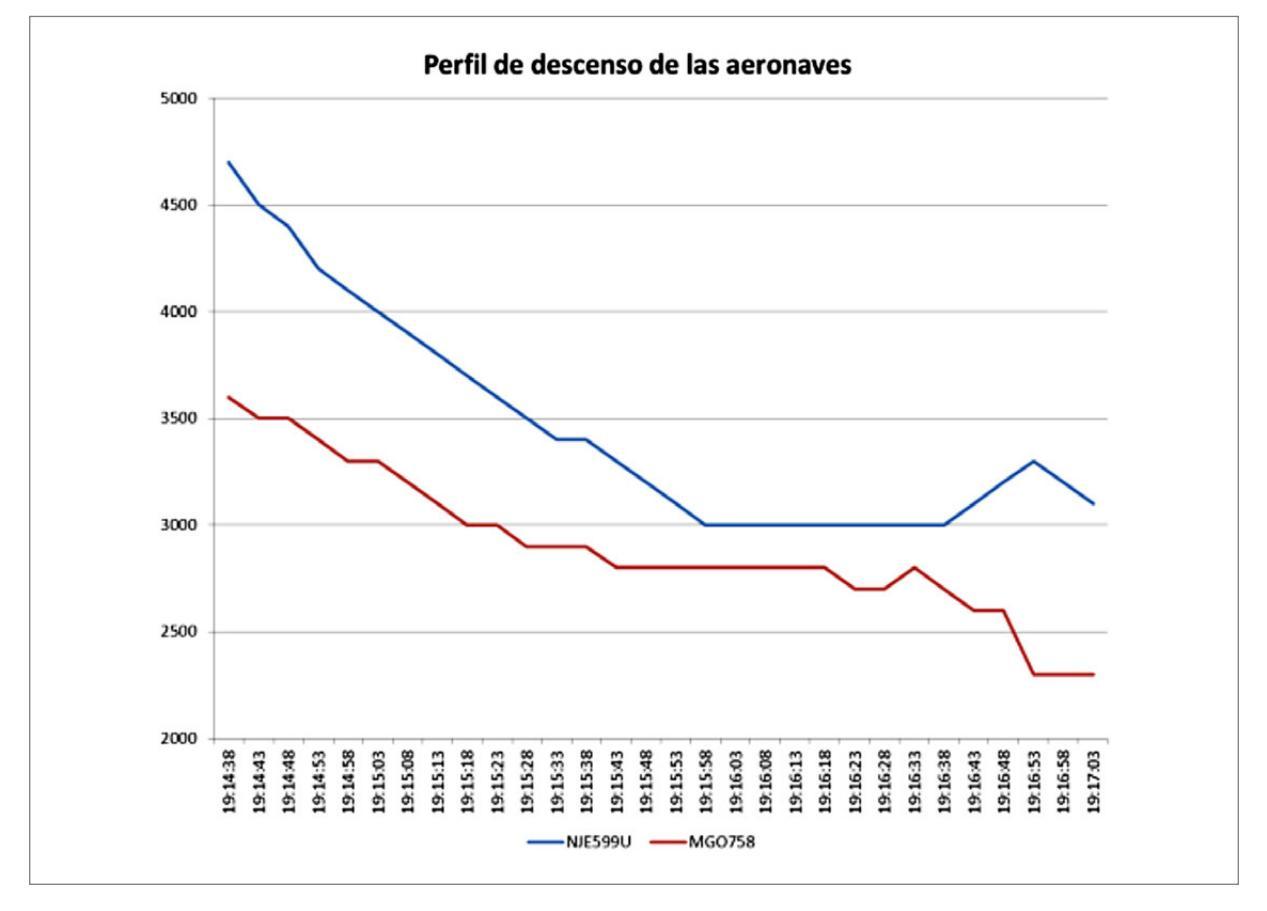
Figure 4. Descent profiles of aircraft NJE599U and MGO758

The radar data provided by the Air Navigation Office of the Balearic Islands show aircraft CS-DNP on a constant descent from 4,700 ft at a rate in excess of 1,800 ft/min that gradually decreased to 1,000 ft/min as it approached its cleared altitude of 3,000 ft. Thirty-five seconds later the close approach with aircraft EC-JIL occurred.

In the meantime, aircraft EC-JIL was descending at a constant rate of about 900 ft/min heading west to an altitude of 2,700 ft, where the near miss with aircraft CS-DNP took place.

The closest point of approach was at 19:16:38, with the two aircraft closing to within 1.2 NM horizontally and 300 ft vertically of each other. Aircraft CS-DNP was at an altitude of 3,000 ft on an easterly heading while turning to HDG 160° as instructed, and aircraft EC-JIL was descending through 2,700 ft heading west.

Five seconds later, aircraft EC-JIL was turning right and descending through 2,600 ft, while aircraft CS-DNP was climbing through 3,100 ft.
