COMISIÓN DE INVESTIGACIÓN DE ACCIDENTES E INCIDENTES DE AVIACIÓN CIVIL

Report IN-034/2018

Incident involving an Airbus A-320-214 aircraft, registration EC-HQL, operated by Vueling Airlines, and a Boeing 737-800 aircraft, registration CN-RNU, operated by Royal Air Maroc, in the airspace of the Barcelona CTR, Spain (control zone) on 6 July 2018

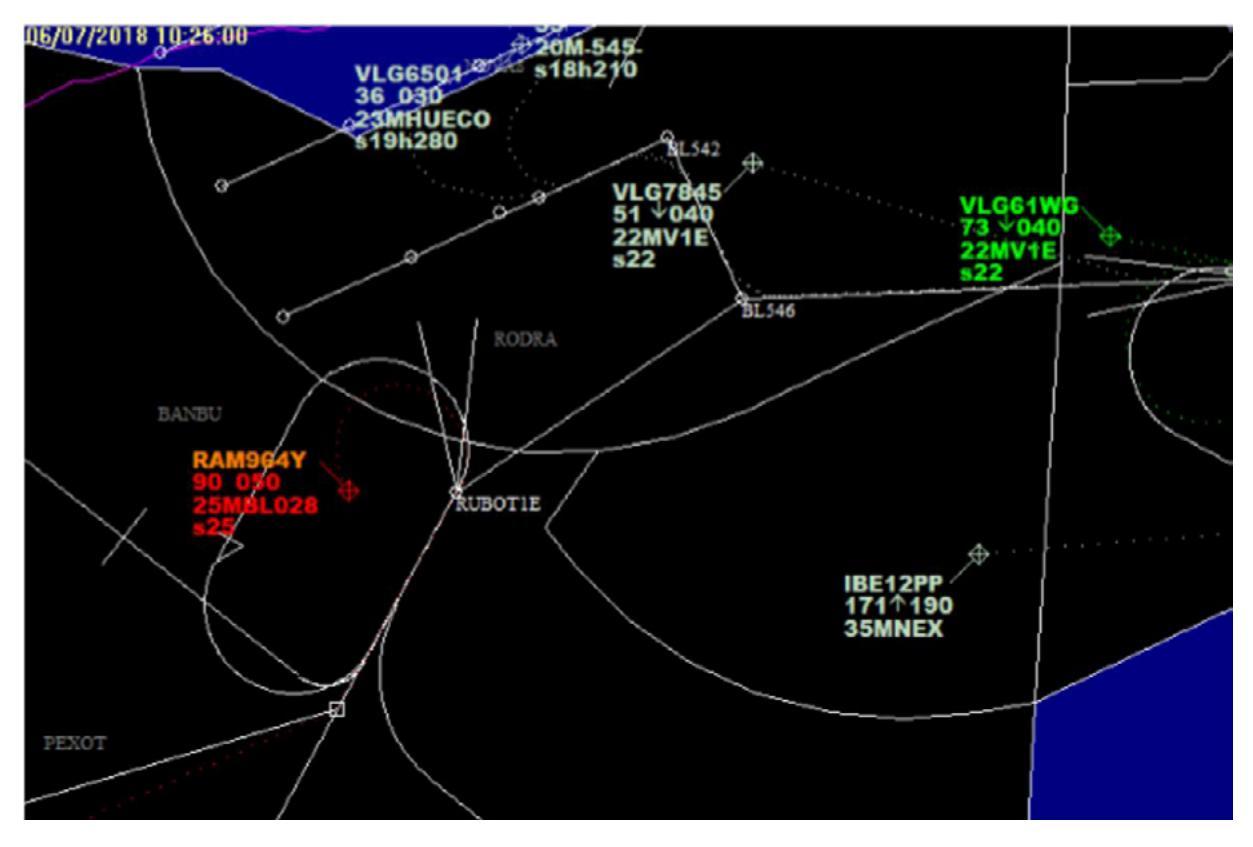
Illustration 1. Positions of VLG61WG and RAM964Y at 12:26:00

The following image shows the positions of the Airbus A-320-214, with callsign VLG61WG, and the Boeing 737-800, with callsign RAM964Y, at 12:26:00. VLG61WG is flying direct to waypoint BL542, descending through 7300 ft for 4000 ft. RAM964Y is flying direct to waypoint BL546, descending through 9000 ft to 5000 ft. The groundspeed of VLG61WG is 220 kt, and the groundspeed of RAM964Y is 250 kt.

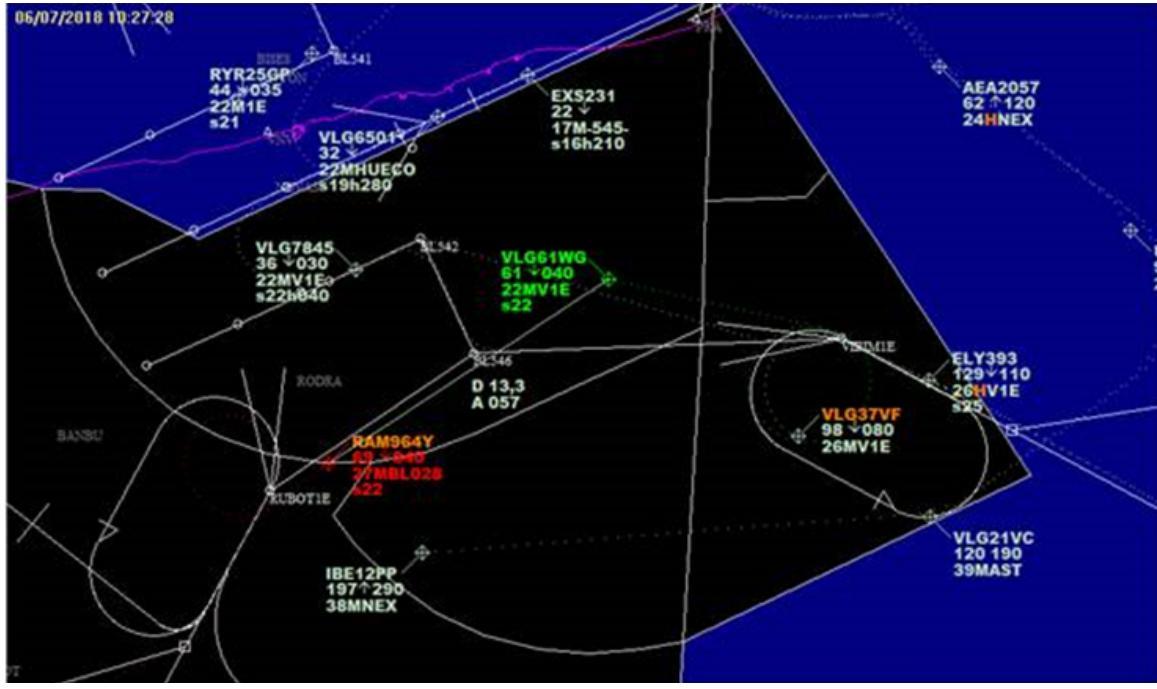
Illustration 2. Positions of VLG61WG and RAM964Y at 12:27:28

The following image shows the positions of the Airbus A-320-214, with callsign VLG61WG, and the Boeing 737-800, with callsign RAM964Y, at 12:27:28. VLG61WG is flying direct to waypoint BL542, descending through 6100 ft for 4000 ft. RAM964Y is flying direct to waypoint BL546, descending through 6900 ft and

cleared to descend to 4000 ft. The groundspeed of VLG61WG is 220 kt, and the groundspeed of RAM964Y is 270 kt.

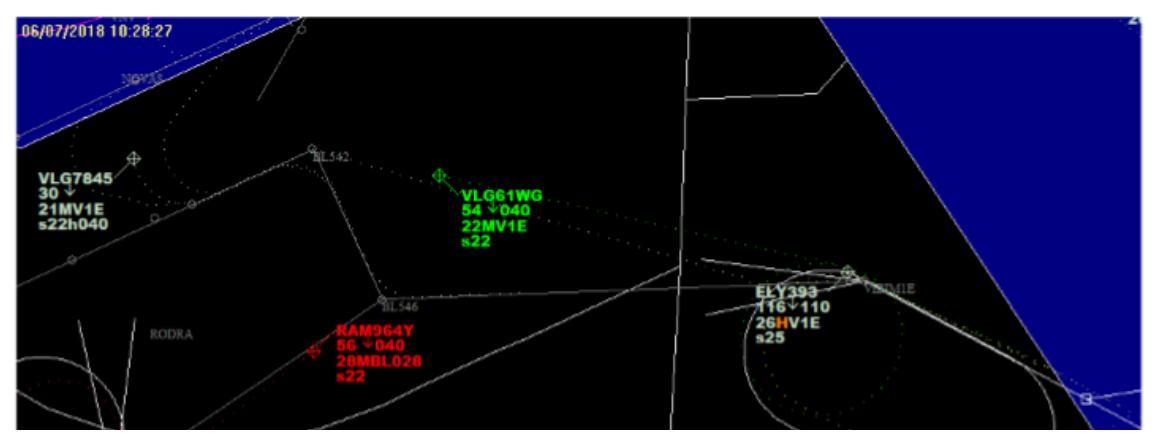
Illustration 3. Positions of VLG61WG and RAM964Y at 12:28:27

The following image shows the positions of the Airbus A-320-214, with callsign VLG61WG, and the Boeing 737-800, with callsign RAM964Y, at 12:28:27. VLG61WG is flying direct to waypoint BL542, descending through 5400 ft for 4000 ft. RAM964Y is flying direct to waypoint BL546, descending through 5600 ft and cleared to descend to 4000 ft. The groundspeed of VLG61WG is 220 kt, and the groundspeed of RAM964Y is 280 kt.

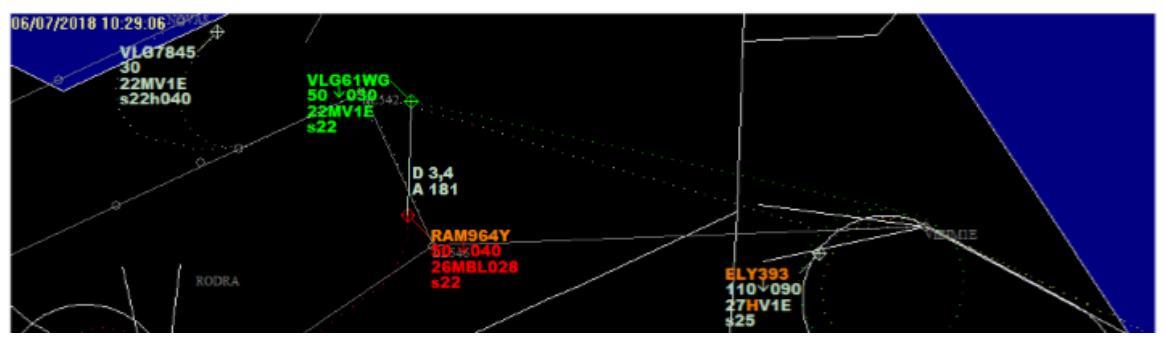
Illustration 4. Positions of VLG61WG and RAM964Y at 12:29:06

The following image shows the positions of the Airbus A-320-214, with callsign VLG61WG, and the Boeing 737-800, with callsign RAM964Y, at 12:29:06.

VLG61WG is flying direct to waypoint BL542, descending through 5000 ft for 3000 ft. RAM964Y is also flying direct to waypoint BL542, descending through 5000 ft to 4000 ft. The LAD (azimuth distance line) indicates that they were 3.4 NM apart at the same altitude. The groundspeed of VLG61WG is 220 kt, and the groundspeed of RAM964Y is 260 kt.

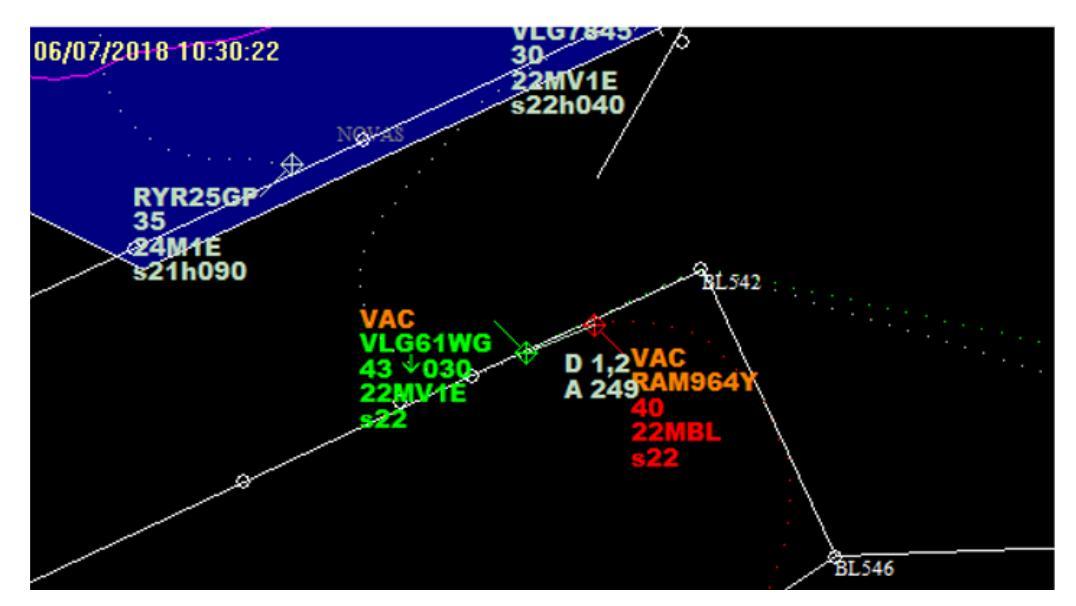
Illustration 5. Positions of VLG61WG and RAM964Y at 12:30:22

The following image shows the positions of the Airbus A-320-214, with callsign VLG61WG, and the Boeing 737-800, with callsign RAM964Y, at 12:30:22. The aircraft were on the south outbound leg, VLG61WG descending through 4300 ft for 3000 ft, and RAM964Y at 4000 ft. The LAD (azimuth distance line) indicates that they were 1.2 NM apart. The groundspeed of both aircraft is 220 kt.

At that point, the conflict violation alert (VAC) on the STCA activates on the displays of the air traffic controllers, as shown in the reproduction.

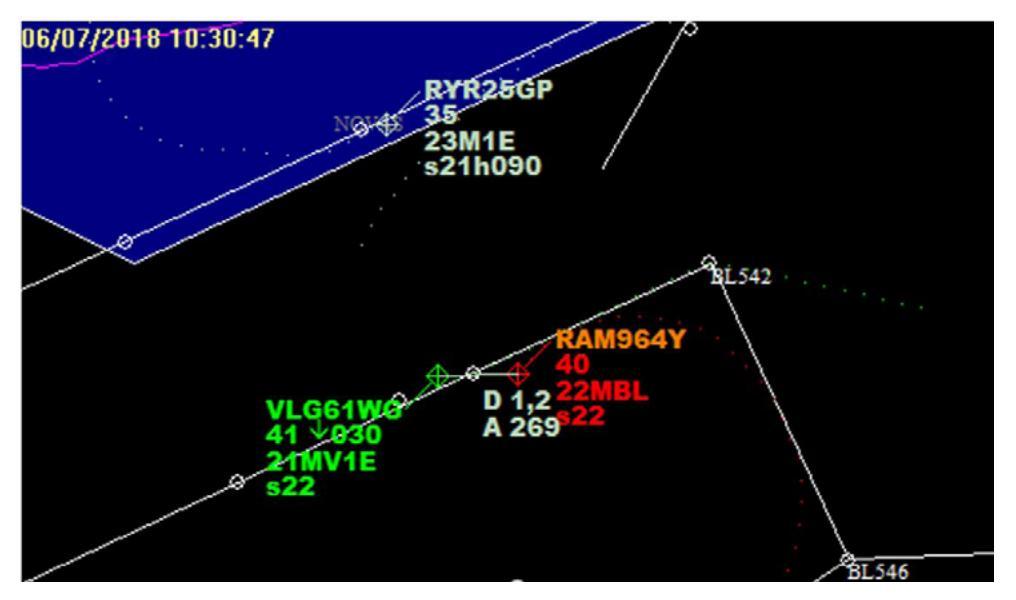
Illustration 6. Positions of VLG61WG and RAM964Y at 12:30:47 h

The following image shows the positions of the Airbus A-320-214, with callsign VLG61WG, and the Boeing 737-800, with callsign RAM964Y, at 12:30:47. The aircraft were on the south outbound leg, VLG61WG descending through 4100 ft

for 3000 ft, and RAM964Y at 4000 ft. The LAD (azimuth distance line) indicates that they were 1.2 NM apart. The groundspeed of both aircraft is 220 kt.

RAM964Y initiated the separation maneuver after reporting it to the air traffic controller.
