# Report A-001/2018

Accident involving an NG4 UL SPEEDY aircraft, registration EC-XGM, at the aerodrome of La Axarquía Vélez-Málaga (Málaga) on 4 January 2018

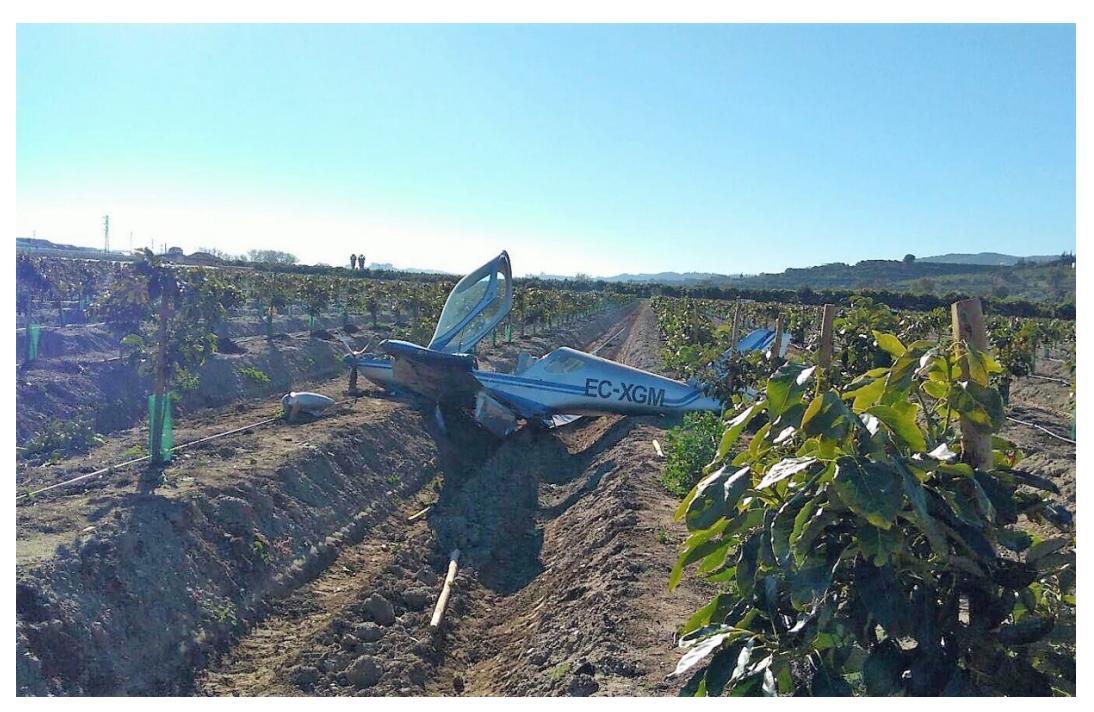
Photograph 1. Accident aircraft at the impact site

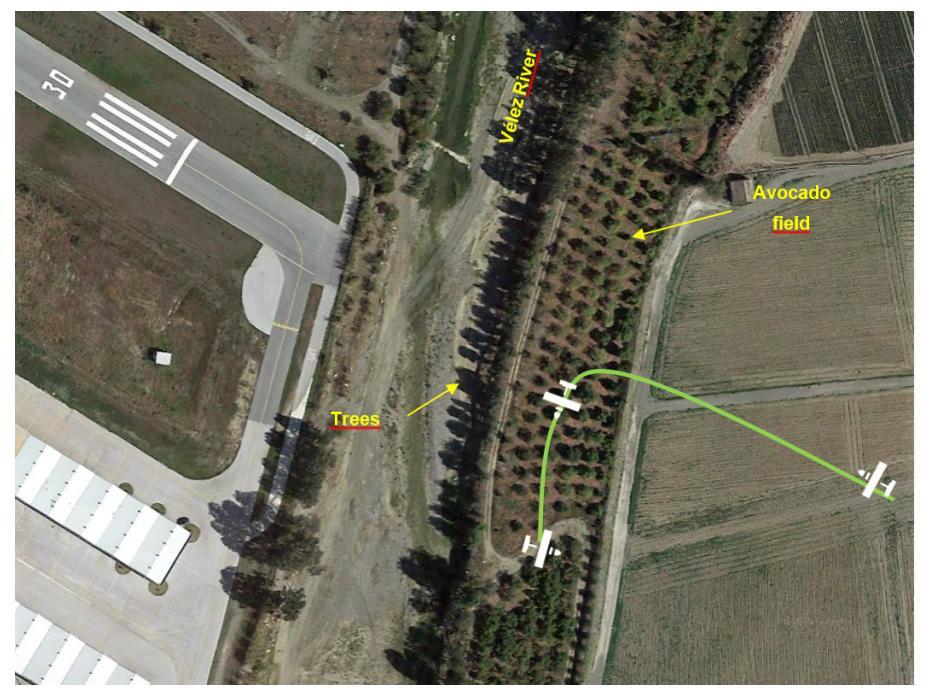
Photograph 3. Accident site and aircraft's flight path

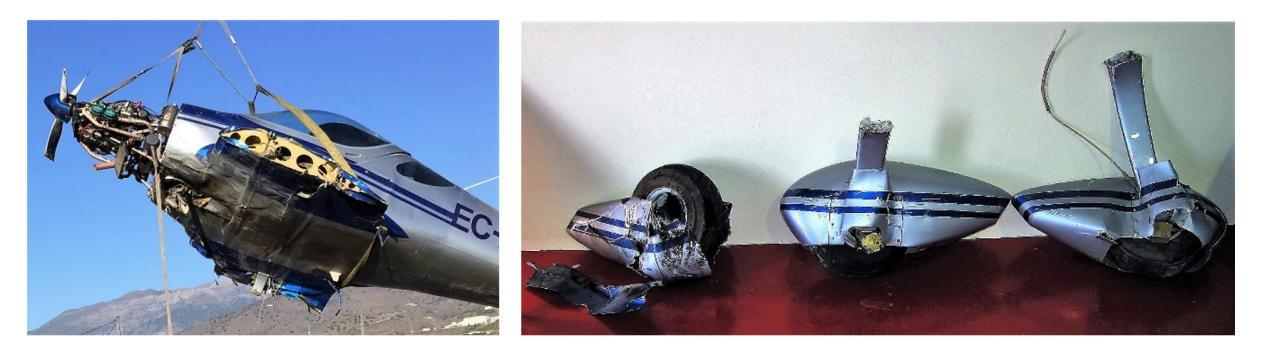
- Main and nose landing gear, destroyed and detached. Photographs 4 and 5.
- Wing bent: impacts to the leading edges and deformation at the roots. The right wing was bent at the root and an opening was found in structure of the left wing near the wingtip. Photographs 6 and 7.
- Horizontal stabilizer: dents on the leading edge near the root and abrasions on the ends of the stabilizer. Photographs 8 and 9.

Photographs 4 and 5. Detached main and nose landing gear

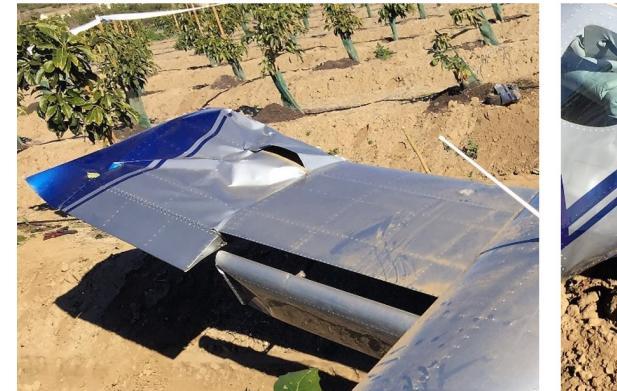
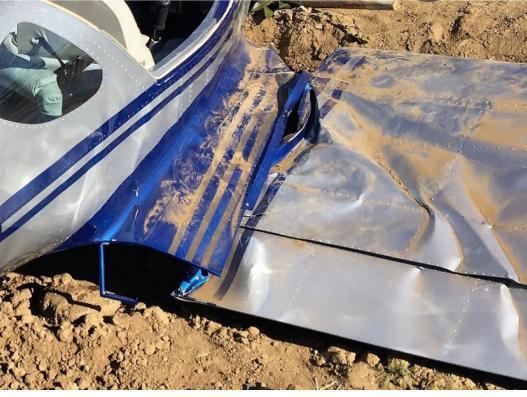
Photographs 6 and 7. Right and left wings

The warping of the wings, with the dents identified on the leading edges, the right wing bent at the root, and the indentation on the left wingtip, serve to indicate the successive impacts that the aircraft endured with the avocado trees on the ground, its flight path aligned with the rows of trees and the various impacts that unbalanced the aircraft and made it turn left and crash to the ground, where it came to a stop. This impact is also consistent with the destruction of the landing gear, the detached remains of which were found with the fuselage with almost no scattering, as well as with the damage to the lower nose fairing and the broken propeller blades, caused when the aircraft's nose dug into the ground.

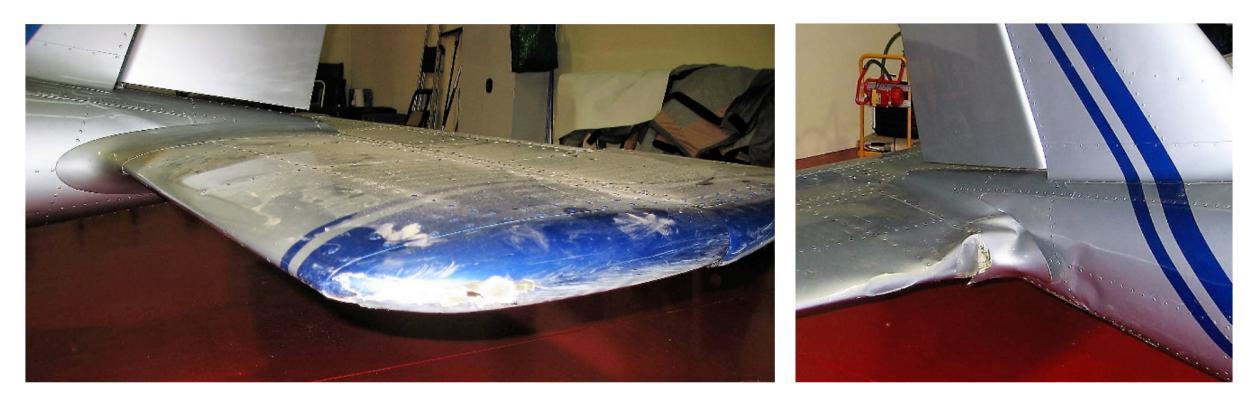
Photographs 8 and 9. Horizontal stabilizers: damage on left and right sides.

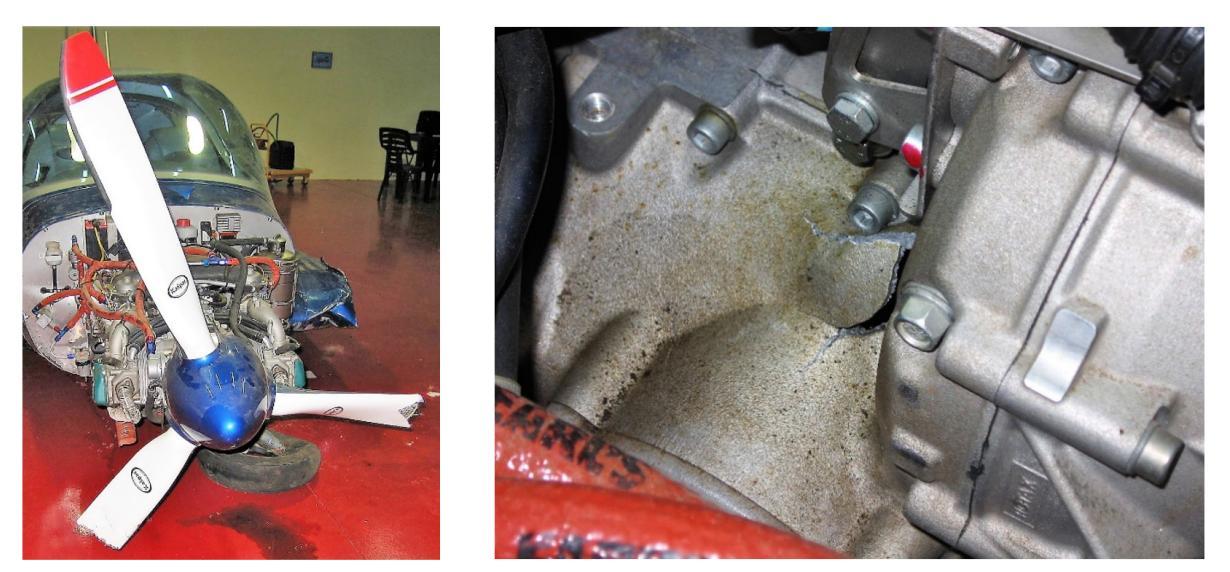
- Nose of the airplane: lower fairing deformed and propeller damaged, with two blades broken. Photograph 10.
- Engine: fracture in body of cylinder 1 and various dents at the bottom of the engine, radiator and air intakes. Photograph 11.

Photograph 10: Damaged nose and propeller

Photograph 11. Fracture in engine body

The loss of power and subsequent engine stoppage are consistent with the damage found on the propeller blades, which shows that at the moment of impact with the ground, the propeller was not rotating.

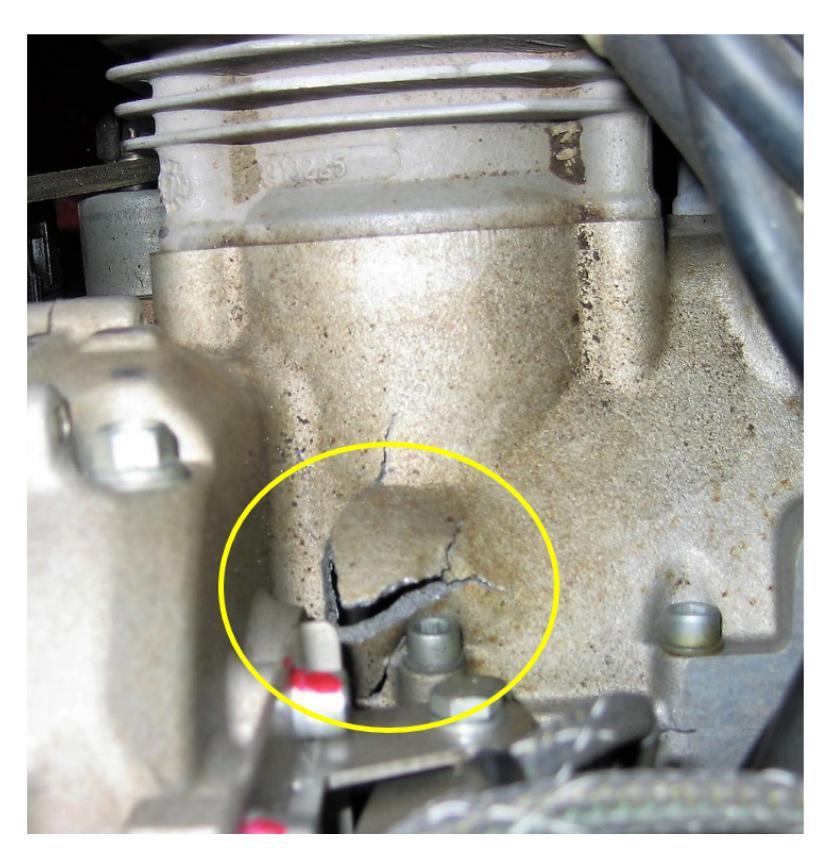
Photograph 12. Crack in the cylinder block

The engine cover was removed at the accident site, and it was subsequently moved to the hangar, where it was inspected. An examination of the engine block revealed a crack that penetrated from the inside of the #1 cylinder in the engine to the outside, as shown in photograph 12.

Although the cylinder with the apparent crack was not disassembled, its location would indicate that the crack was caused by an impact from a connecting rod once its components seized.

The seizing found in the engine block (see photographs 11 and 12) above the #1 cylinder is evidence of the extreme lack of lubrication, which caused one of the connecting rods to break.

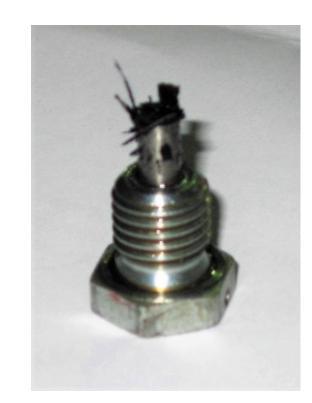
The chip detector was also removed from the engine. As photograph 13 shows, there was a large number of large metal particles adhering to the detector.

Photograph 13. Chip detector block

The presence of metallic particles in the chip detector indicates the friction and wear to which the moving components in the engine were subjected due to the lack of lubrication. The presence of large chips also reveals that the engine seized quickly, which is consistent with the brief duration of the flight and the ensuing engine stoppage.

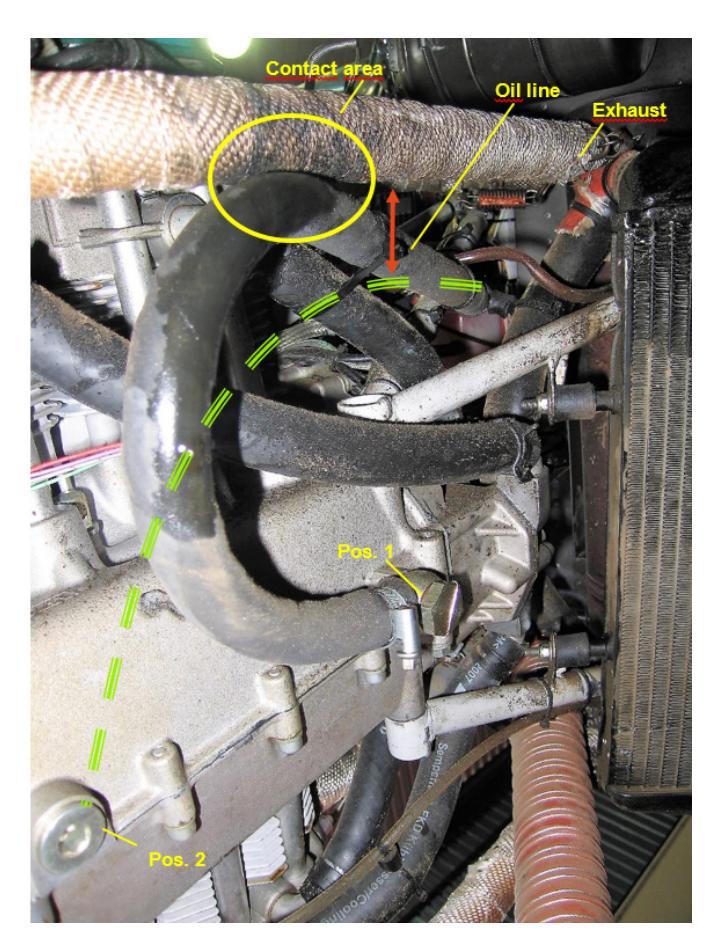
The oil return line from the engine to the oil tank had been connected to position 1, of the two possible connections available (see Figure 3 and Photograph 14). The

Photograph 14. Layout of the connection for the oil return line

potential layout that could have resulted from using position 2, which would have been more suitable given the layout of the exhaust duct, is shown in green.

Given the two connections provided in the engine for installing the oil return line, it is obvious that the installer selected the worse option. He did not consider how the layout failed to satisfy the bending radius and length requirements specified by the engine manufacturer. More importantly, he did not consider the effect of overheating on the line through which all of the engine's oil was lost due to the proximity between this line and the exhaust duct.

Since the engine allows for different configurations, the one that minimizes this risk must be selected by laying out the lines in a way that minimizes their lengths and either keeps them separated from hot areas that can damage them or employs good thermal insulation.

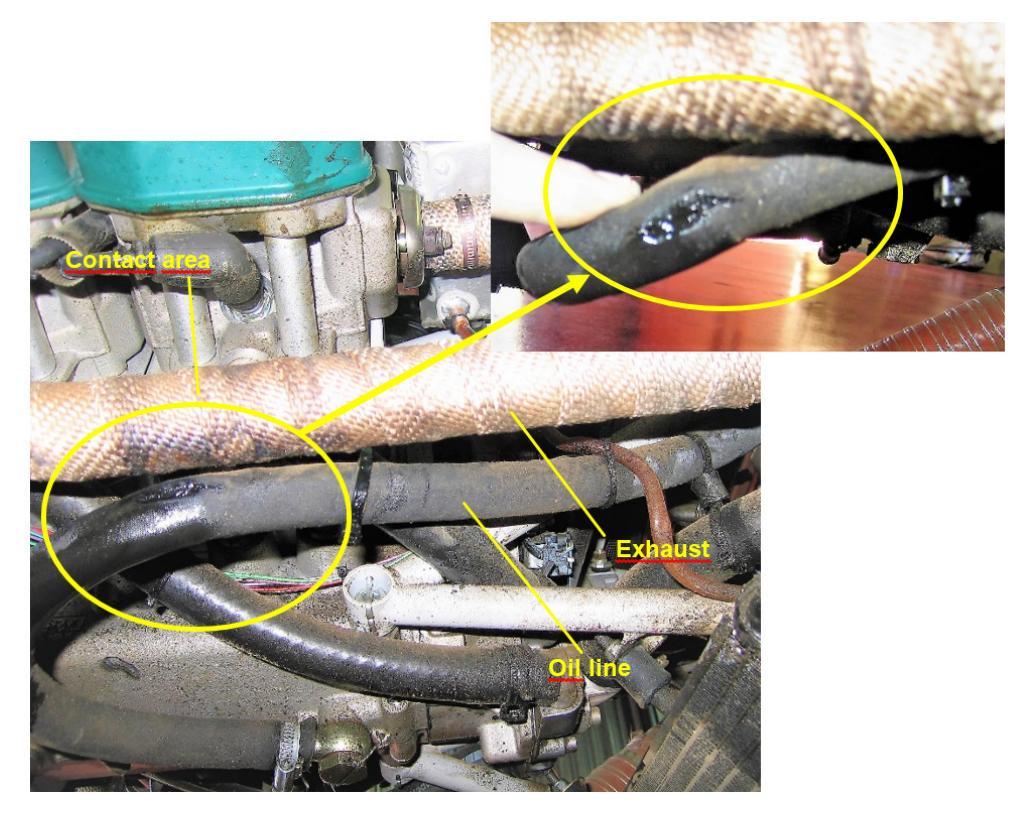
Near the engine inlet, one of the clamps securing the oil return line and one of the exhaust pipes was very loose. The two lines were touching one another.

The spacer was missing and the clamp provided over 1 cm of clearance.

An irregular longitudinal crack some 5 cm long was found in the oil line, and there were several burned oil stains on the exhaust collector (Photograph 15).

Photograph 15. Close-up of contact area identified between the oil return line and one of the exhaust ducts.

The expanded view shows the crack discovered in the oil return line in more detail.

The materials used in oil lines, especially those for aviation use, are synthetic rubbers, nitrile butadiene rubber that can withstand temperatures from  $-40^{\circ}$  C to  $+108^{\circ}$  C. The contact between the oil return line and the exhaust manifold, whose temperature was at least 800° C, caused the material to melt 9 minutes into the flight. This created a longitudinal gash in the hose through which the engine lubricating oil was lost during the flight. This is evidenced by the burned oil residue found on the components on the lower engine fairing, the exhaust ducts and the fairing itself.

The design of piping runs must ensure that even if clamps or spacers break, the likelihood of oil lines coming into contact with sources of engine heat that can damage them is as low as possible.
