Technical report A-003/2022

Accident on 10 January 2022, involving a PS-28 Cruiser aircraft operated by Flyschool Air Academy, registration EC-NKP, at Casarrubios del Monte Aerodrome (Toledo, Spain)

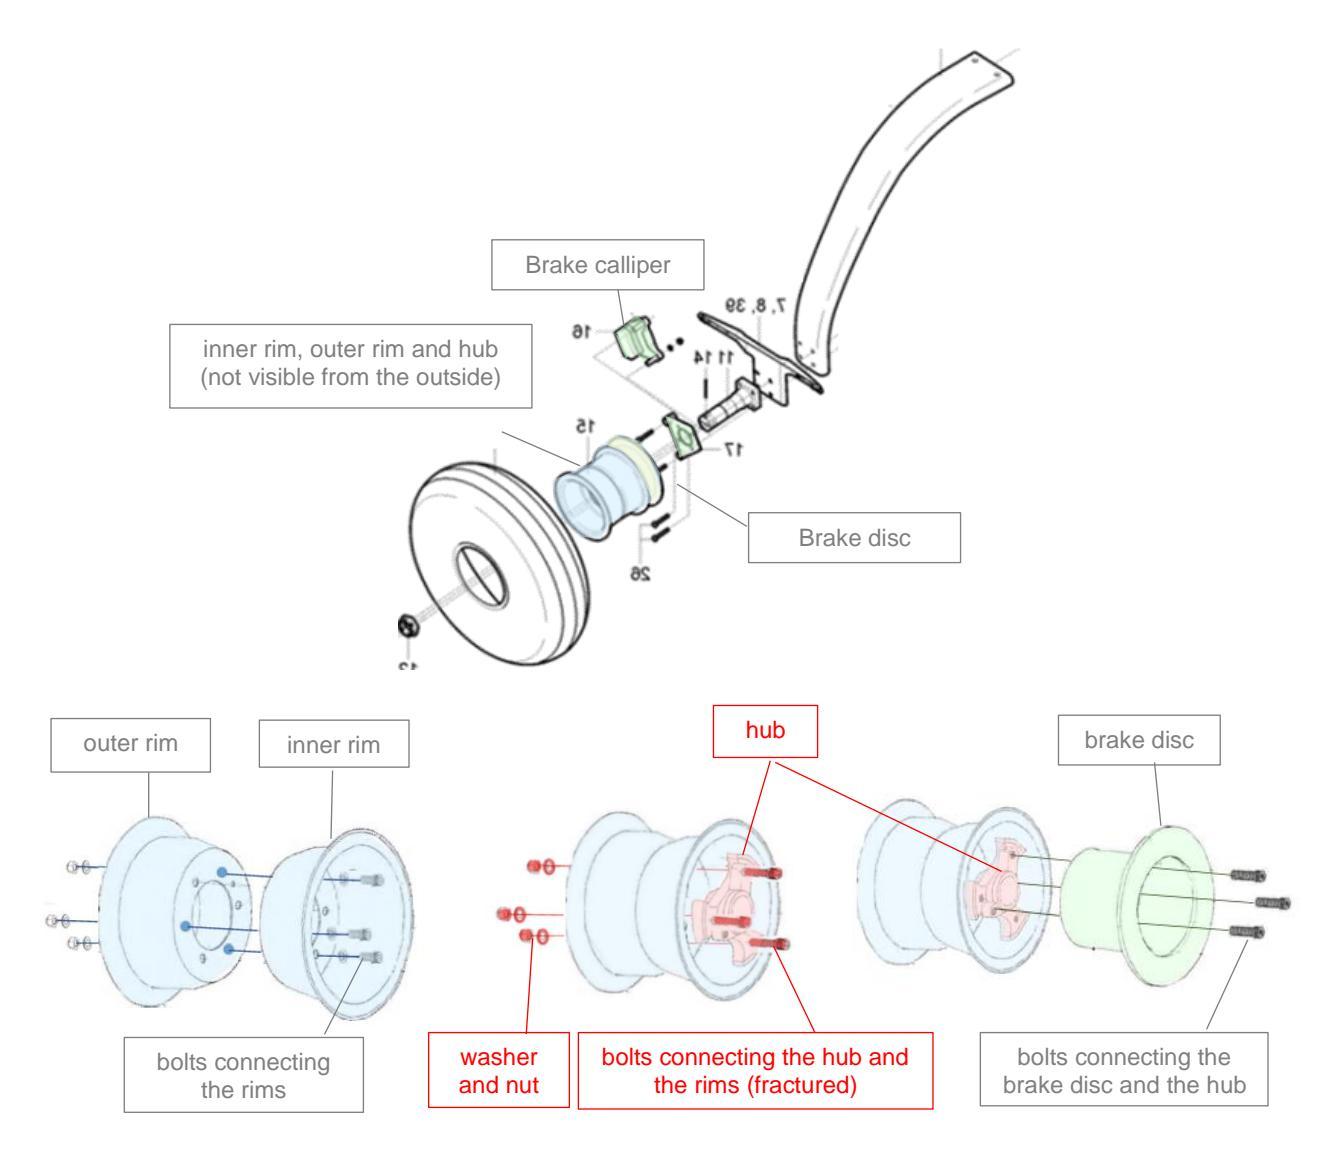
Figure 3. Fractured bolts on the MATCO MEH51CZ wheel and brake assembly

- The 3 fractured bolts connect the hub to the wheel rim.
- The fractured bolts are inserted through a threaded hole in the hub and then pass through two non-threaded through-holes in the wheel rims. In other words, the head of the bolt sits on the hub and it passes through three parts.
- The hub, which supports the wheel rims, is not only screwed but also fitted into the two rims.
- The fractured bolts were secured with a washer and a self-locking nut on the outer rim.
- The hub is also connected to the brake disc with three bolts.
- In addition, the two rims are joined by three bolts that are similar to the ones that fractured but shorter.
- Therefore, on the outer rim, you can see the ends of 6 bolts with their washers and selflocking nuts: the 3 bolts connecting the inner and outer rims and the 3 bolts that secure the hub to the rims.

The MATCO Technical Service Bulletin (Chapter O. Wheel assy. Torque values) states that the torque applied to all the bolts and nuts on the wheel and brake assembly should be 11.3 Nm (100 inch-lb). The aircraft's Maintenance Manual did not specify this for the fractured bolts and their nuts, although it was indicated for other wheel bolts, such as the three that join the inner and outer rims (see section 1.16.4).

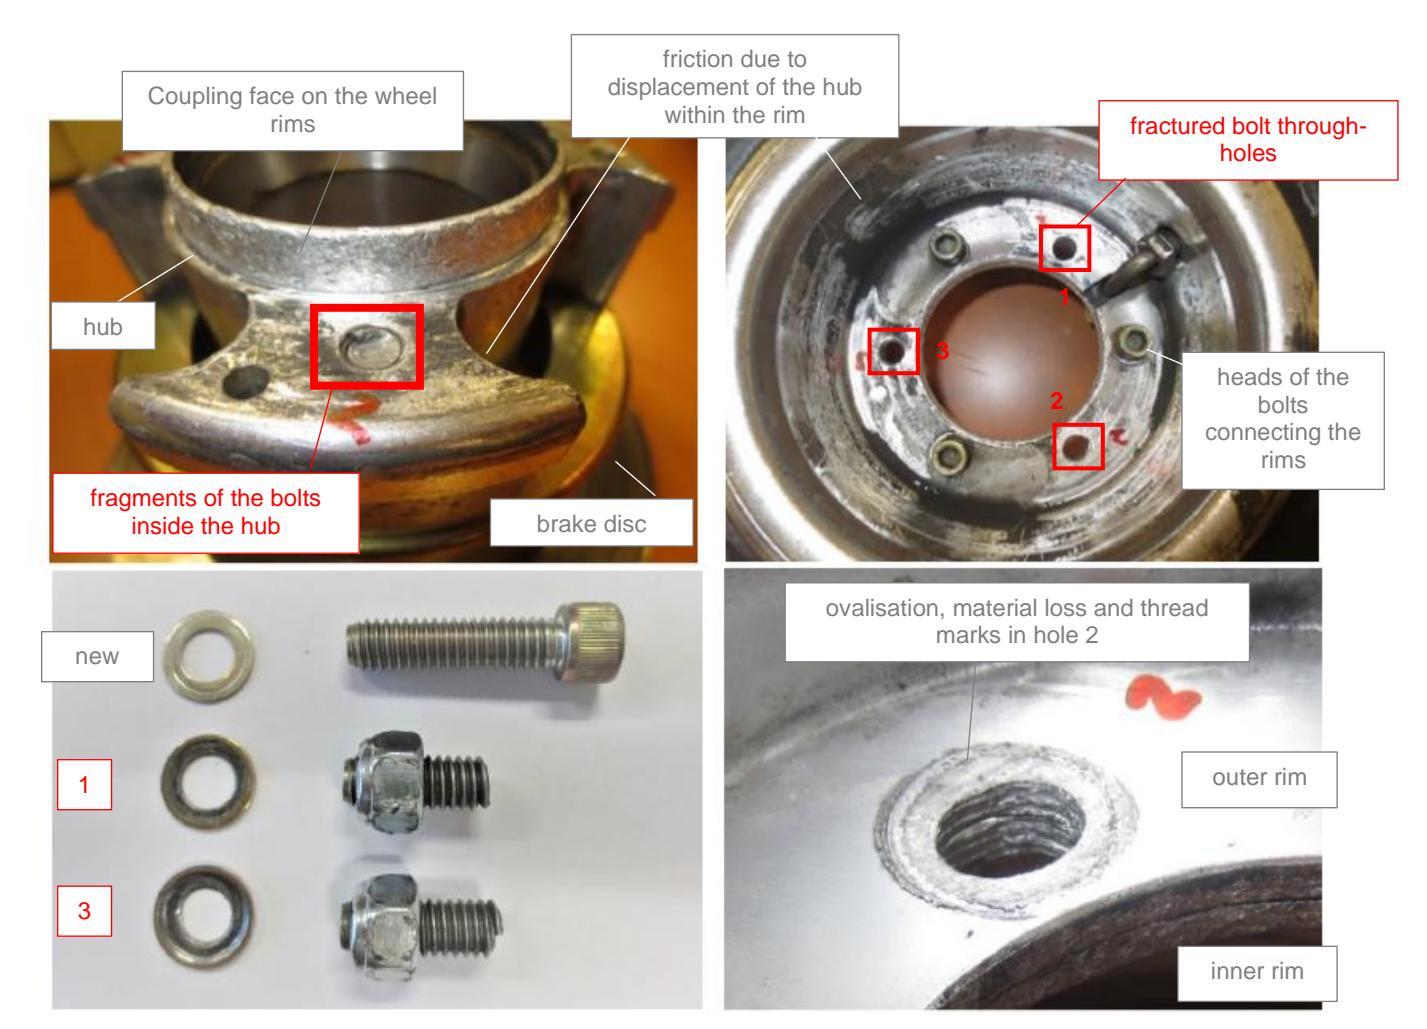
Figure 4. Wheel rims, hub and bolts

- Detached components:
 - a) The rims and tyre, which the crew reported seeing rolling ahead of them during the incident, were recovered 30 m from the aircraft's final position.
 - b) The fractured ends of the three bolts connecting the wheel rims to the wheel hub, of which only two were recovered. These fragments had retained their nut and washer. The results of the fractographic analysis of the fractured bolts are shown in section 1.16.1.
- Components attached to the aircraft:
 - a) The hub, where the three fractured bolts connecting the rims to the hub were embedded.
 - b) The brake disc, which had been dragged along the runway, and the brake calliper.

- Rims and hub:
 - a) The three bolts connecting the wheel rims remained correctly installed.
 - b) The three empty holes (randomly numbered 1, 2 and 3) for the fractured bolts were identified. These holes (particularly hole 2) had a high degree of ovalisation produced during the rupture process.
 - c) Despite their ordinarily smooth surface, the sections of all three holes revealed irregular thread marks, indicating that the bolt had been moving inside the holes.
 - d) The surface of the <u>inner rim</u> had notably deteriorated. Abrasive wear had given it a rough, shiny texture with circular and concentric linear marks. These marks and signs of wear were also identified on the hub, suggesting that the hub was moving inside the rim during the breakage process.

- e) The <u>outer rim</u> had a more uniform overall appearance, but the bearing surface of the washers was deteriorated, with superficial pitting and a rough, matt texture. Circular marks made by the torque spanner when tightening the nut were visible around the contour of the washer because the rims are made from a softer material than the nuts.
- Brake disc:
 - a) The entire perimeter showed signs of abrasion but it was particularly noticeable in one area where material loss had produced a flat spot. This abrasion suggests that the disc was in direct contact with the asphalt as it dragged along the runway.

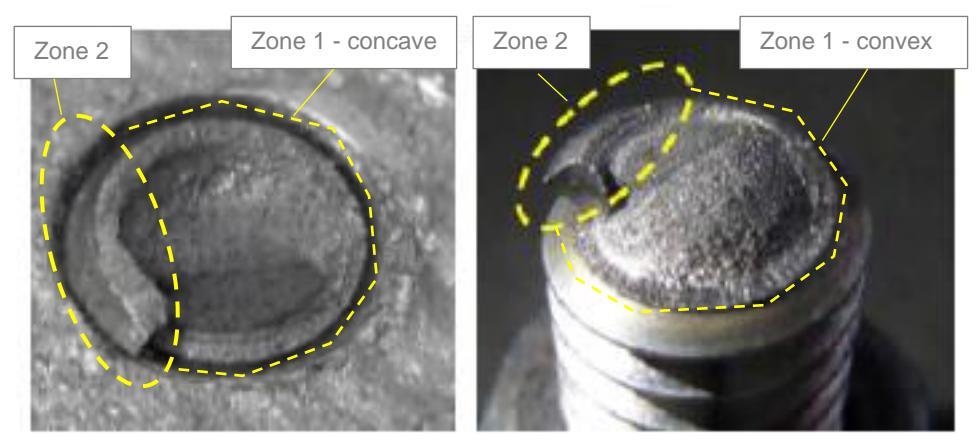
Figure 5. Bolt 1

Both pieces of this bolt were recovered: the fragment in the hub and the fragment that had detached. It had ruptured close to where the hub meets the inner rim and displayed two distinctly affected zones:

- Zone 1: comprised most of the surface and had a rough, wood-like texture, typical of a semifragile tear. In the fragment from the hub, the fracture surface was concave, while the fracture surface of the detached fragment was convex and cone-shaped, as is typical of tensile breakages.
- Zone 2: the last area to rupture, located on the outer surface of the bolt close to the thread. This zone showed a change of plane in a helical direction which had even resulted in a small tear in the form of a crack in the valley of the thread.

- Finally, the failure of bolt number 1 was caused by a pure traction mechanism when the loads on the only remaining bolt increased, following the loss of the other two bolts (2 and 3).

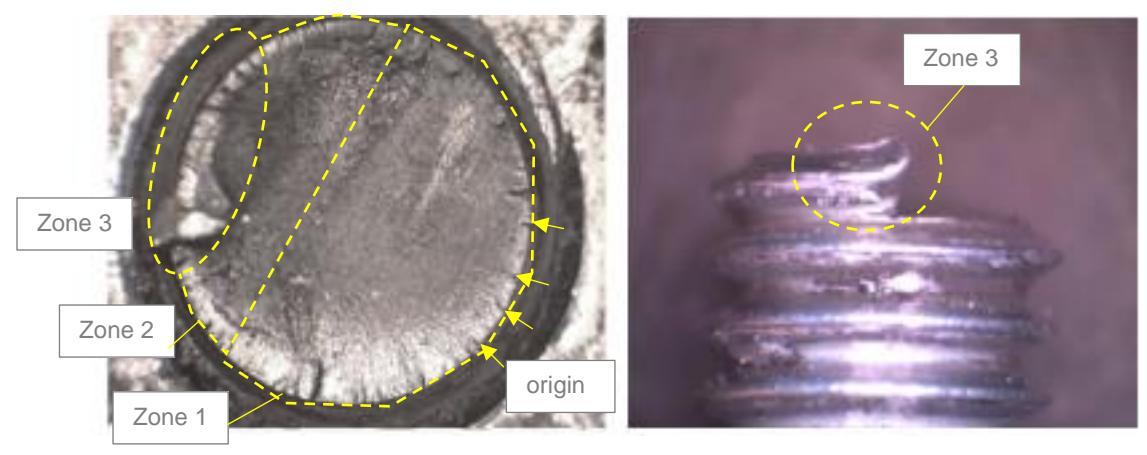
Figure 6. Bolt 2

For bolt 2, only the piece embedded in the hub was recovered; the detached fragment was never found. The fracture surface had developed perpendicular to the axis of the bolt and the maximum tensile stresses, with three distinct distinguishable zones:

- Zone 1: the surface was smooth, even and matt, and fine, straight lines running almost parallel to each other were discernible, showing the sequential progress of the breakage, commonly known as beach marks. Radial striations were visible around the perimeter where the beach marks were located, indicating numerous breakage origin points. Therefore, in this bolt, the breakage had originated in the peripheral zone, specifically the thread valley, due to a concentration of elevated stresses that generated several fatigue initiations (striations), which then rapidly joined together to create a single fatigue crack that advanced over approximately 70% of the surface.

- Zone 2: had a rough, wood-like texture typical of a semi-fragile tear, with some orientation towards the direction of the breakage.
- Zone 3: was the last area to rupture and showed a change of plane with some degree of plastic deformation. Zone 3 is diametrically opposed to the origin of the break.

- The next bolt to fail was number 2 due to a unilateral flex fatigue process with several origins, indicating an elevated and highly concentrated stress level in the fracture zone. In this instance, the surface area of the bolt that withstood the fatigue was smaller than that observed on bolt 3, leading to a semi-fragile tearing that ended with the rapid breakage of the remaining section of the bolt. The reduced fatigue surface, together with the extensive ovalisation in this bolt's housing, confirms an uneven stress distribution after the loss of bolt 3, which accelerated the rupture of bolt 2.

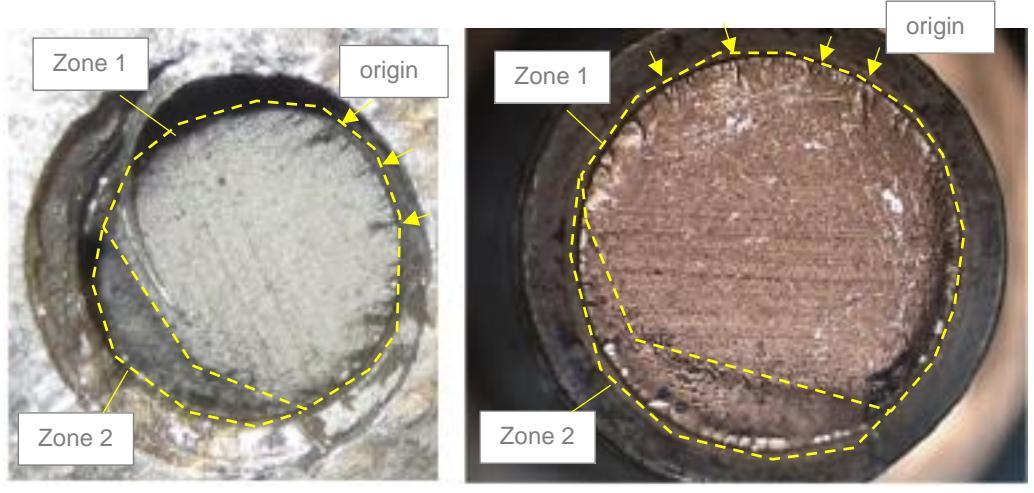
Figure 7. Bolt 3

Both fragments of this bolt were recovered, and, as with bolt 2, the fracture surface had developed perpendicular to the bolt's axis and the maximum tensile stresses. Two zones were identified on the fracture surface:

- Zone 1: comprised 90% of the surface and had a matt, even and smooth morphology in which thin, straight and parallel lines were identified (beach marks), indicating the advance of the fracture. Radial striations were also identified around the perimeter of the breakage, suggesting the fracture mechanism originated in multiple places and then merged into a single advancing fatigue crack, similar to zone 1 on bolt 2.
- Zone 2: had a wood-like texture and was the area diametrically opposite the origin of the break. It was, therefore, identified as the final point of rupture.

- Bolt number 3 was the first to fracture due to flex fatigue, with an elevated and highly concentrated stress level evident in the fracture zone. The fatigue process started on the surface of the bolt, in the zone where the hub ends and the inner rim halve begins. The extent of the fatigue zone indicates that almost the entire section of the bolt withstood the fatigue progression until, finally, the minimal remaining section ruptured under the static load. The sizes of these distinct zones allowed to identify this bolt as the first to break.

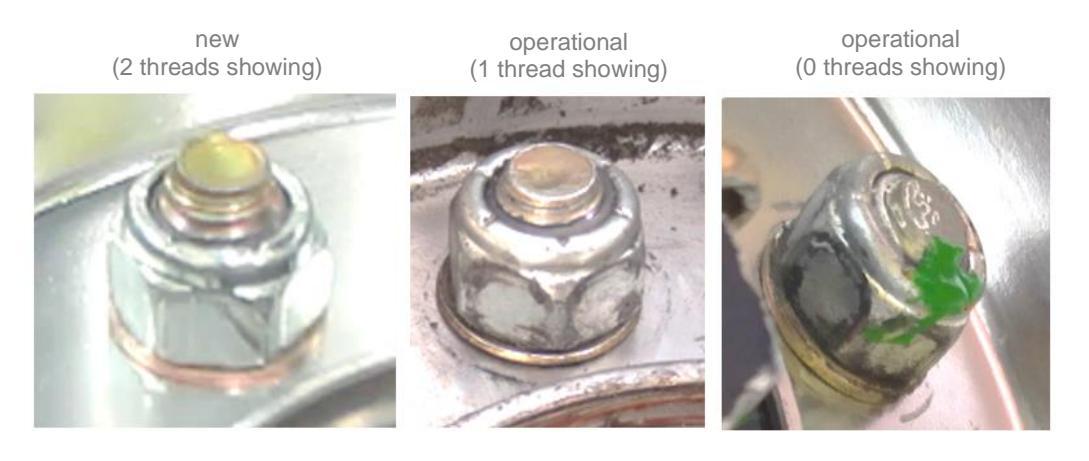
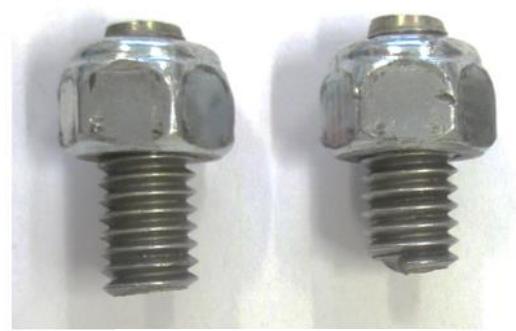
Figure 8. Nuts and bolts connecting the hub and the rims

- On the new assembly, all the bolts had 2 threads showing past the nut.
- On all the wheels in operation, the bolts had fewer than 2 threads showing past the nut. The fractured bolts had 1 and 0 free threads showing past the nut.

EC-NKP (0 threads showing)

The description in Figure 8 indicates that the EC-NKP has 0 threats shown above the nut. In spite of this claim Figure 4 shows the same bolts in perpendicular view and the 1 thread above a nut is clearly visible.

- It incorporated the obligation to replace the installed nuts and washers with new ones at every tyre change in Maintenance Manual procedure 8.5.1 Tire change.
- It issued an operational safety communication (CSO 2022-01, dated 20/02/2022, called "Visual inspection PS28") to all crews specifying that before each flight, they should check that the main gear wheel bolts show 2 threads past the nut.

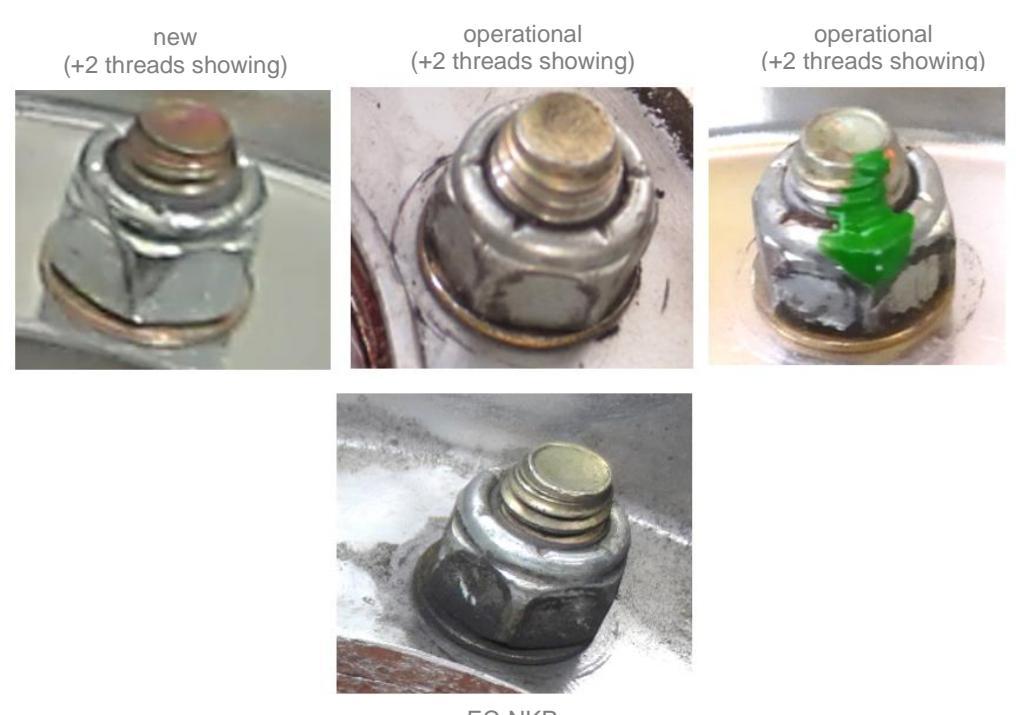
Figure 9. Nuts and bolts connecting the rims

• This was only the case for the 3 bolts connecting the hub to the rims. By contrast, the nuts on the 3 bolts joining the rims were in the same position as those on the new assembly, with 2-3 threads showing.

EC-NKP (+2 threads showing)

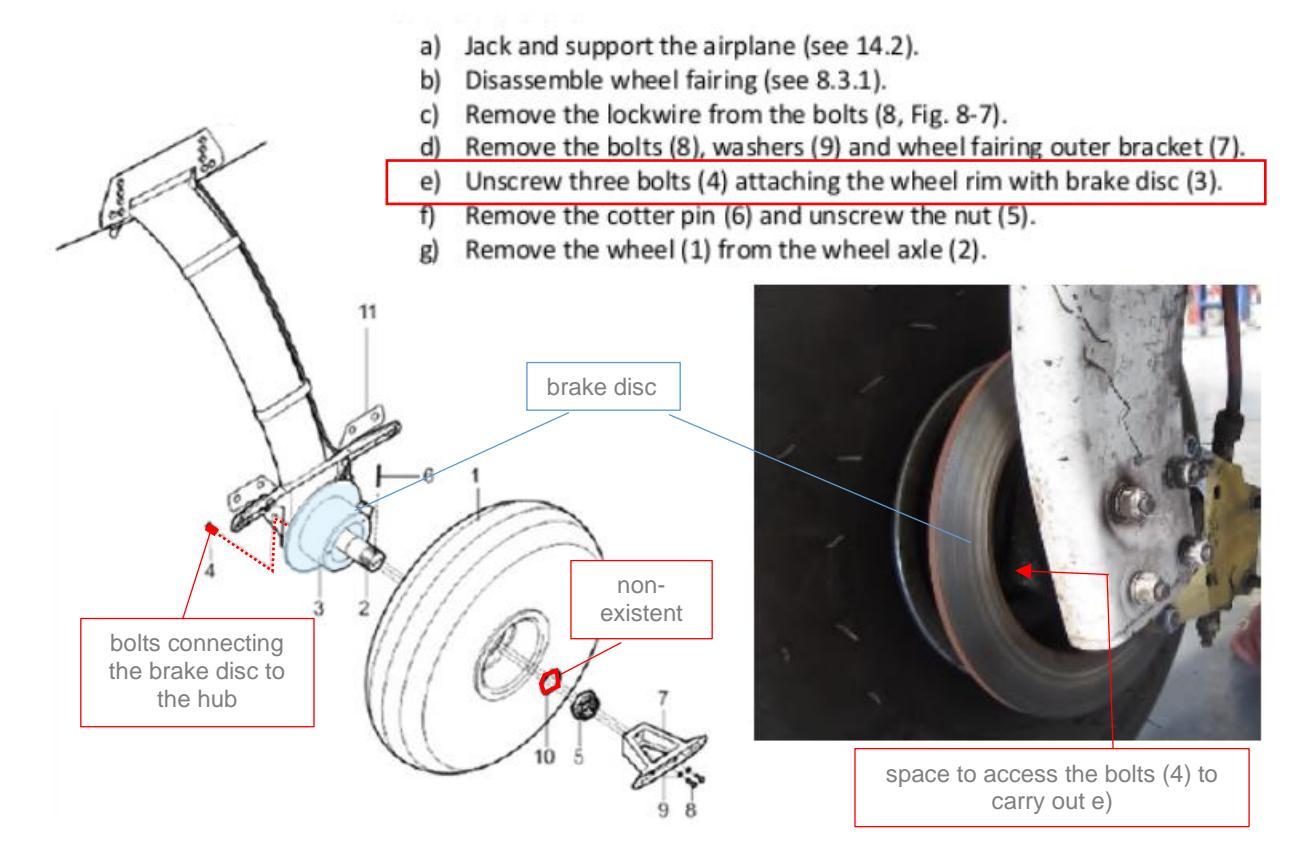
From procedure 8.3.3 Removal of Main Landing Gear Wheel (figure 8-7) in the CR-MM.

- Step (e) contains an error, as the bolts (4) shown attach the brake disc to the hub, not to the wheel rim.
- The washer (10) in figure 8-7 of the Maintenance Manual does not exist.
- If the disassembly were carried out according to the published procedure, the wheel would be removed without the brake disc, which would have been separated from the hub in step e). This step conflicts with section e) of procedure 8.5.1.

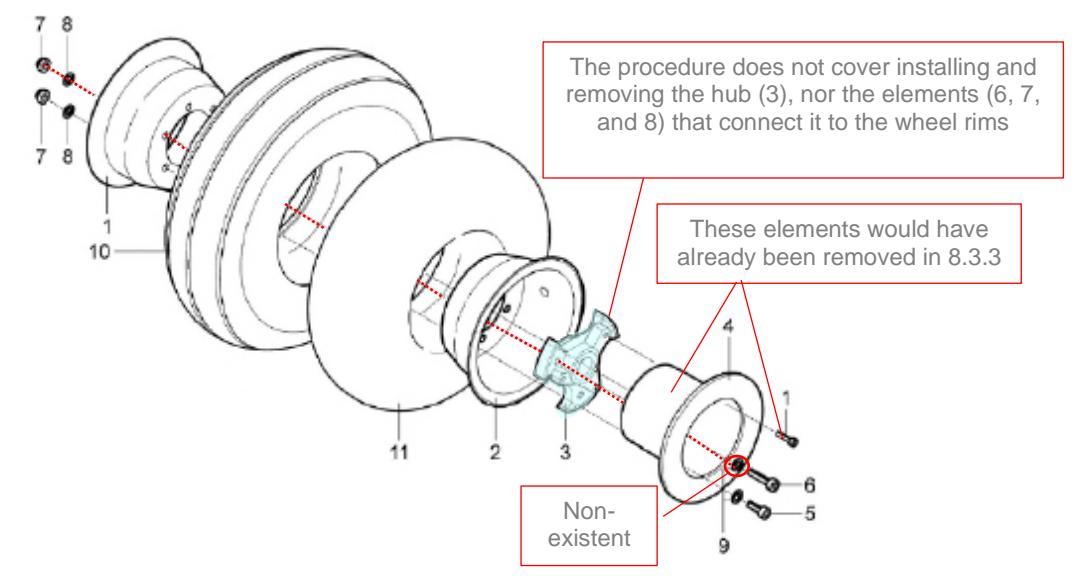
From procedure 8.5.1 Tire Change (figure 8-16) of the CR-MM.

- Step e) instructs technicians to unscrew the bolts connecting the brake disc to the hub, a task that has already been completed in procedure 8.3.3 step e).

- To carry out step f), the hub must first be removed from the two wheel rims,
- The step to remove the hub from the rims is omitted. It should be carried out prior to step f). This new step should specify that the removed nuts and washers are to be discarded.

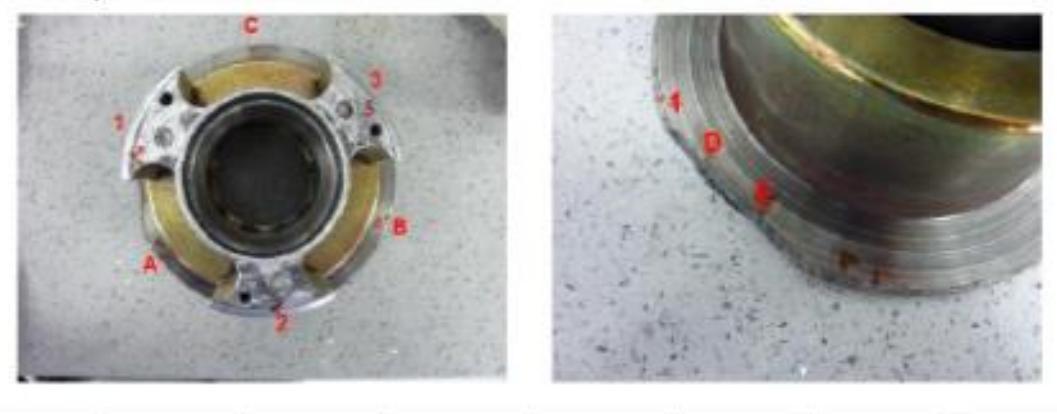
Assumes, that brakes were checked with satisfactory results. According to provided measurement in the document title: Medidas de espesor.pdf the disk was worn below limit 4,25mm in most of measured points.

1	2	3	A	B	c	D	E
4,14	4,18	4,22	4,78	4,17	4,40	5,42	5,43

Notwithstanding that condition of brake disk is not the direct cause of the incident, if chapter 1.1 is dealing with brake system, it would be appropriate to provide all information obtained.
