# Technical report A-048/2022

Accident involving a CZECH AIRCRAFT WORKS SPORT CRUISER aircraft, registration EC-ZXG, on 07 September 2022 at Mutxamel Aerodrome (ALICANTE).

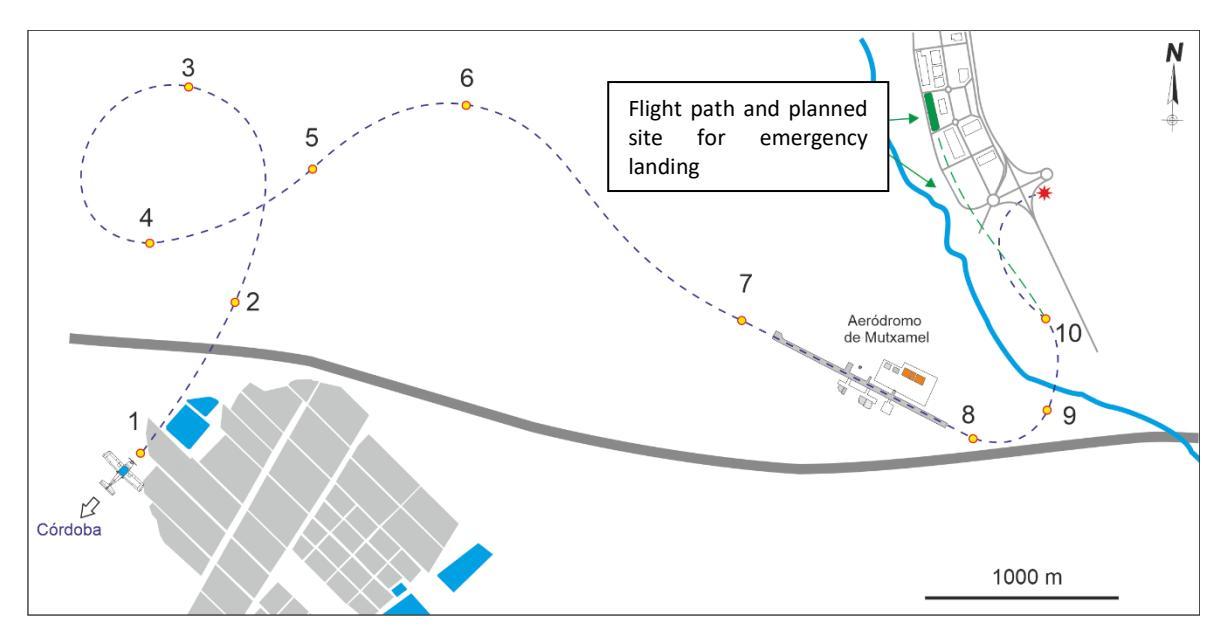
From that moment on, the aircraft began to descend, initiating a spiral at an altitude of 720 m (2) and exiting it at an altitude of 392 m (5). It then manoeuvred in a continuous descent to align with runway 12 at the aerodrome, with an altitude of 90 m (7) over the head of runway 12 and 43 m (8) over the head of runway 30.

Once past the runway, the aircraft turned left, initially increasing its altitude by 10 m midturn (9) and then completing the turn to close to 180° (10) and losing altitude to 50 m above the ground.

Fig. no. 1.- Flight path of the aircraft. Final leg

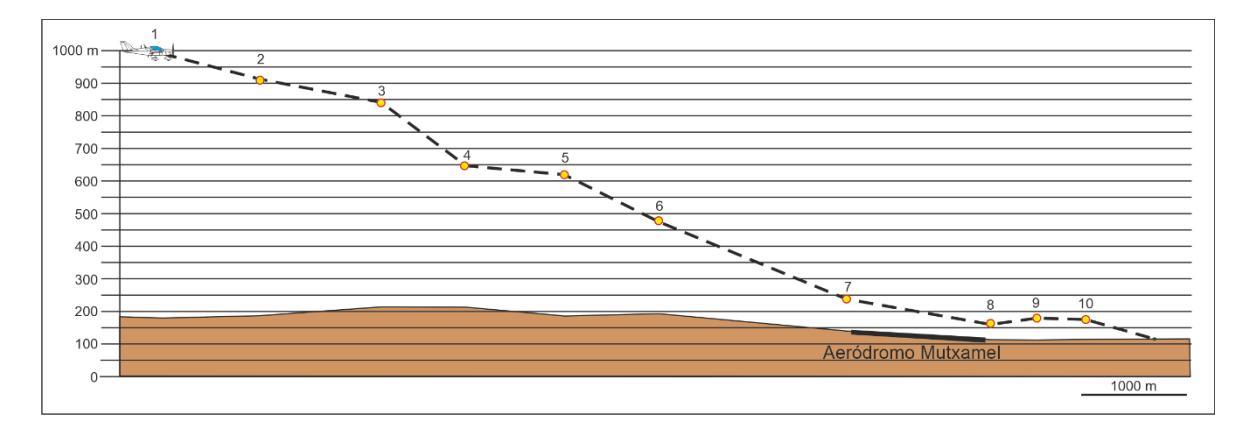
Fig. no. 2.- Depiction of the aircraft's altitude on the final leg of its flight path.

According to the data extracted from the navigator, the aircraft made a single 360° turn in which it lost 300 m (1,000 ft), so when it was aligned with runway 12 on the airfield (point 6 in figure 1) it was at an altitude of more than 450 m (approximately 1,500 ft) above the ground. At this point, the aircraft was very high and very close to the runway head where it intended to land, which meant it ended up overflying the runway, reaching its end at 150 m (approximately 500 ft) above the ground.

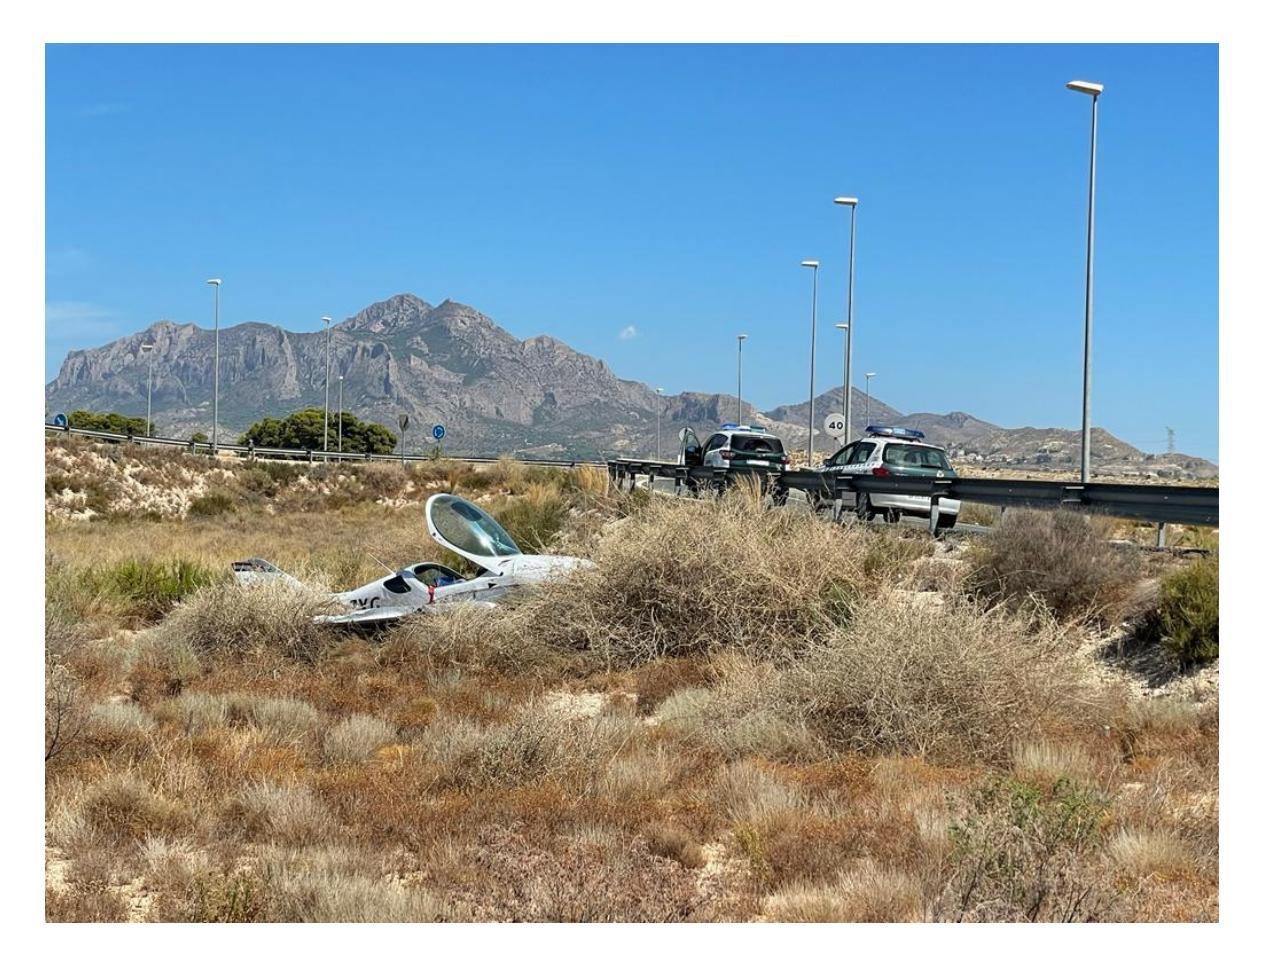
Fig. no. 3.- Vicinity of the crash site

The wreckage was found on a concrete channel belonging to the transversal rainwater drainage works in the space between the central lanes of the CV-800 road, the deceleration lane and the change of direction lane, which crosses perpendicularly over the central lanes.

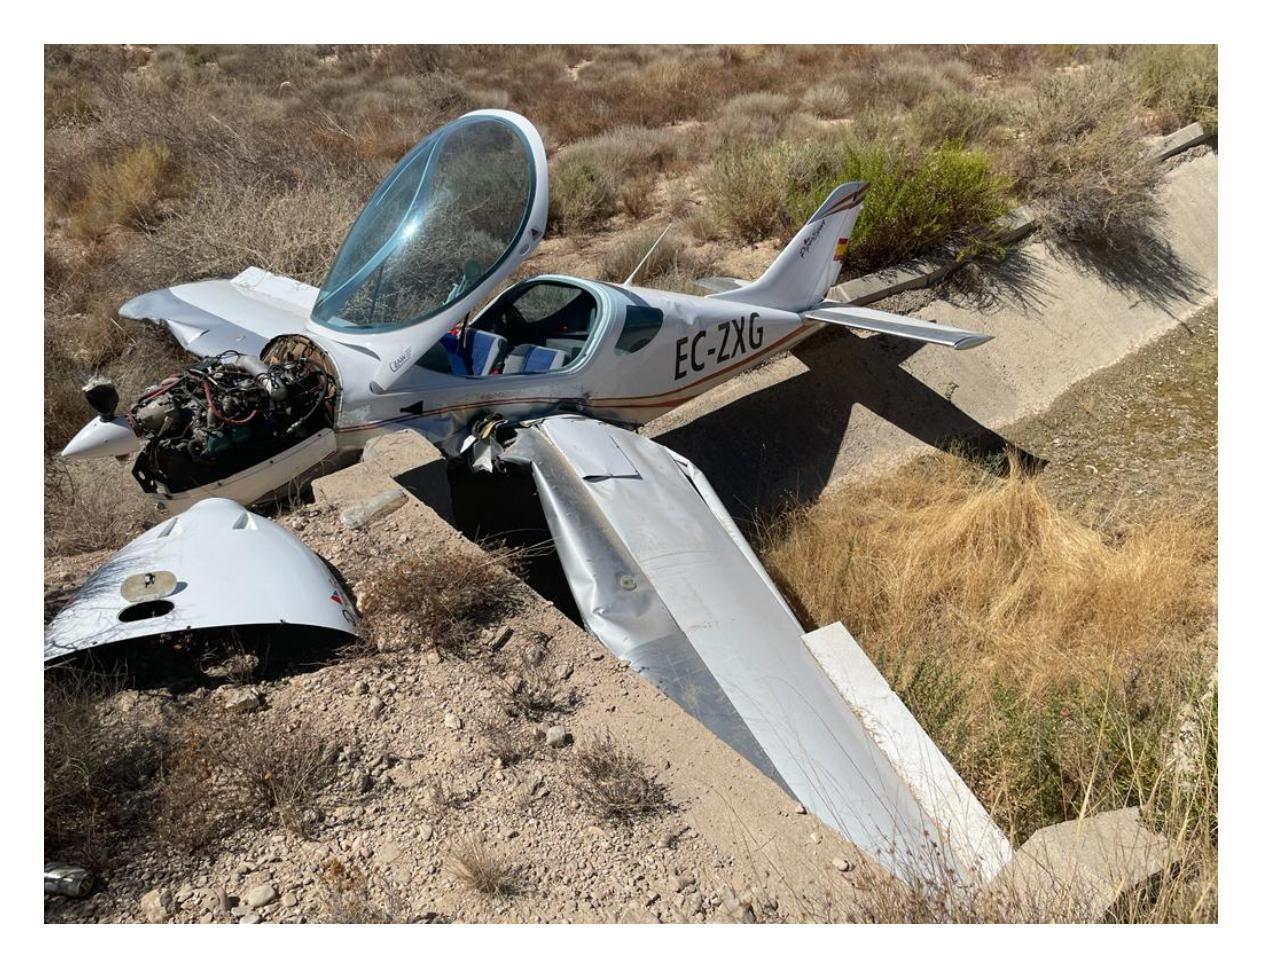
The structure of the aircraft remained largely intact, except for the propeller blades which had broken and the wings which were damaged and deformed, particularly at the base of the left wing.

Fig. no. 4.- Final condition of the aircraft

The wreckage of the aircraft was resting on the right side of the channel, according to the aircraft's direction of travel, on the right leg of the main gear and the right lower part of the tail assembly. The lower forward part of the fuselage at the base of the left wing was resting on the edge of the framework of the concrete structure. The left wing was overhanging the channel itself.

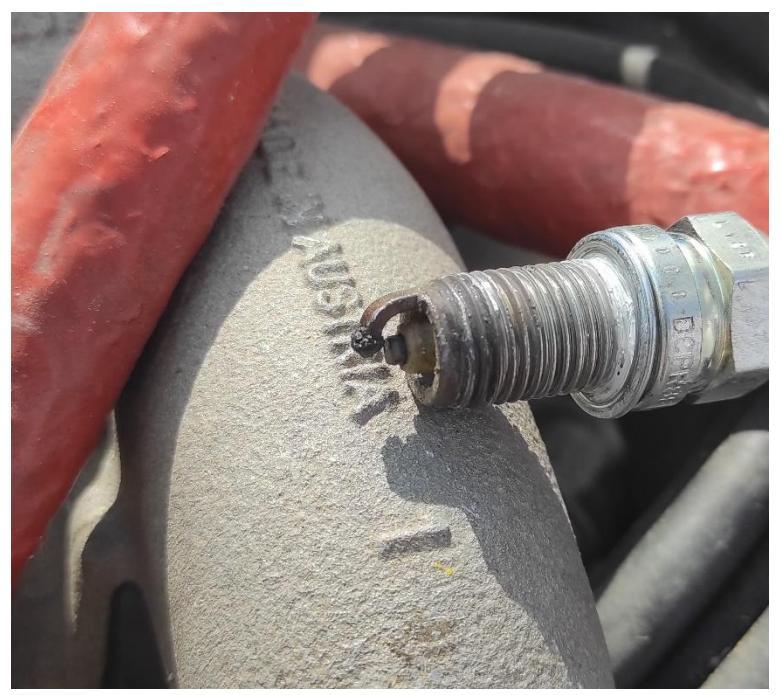
As regards the engine, the spark plugs of cylinders No. 1 and No. 3 indicated poor carburation, and the spark plug in No. 1 had a defective electrode. The fuel hoses and pump were out of date. The lubrication and cooling system hoses were also out of date.

Fig. No. 5.condition of the

cylinder No. 1

Close-up of the spark plug in

As for the engine, some of its components, such as the fuel pump hoses and the lubrication and cooling system hoses, had been inadequately maintained. In addition, the condition of the spark plugs of cylinders No. 1 and No. 3 indicated poor carburation, and the spark plug in No. 1 had a melted electrode. Irrespective of their condition, these circumstances were not decisive factors in the functioning of the engine.

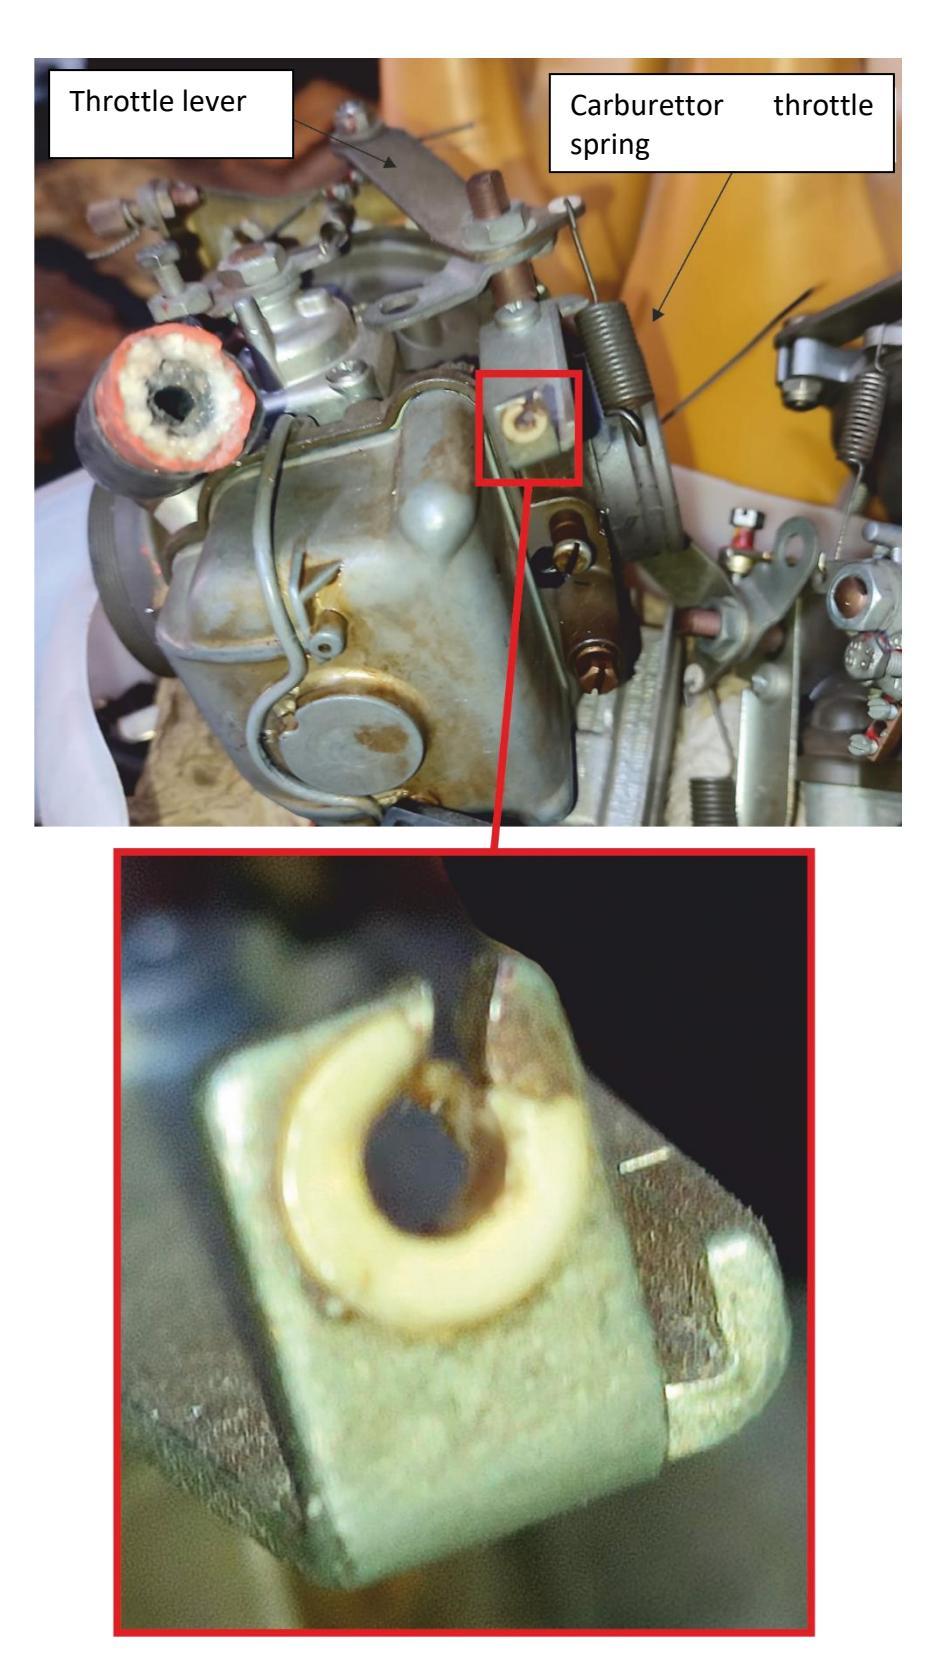
The carburettor throttle spring on the 1/3 side was loose due to material wear on the throttle lever and the plastic guard.

Fig. no. 6.- Close-up of the condition of the throttle lever

A separate issue was that the carburettor throttle spring on the 1/3 side was loose due to material wear on the throttle lever and the plastic guard.

The 2/4 carburettor was working normally, but the 1/3 carburettor had a loose throttle spring, which meant it was not accelerating correctly. This caused a desynchronisation between the carburettors, resulting in strong vibrations and spluttering.

The material wear on the throttle lever and the corresponding plastic guard at the spring attachment point indicates poor maintenance work in this regard.
