# Technical report IN-019/2021

Incident on 28 May 2021 involving a Boeing 737-800W aircraft, registration PH-BXF, operated by KLM, and a Tecnam P2006T, registration EC-MNG, operated by the European Aviation School of Barcelona, to the SE of the Barcelona TMA Area 1 (Barcelona, Spain)

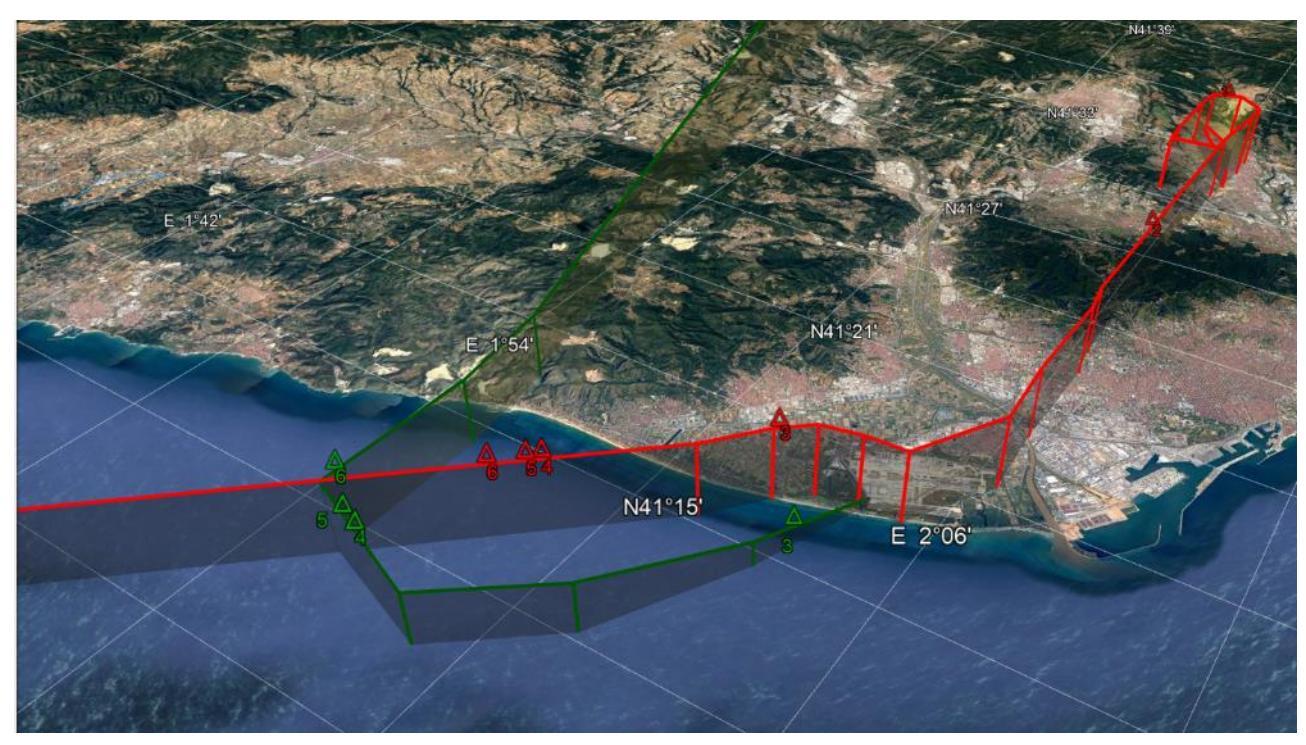
Illustration 2: Position of the aircraft at different points in time

Point **4.** Position of the KLM22B aircraft at 11:32:06 UTC (13:32:06 h), which was the moment the STCA-PAC alarm was triggered.

Point **5.** Position of the KLM22B aircraft at 11:32:13 UTC (13:32:13 h), which was the moment the STCA-VAC alarm was triggered.

Point 6. Position of the KLM22B aircraft at 11:32:30 UTC (13:32:30 h). As the aircraft was approaching the DOTIS waypoint through FL86 and climbing from to FL190, it had to stop

its ascent upon receiving a TCAS RA alert. At that moment, the distance between the two aircraft was 1.52 NM and 350 ft.

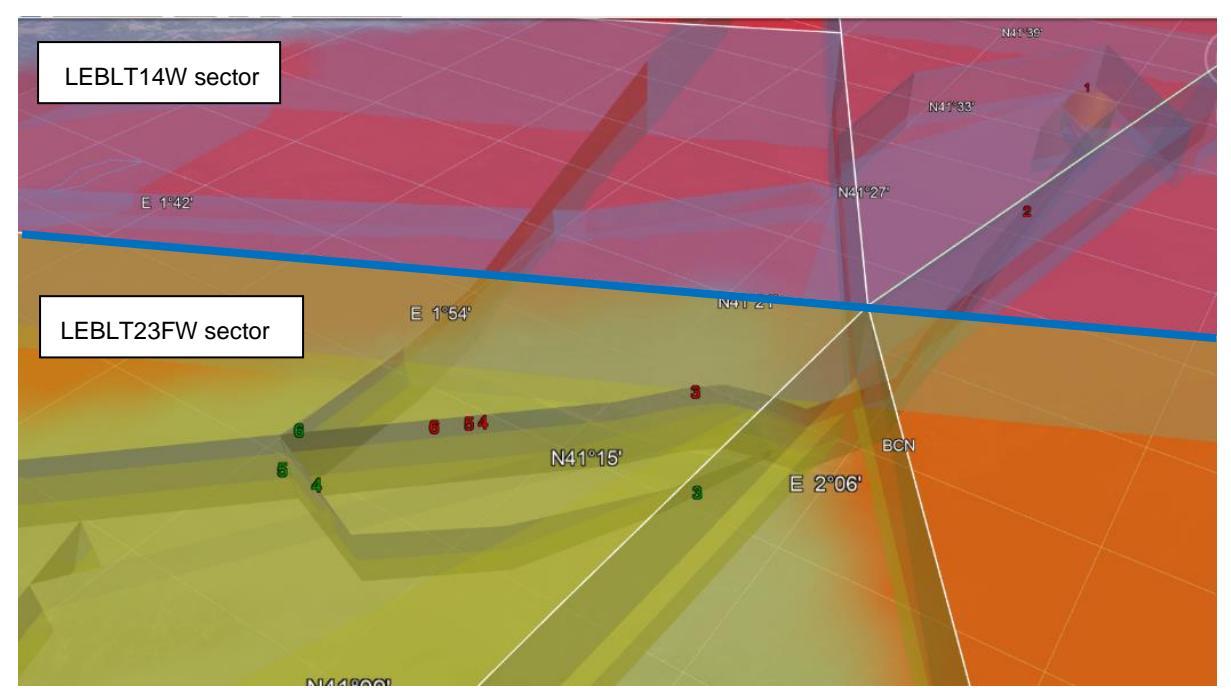
Illustration 3: Position of the aircraft at different points in time and control sectors involved in the incident

The following image show the two air traffic control sectors involved in the incident and the position of the aircraft at various points in time. The boundary between them has been highlighted with a blue line:
