# Technical report IN-034/2022

Incident on 2 July 2022 involving an Airbus A-330-323X aircraft operated by Delta Airlines, registration N803NW, and a Boeing 737-8AS aircraft operated by Ryanair, registration El-DYO, at Barcelona Airport

COMISIÓN DE INVESTIGACIÓN DE ACCIDENTES E INCIDENTES DE AVIACIÓN CIVIL

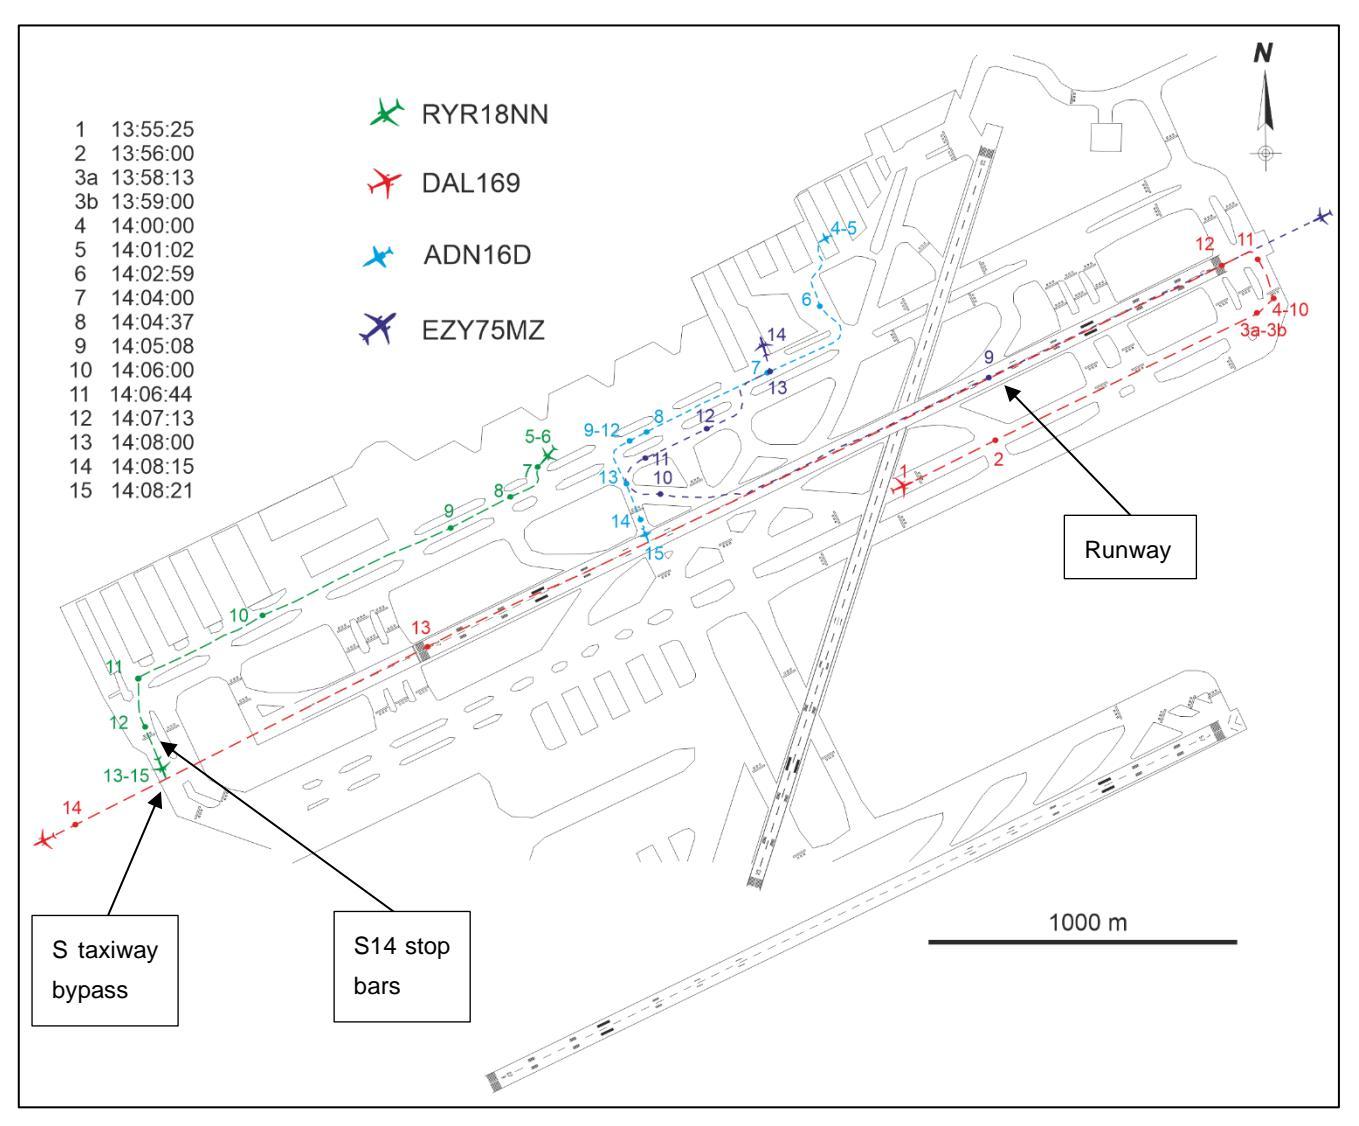
Image 1: Trajectories and relevant time points of the aircraft

Meanwhile, at 13:57:50, the crew of the Ryanair aircraft (with registration EI-DYO and flight callsign RYR18NN) contacted the GMC N controller to request a towed pushback from its stand, which was authorised by the latter. Five minutes later, the crew requested clearance to taxi, and the controller authorised them to so, immediately providing a complete route to follow from the parking stand to the boundary between the GMC N area of responsibility and the central ground movement controller's area of responsibility (GMC C). This instruction implied taxiing around runway 24R and crossing its extension on the S taxiway bypass (See Image 1).

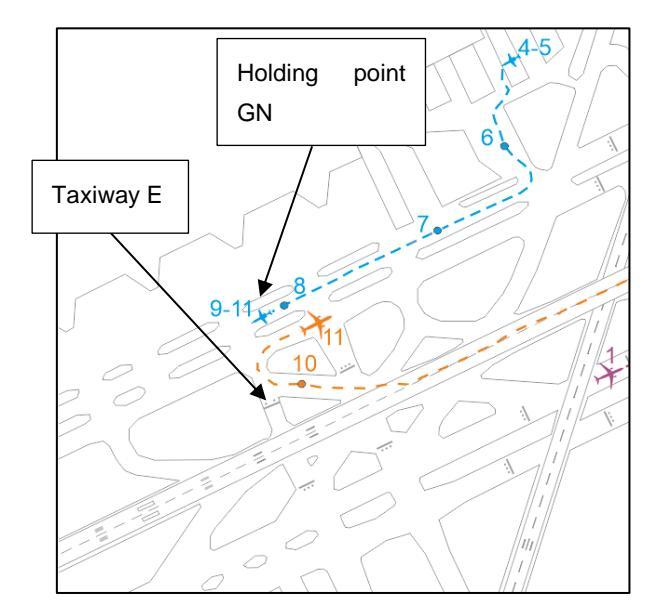
Image 2: Detail of the paths of the ADN16D and EZY75MZ aircraft until 14:06:44

EZY75MZ) used runway exit P5 (at 14:05:40). This meant it blocked the path of aircraft ADN16D, causing its taxi to take longer than anticipated and leaving it unable to cross the runway when it was scheduled to do so. As a result, it was decided that the plan would be changed again and that the non-preferential take-off would take place before the runway crossing, and the GMC N controller asked the EZY75MZ aircraft to speed up its taxi (at 14:06:00).

Following these changes to the plan, the LCL ARR controller cleared aircraft DAL169 for take-off at 14:06:44. At the time of issuing the clearance, he had not re-coordinated the bypass release with GMC N nor had he turned on the S14 stop bar, which the RYR18NN aircraft was approaching, just few metres away. The controller subsequently stated that, when it was time to clear the take-off, the gap for it do so before the next landing was tight.

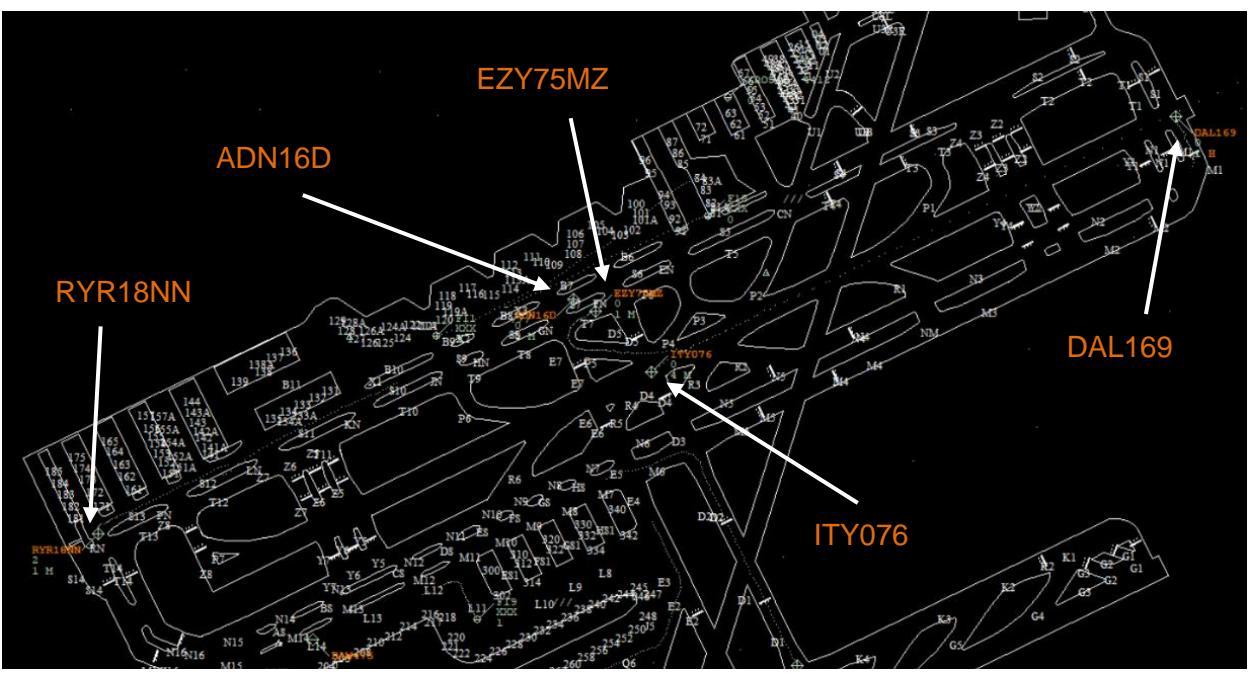
Image 3: Positions of the aircraft at 14:06:49 h

At 14:06:49 h, the radar image shows aircraft DAL169 entering runway 24R to commence its take-off and aircraft RYR18NN taxiing along taxiway S and reaching gate RN. See Image 3. It also shows the EasyJet aircraft, callsign EZY75MZ, blocking the medical transport aircraft's (ADN16D) planned route across the runway after the landing of the ITA Airways aircraft (ITY076).

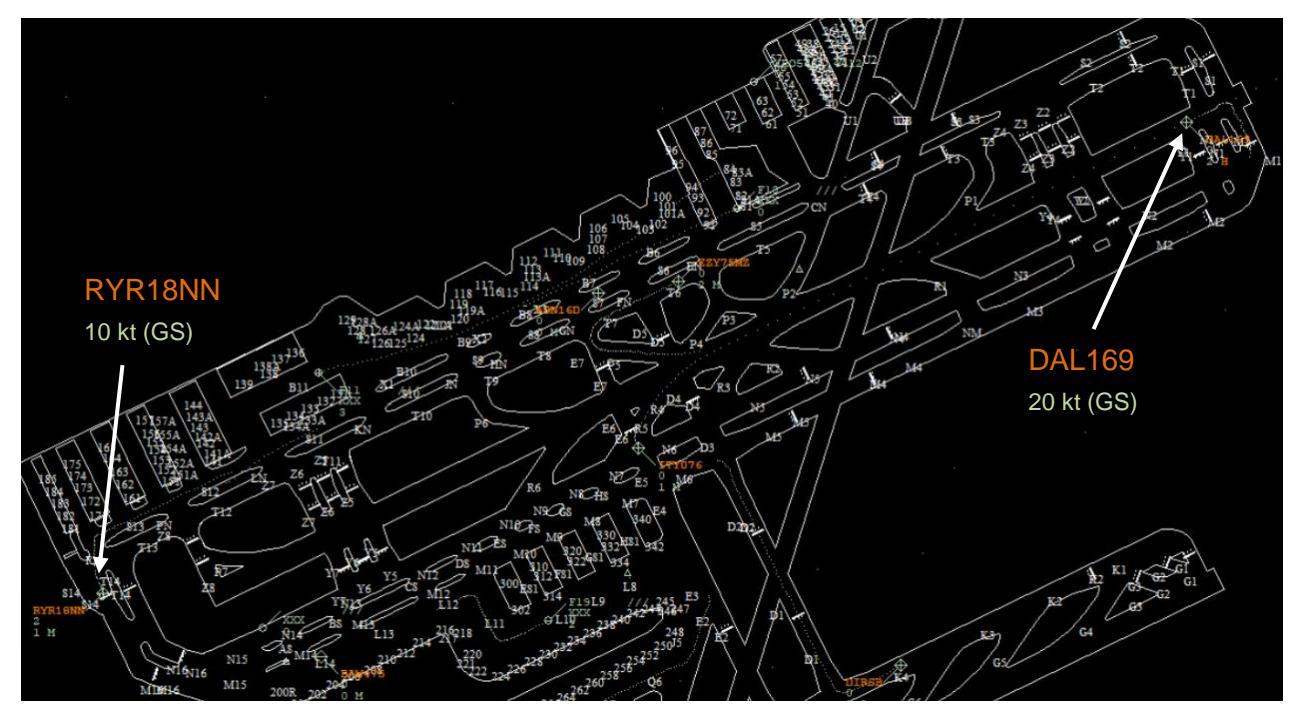
Image 4: Positions of the aircraft at 14:07:16 h

At 14:07:16 h, the radar image shows aircraft DAL169 initiating its take-off run at 20 kt (GS) and aircraft RYR18NN just passing over the S14 stop bar. See Image 4.

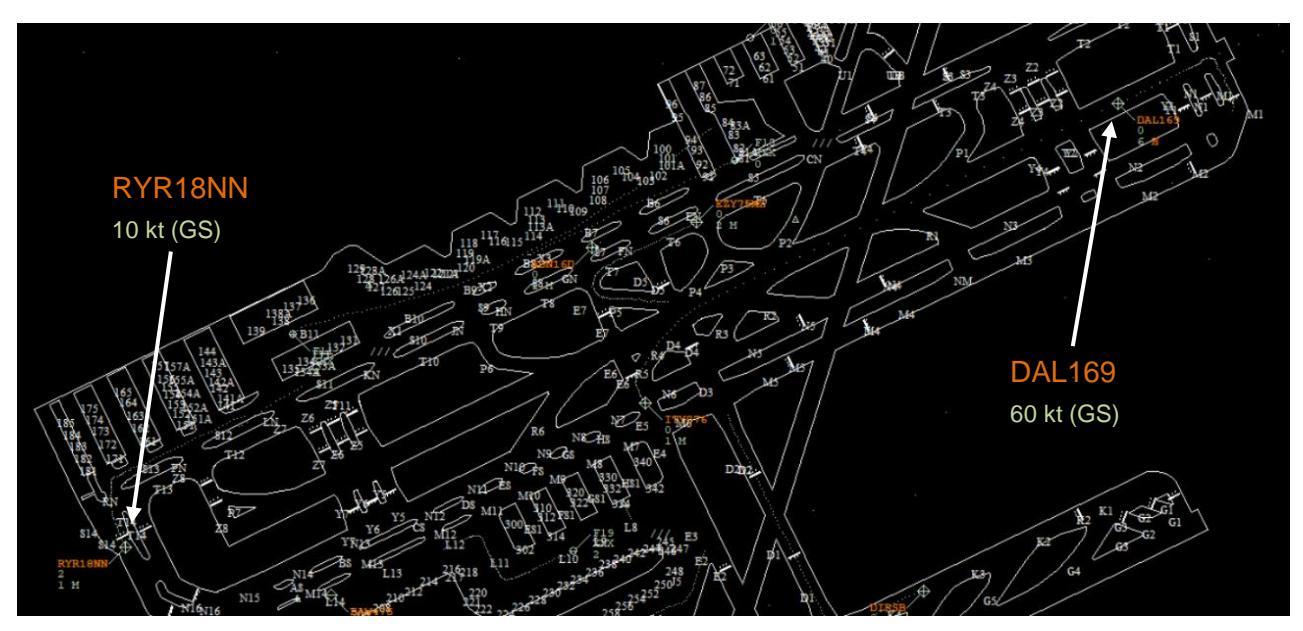
Image 5: Positions of the aircraft at 14:07:23 h

At 14:07:23 h, the radar image shows aircraft DAL169 on its take-off run at 60 kt (GS) and aircraft RYR18NN having passed the S14 stop bar. See Image 5.

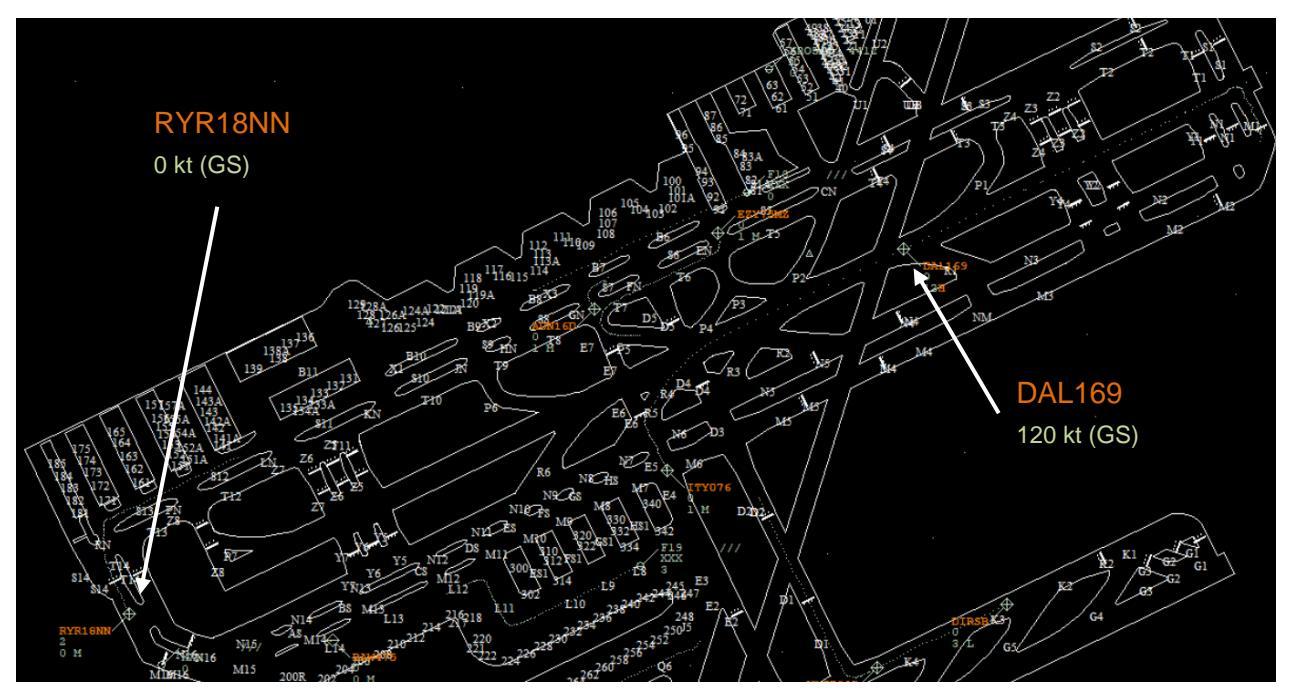
Image 6: Positions of the aircraft at 14:07:39 h

At 14:07:39 h, the radar image shows aircraft DAL169 on its take-off run at 120 kt (GS) while aircraft RYR18NN is stationary on the extension of 24R having passed the S14 stop bar. See Image 6.

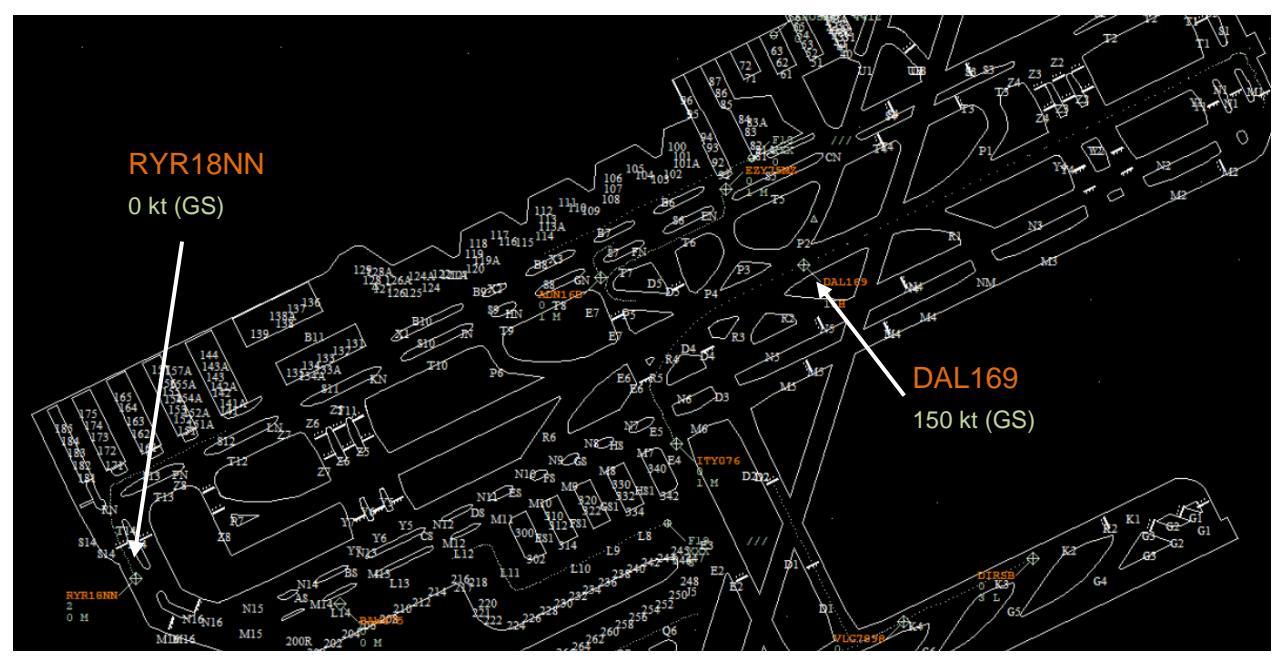
Image 7: Positions of the aircraft at 14:07:44 h

At 14:07:44 h, the radar image shows aircraft DAL169 on its take-off run at 150 kt (GS) while aircraft RYR18NN is stationary on the extension of 24R having passed the S14 stop bar. According to the information sent by AENA, it was at this moment that the S14 stop bar was activated in the tower's lighting system. See Image 7.

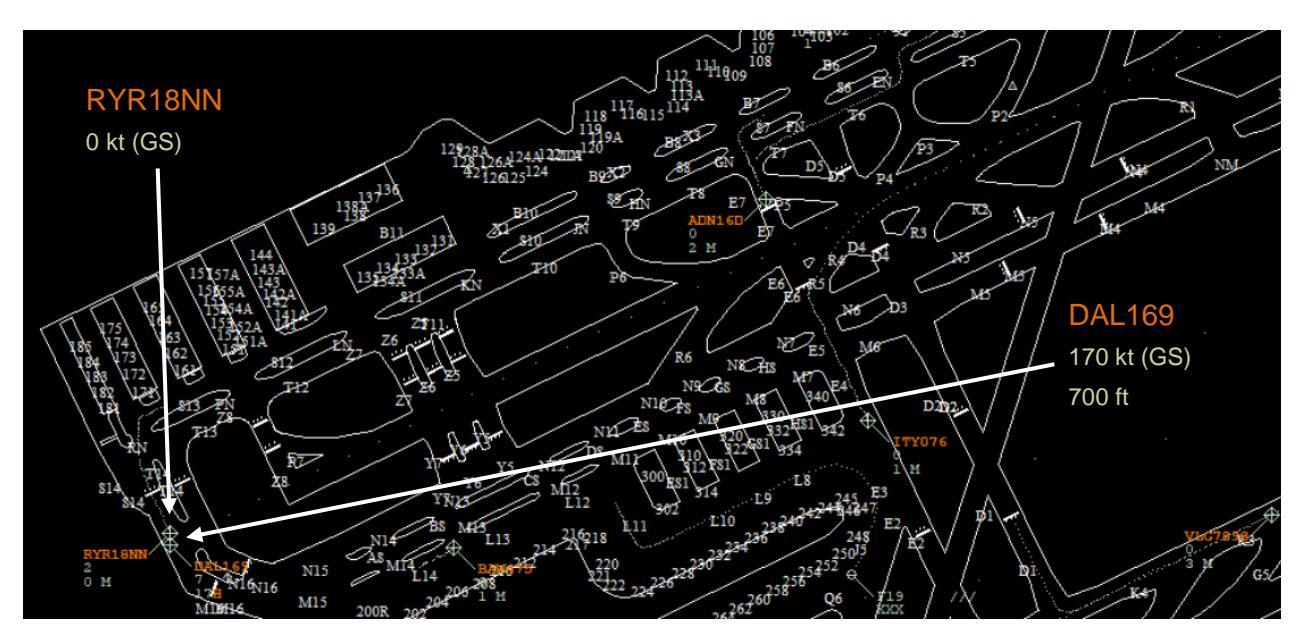
Image 8: Positions of the aircraft at 14:08:11 h

At 14:08:11 h, the radar image shows aircraft DAL169 on its initial climb at 170 kt (GS) and an altitude of 700 ft overflying aircraft RYR18NN, which was continuing to hold on the extension of 24R. See Image 8.

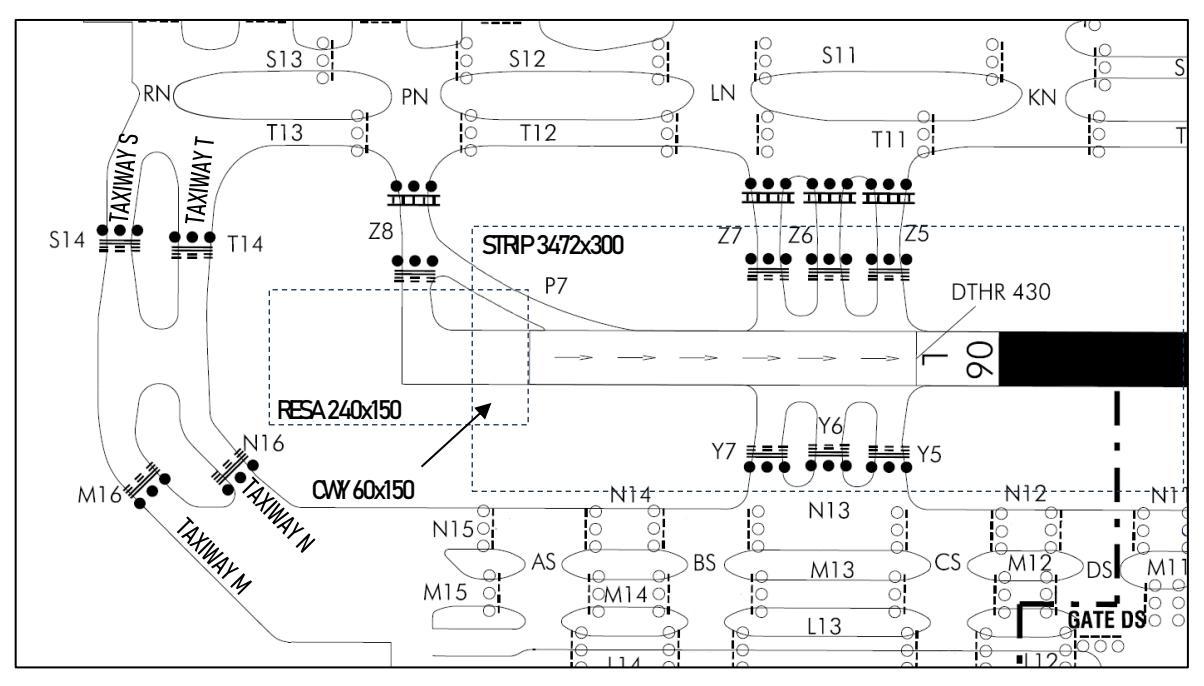
Image 10: Detail of the end of runway 24R and the S/M & T/N taxiway bypasses

Taxiways S/M and T/N, which cross the extension of runway 24R outside the strip, are 350 and 280 m from the end of the clearway (CWY), respectively. After the clearway, there is a take-off climb obstacle limitation surface, with a gradient of 2%. In the West configuration, this obstacle limitation surface would be breached if an aircraft with a height of more than 7m crosses the runway extension using the S/M taxiway. For this reason, the airport's procedures do not allow aircraft to cross these taxiways while another aircraft is taking off from the runway (see Image 10).

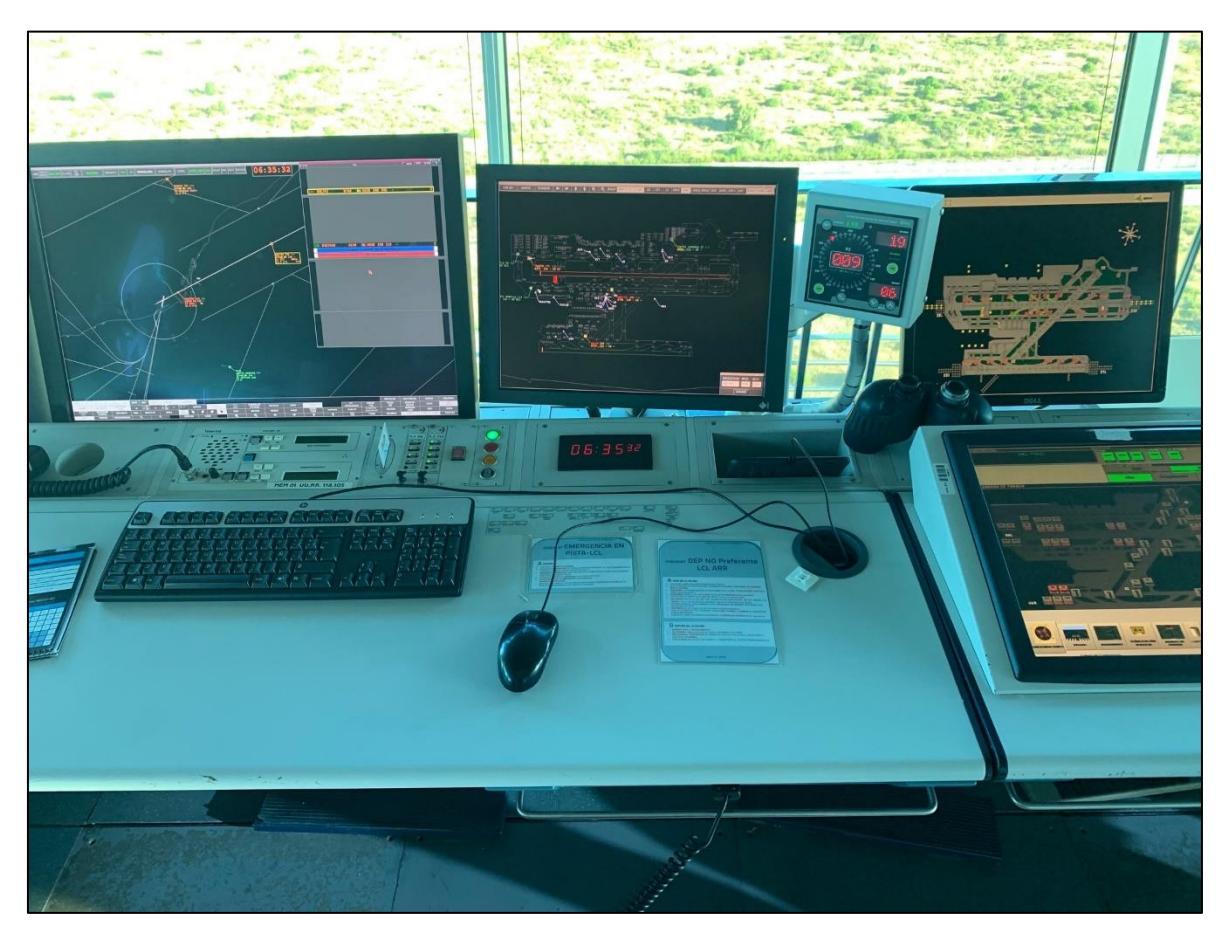
Image 13: Position of the local arrivals controller (the SMP control panel is on the right).

As noted in point 1.17.1, the SMP is approximately one metre away from the controller's normal position, and its orientation prevents it from being seen unless the controller is in front of it. This means that to modify or check the status of the stop bars, the controller has to move from their principal position in front of the radar screens. Consequently, if the controller forgets to change the status of a stop bar, there would be no visible warning to alert them of the oversight whilst in their normal position.

REC 25/23: It is recommended that AENA, in collaboration with ENAIRE, improve the lighting control and monitoring system at Josep Tarradellas Barcelona-El Prat Airport so that it can be monitored from the controller's principal working position.

REC 26/23: It is recommended that ENAIRE, in collaboration with AENA, improve the lighting control and monitoring system at Josep Tarradellas Barcelona-El Prat Airport so that it can be monitored from the controller's main working position.

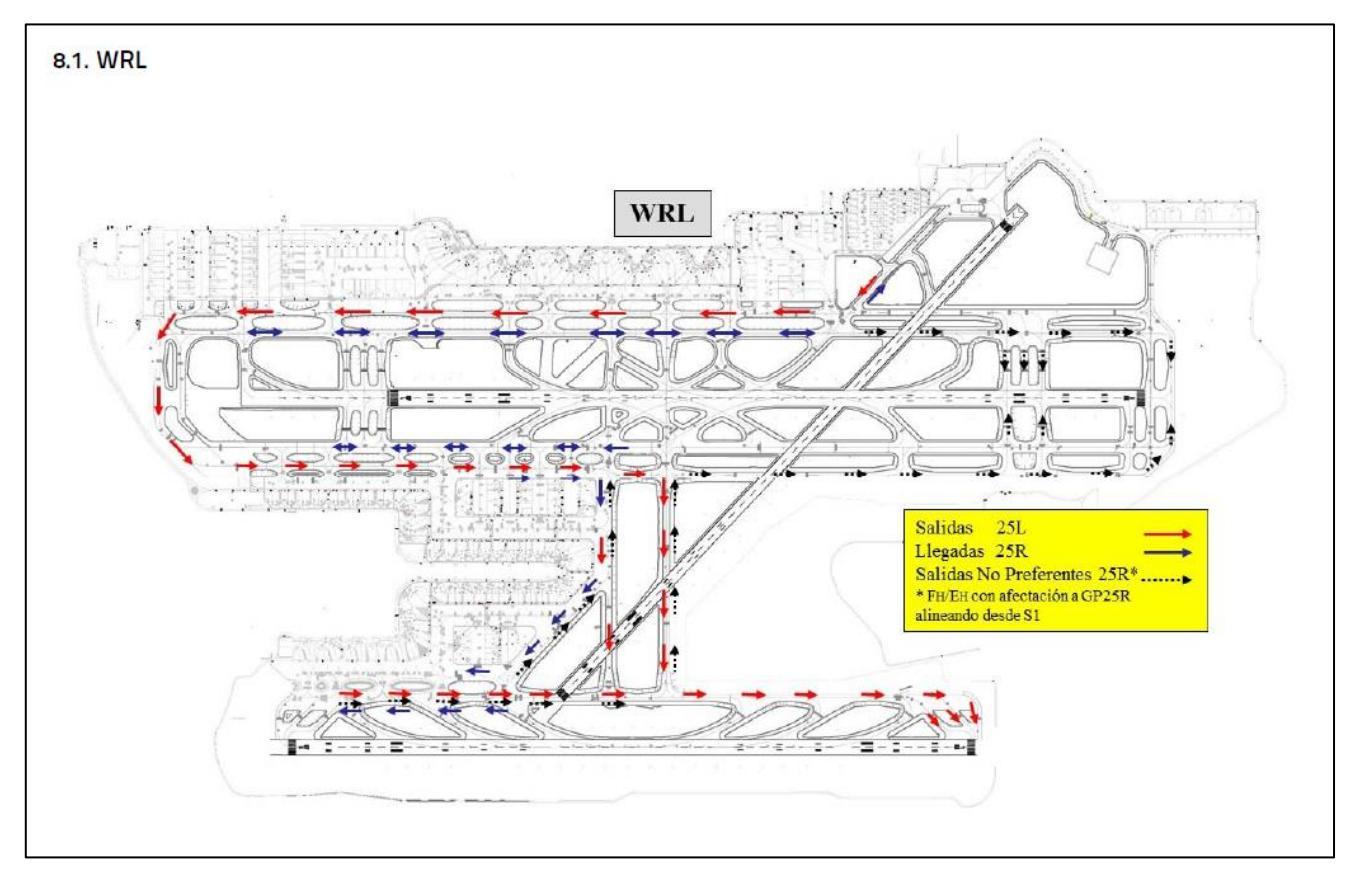
Image 14: Ground movement procedure for arrivals and departures in WRL configuration

- In the Barcelona-El Prat Tower Operating Manual, Annex E provides a checklist for the local arrivals controller, containing the procedures to be carried out before the take-off of non-preferential traffic. This checklist is comprised of 10 points to complete before the non preferential take off. Each point is comprised of a phrase with a mean of fourteen words, and five of them highlighted in red.
- The annexes to the October 2020 Document on Ground Movement Procedure at Josep Tarradellas Barcelona-El Prat Airport contain the ground movement plans with runway 25L for take-offs (in red), runway 25R for arrivals (in blue) and in exceptional cases for some non-preferential departures on 25R (in black):

The local arrivals controller started going through the checklist items correctly, following the initial plan. However, after the take-off of aircraft DAL169 was postponed, and then the runway crossing of ADN16D was delayed, the controller did not restart the checklist from the beginning (or skipped a few steps) because he failed to re-coordinate the take-off with the GMC N controller (second item on the checklist) and did not activate the stop bar (seventh item on the checklist) nor advise his colleagues.
