# Technical report IN-044/2020

Incident involving a Boeing 737-800 aircraft, registration EI-EBC, and a Beechcraft B200 aircraft, registration EC-MUP on 23 October 2020 at Málaga Airport

CIVIL AVIATION ACCIDENT AND INCIDENT INVESTIGATION COMMISSION

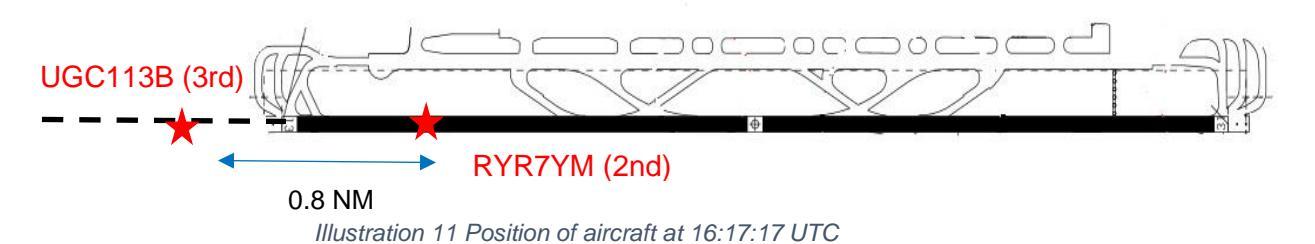
At 16:17:17 UTC, the trace shows aircraft RYR7YM on take-off run at a speed of 90 kt and aircraft UGC113B on short final proceeding at a speed of 130 kt. This was the point of minimum separation between the aircraft, it being 0.8 NM.

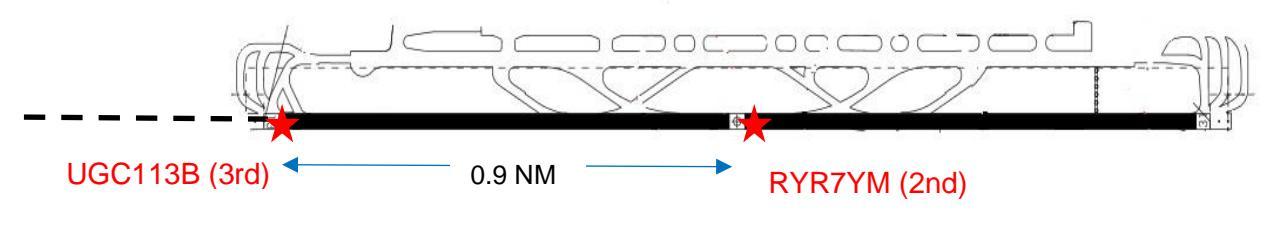
Illustration 12 Position of aircraft at 16:17:33 UTC

At 16:17:33 UTC, the trace shows aircraft RYR7YM on take-off run at a speed of 140 kt and aircraft UGC113B overflying the threshold of runway 13 at 300 ft AMSL and at a speed of 120 kt. At this point, the horizontal separation between the aircraft was 0.9 NM.

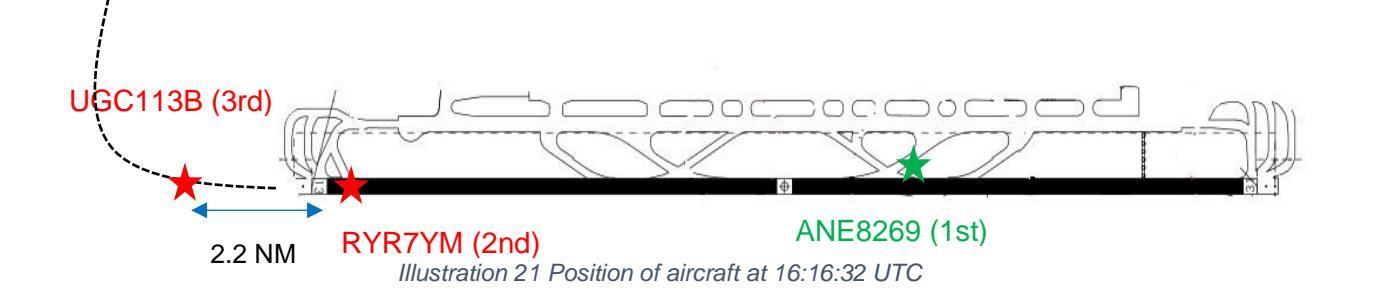
At 16:16:32 UTC, the air traffic controller cleared aircraft RYR7YM for take-off when aircraft UGC113B was on final, 2.2 NM from the runway threshold. The departing aircraft started the take-off run (at a speed of 20 kt) 23 seconds after acknowledging the clearance. Given the time required to select take-off power and the time it takes for the aircraft to begin to move, we have concluded that the crew did not take an excessive amount of time to begin the take-off run.

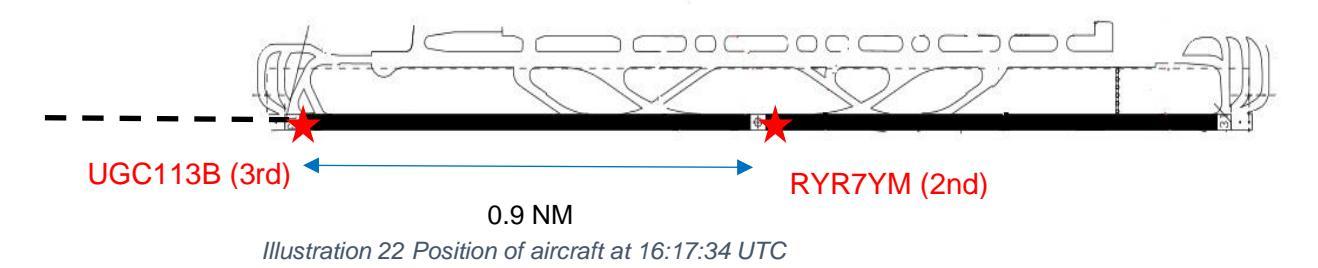
At 16:17:34 UTC, the air traffic controller cleared aircraft EC- MUP with callsign UGC113B to land as it passed over the threshold of runway 13 at 300 ft AMSL. The RYR7YM aircraft on take-off was completing its rotation manoeuvre. The horizontal separation between the two aircraft was 0.9 NM.

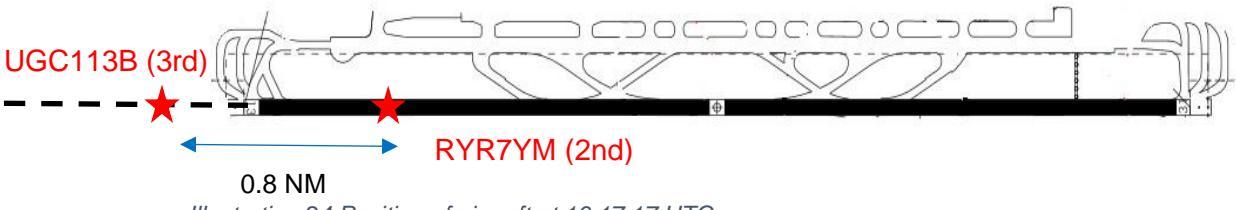
The moment of minimum separation between the aircraft occurred at 16:17:17 UTC when aircraft RYR7YM was on take-off run at a speed of 90 kt, and aircraft UGC113B was on short final at 130 kt. The horizontal separation between the aircraft was 0.8 NM.
