Technical report ULM A–005/2018

Accident involving a FLIGHT DESIGN CTSW, registration EC-LXE, in Gurrea de Gállego (Huesca, Spain) on 3 March 2018

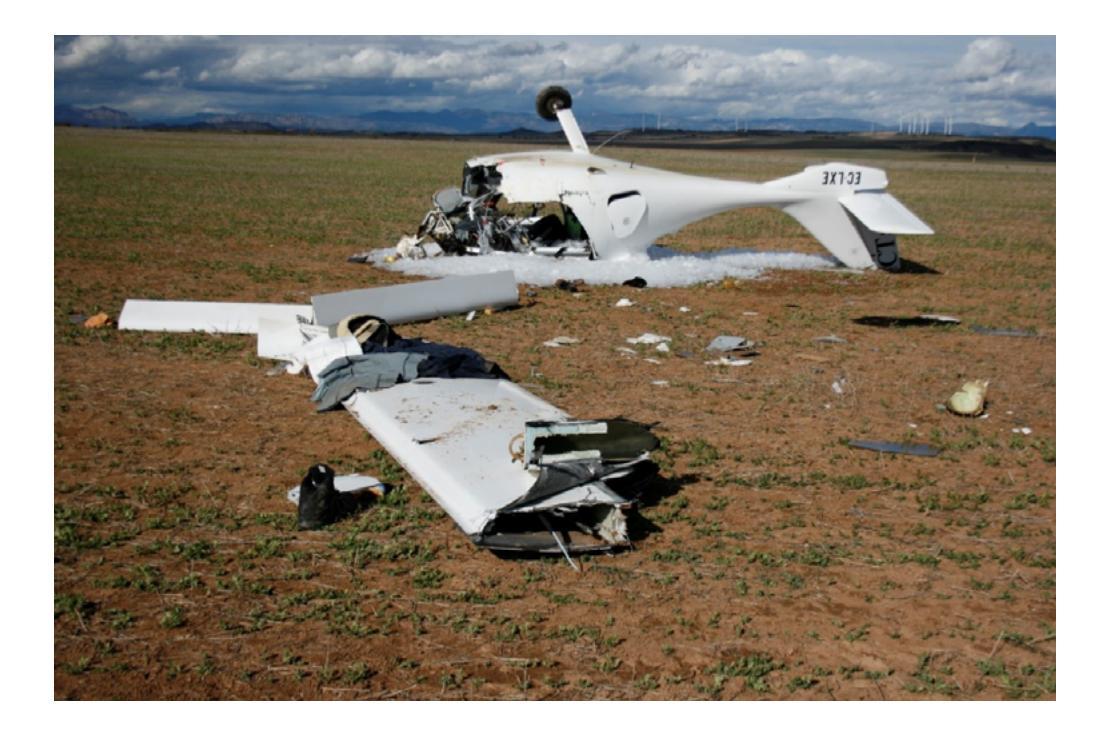
The aircraft crashed in farmland next to the aerodrome, some 100 m to the right of runway 30. The impact caused an initial mark, made by the right wingtip, some 85 m away from the runway centerline. Eight meters north of this mark was another impact mark made by the bottom of the cabin. The aircraft came to a stop in an upside-down position 16 m north of this second impact mark.

Figure 1. Final position of aircraft.

The aircraft came to a stop in an upside-down position facing approximately northwest. Since it was leaking fuel, it was covered in foam by firefighters so as to prevent a potential fire.

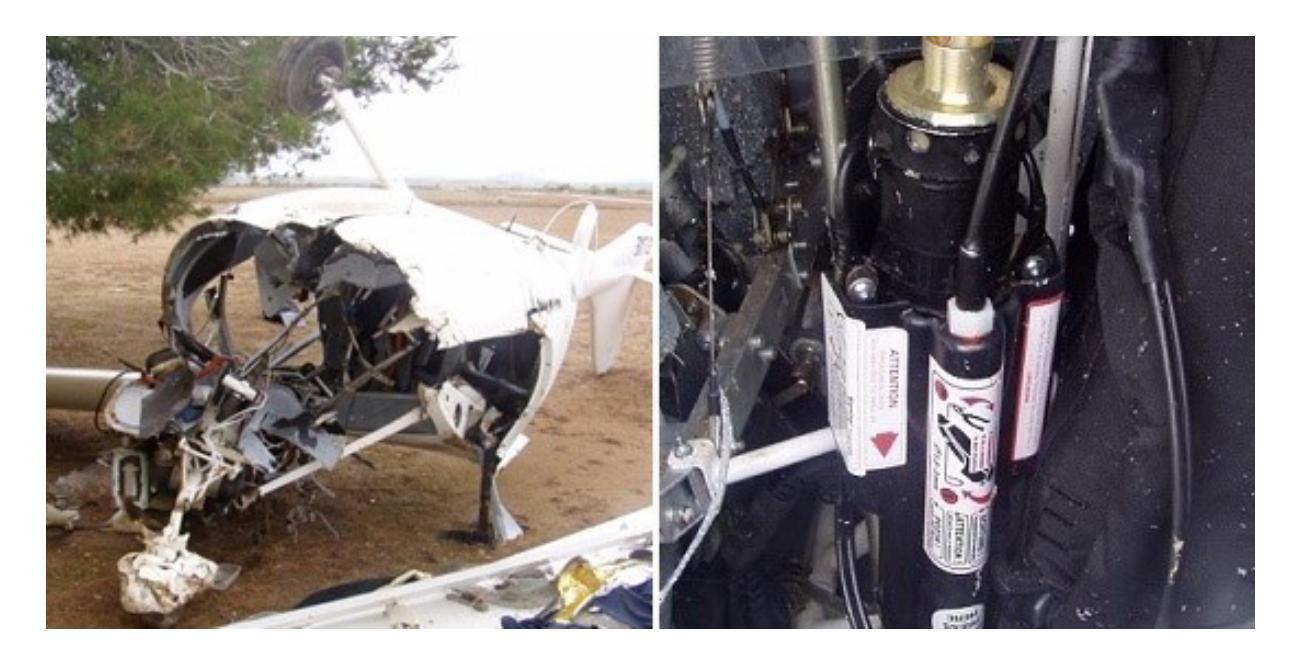
The propeller blades had been fractured by the impact with the ground and the right wing had detached.

The engine mount was broken, which shifted the engine from its position and damaged multiple components. The control panel in the cockpit was also shifted and damaged.

Due to their condition, the continuity of the controls could not be verified. The aircraft was also equipped with a ballistic parachute, which did not detonate.

Figure 2 shows the condition of the aircraft after the accident, with the cockpit destroyed due to the impact with the ground, and the installed ballistic parachute system.

Figure 2. Final condition of aircraft and ballistic parachute.

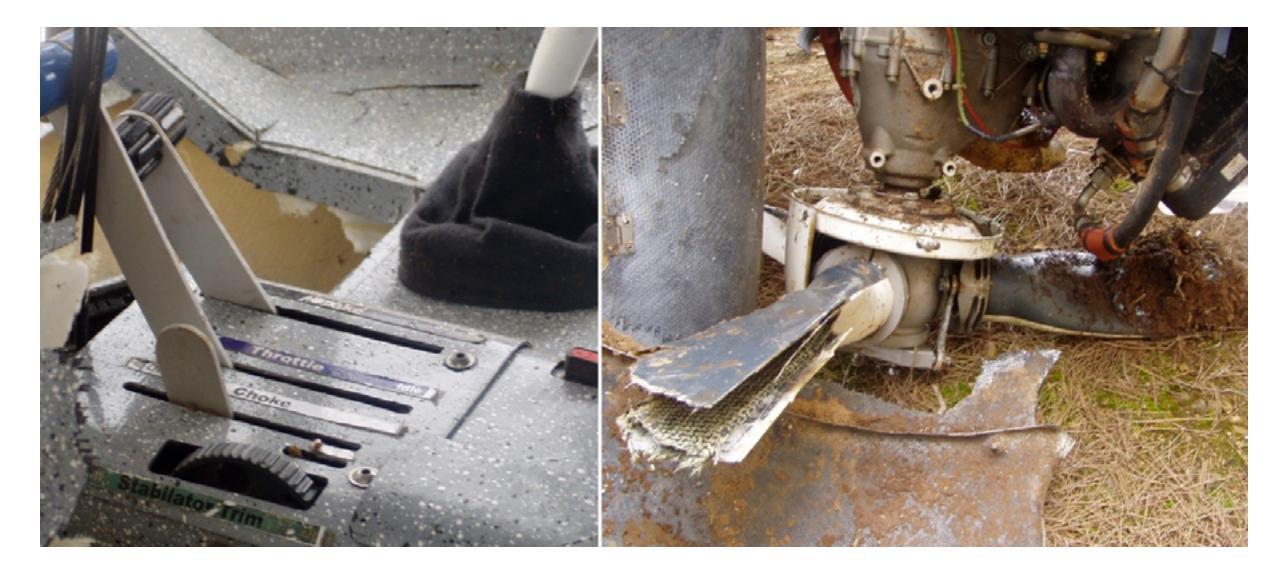
The throttle and mixture controls were set full forward. The images in Figure 3 show the positions of the levers in the cockpit, as well as the condition of the propeller blades.

Figure 3. Lever positions in cockpit and propeller blades.

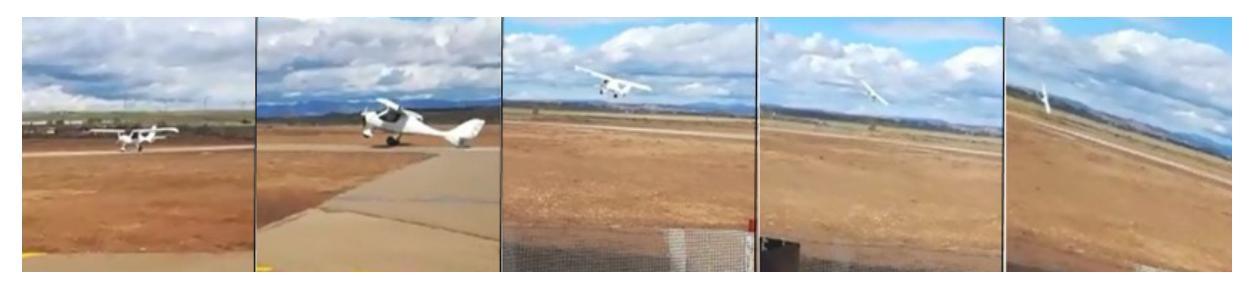
Figure 4 contains five frames that show this sequence, from the start of the climb until just before the impact.

Figure 4. Initial climb and stall.

The last frame shows how, just before impact, the aircraft was in a sharp right-bank attitude. The initial contact with the ground was with the right wing, with the airplane eventually coming to a stop in an upside-down position 24 m away from this initial impact mark.

The video recorded by the eyewitnesses allowed investigators to determine that the rotation was started after traveling about 70-80 m from the runway threshold. Immediately after starting the climb, the aircraft began an uncommanded right turn. This was caused by having taken off at a speed that was too low for the aircraft's weight, which resulted in insufficient aerodynamic control of the aircraft. This, in turn, caused the pilot to lose control of the aircraft. The wind conditions present at the airfield induced the aircraft to deviate, which resulted in the uncommanded turn to the right of runway 30.

When the aircraft turned right, influenced by the crosswind from an approximate direction of 200-210°, which then transitioned into a tailwind, the situation worsened, causing the stall that resulted in the airplane's impacting the ground with a right-bank attitude.
