TECHNICAL REPORT

A-005/2000

Accident of aircraft
YAK-52, registration
LY-EST, in El Alamo
(Province of Madrid)
on 10 March 2000

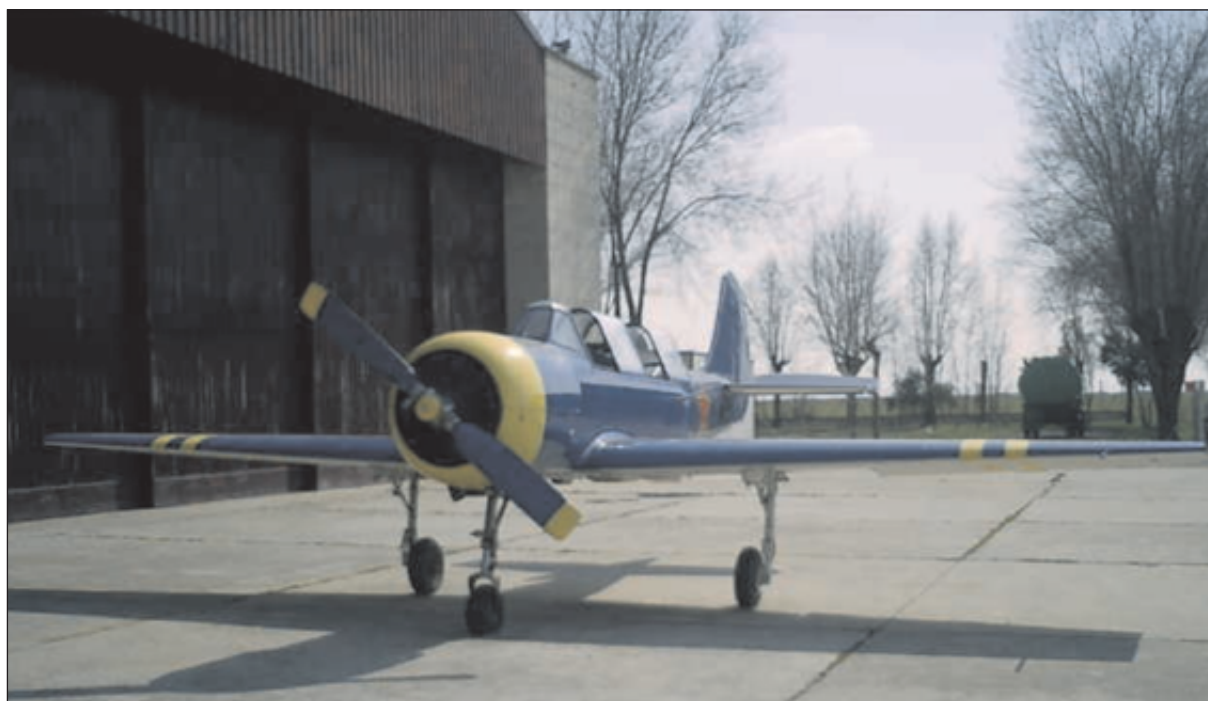
Photo 1. *Aircraft of the type in the accident*

The Yakovlev YAK-52 is a two-seater military training and aerobatic aircraft of Russian origin, with structural limits of +7 g's and of -5 g's, with a Vedeneyev M14P radial piston engine and semi-retractable undercarriage. It was designed for primary instruction of military pilots who would then go on to jet aircraft; however, today it is popular throughout the western world among enthusiasts of recreational flying. (See photo 1.)
