CIAIAC

TECHNICAL REPORT

A-028/2000

Accident to the
aircraft Nimbus 4DT,
registration G-929,
at Campillo de la Jara
(Toledo), on 31st
July 2000

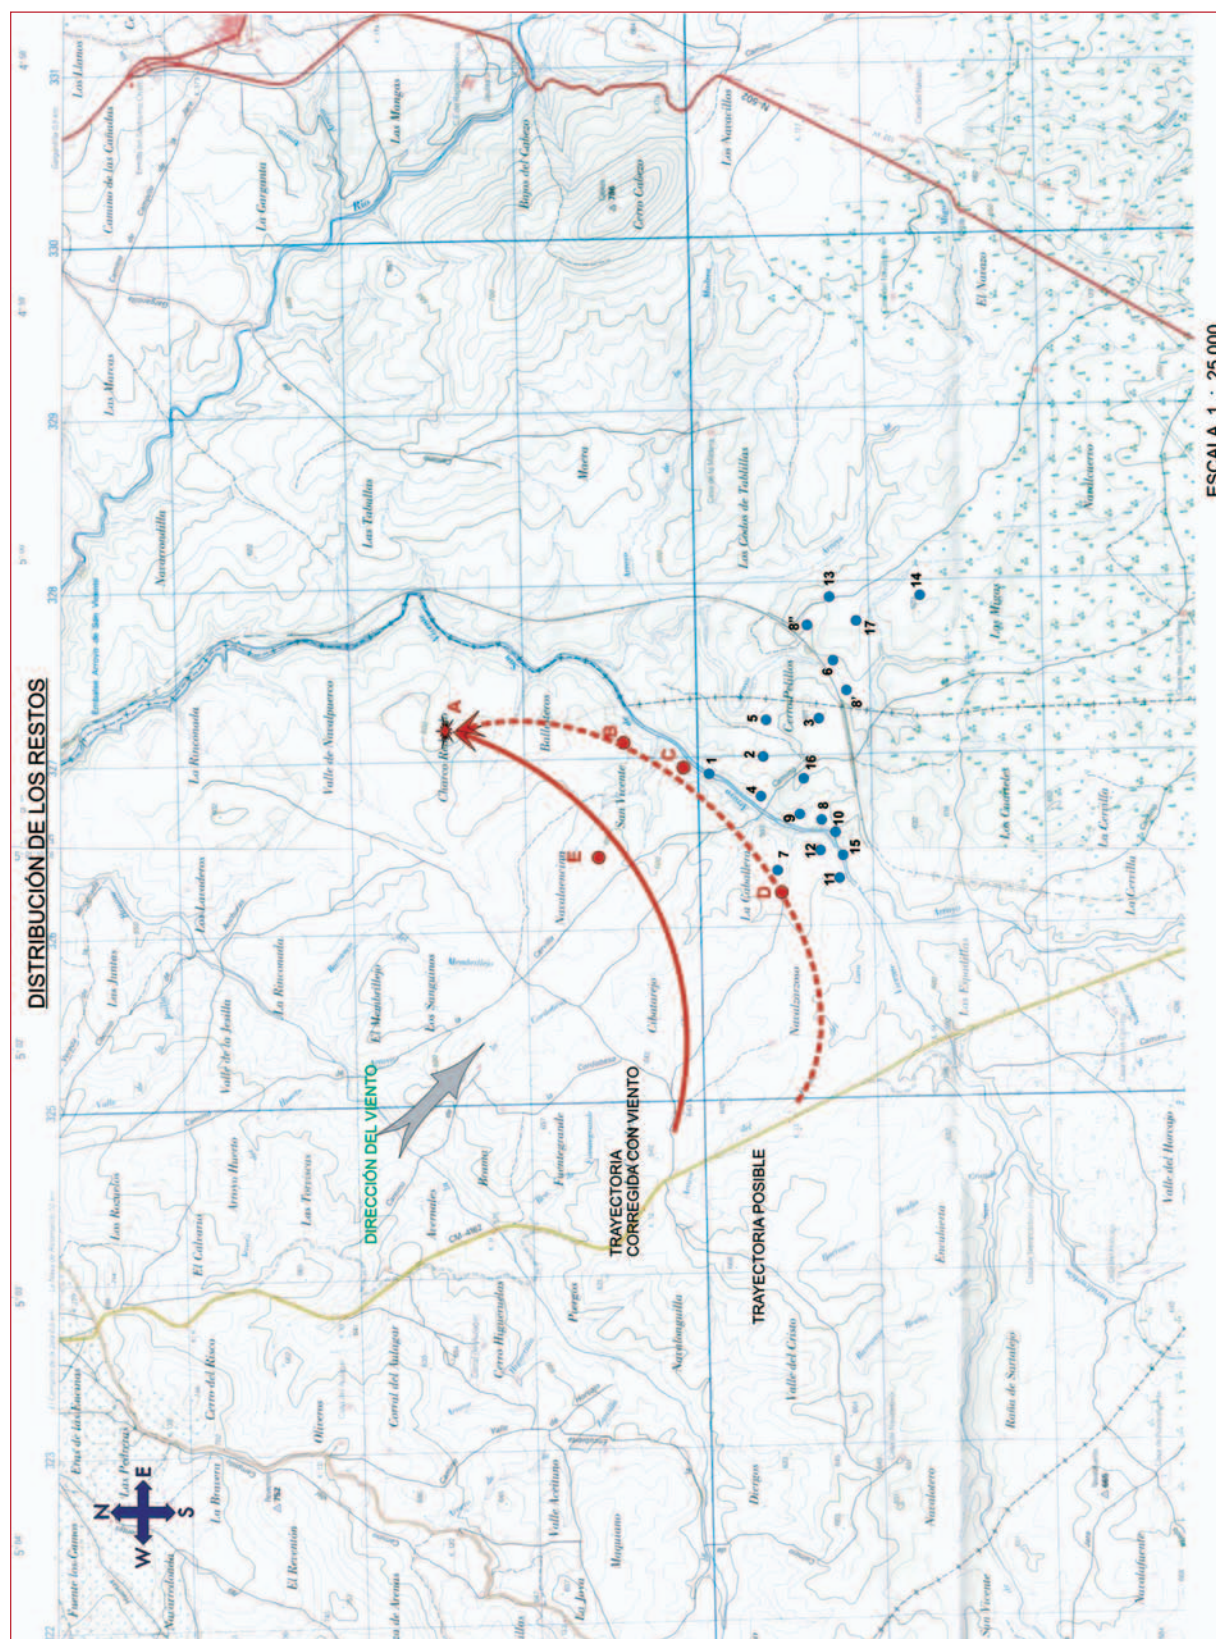
Figure A2. Impact area

The wreckage was spread over an area of some 1,800 m in diameter, accumulated in four Zones D, C, B and A, aligned in a SW-NE direction. A mass of minor remains, pieces of covering, fragments of plastic and small items were found to the SE of the line of Zones A, B, C and D.
