DATA SUMMARY

Registration	EC-FJG
Type and model	PIPER PA-36-300

Operation	Aerial work – Commercial – Agricultural
Phase of flight	Manoeuvring – low flying

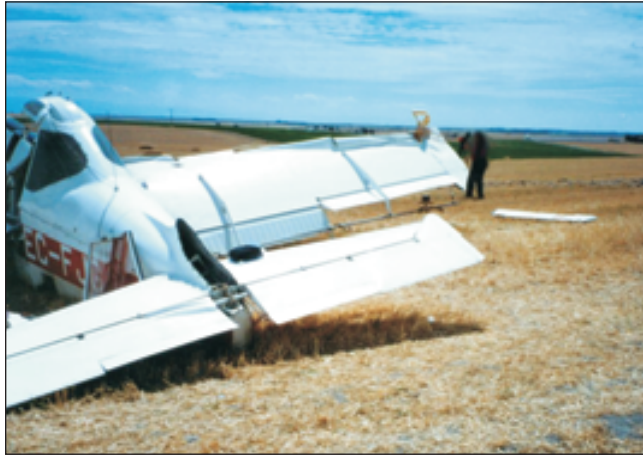
The pilot was fumigating on an irregularly-shaped beet field. A power line ran along the side of the field. Beyond the power line, the land rose forming a hill, with a second power line behind it. The pilot was carrying out the spray runs so that at the end of each run he would pass under the first power line, then immediately climb to clear both the hill and the second power line, and finally turn to begin another spray run.

During what was supposed to be the last spray run, with the hopper practically empty, the aircraft impacted against the two lowermost wires of the three-wire power line that ran along the edge of the field being sprayed. These impacts were produced somewhere in between the protective cable that goes from the wire cutting sheet located in the front of the cabin to the uppermost end of the vertical stabilizer (fin).
