## **TECHNICAL REPORT**

**A-002/2003**

Accident of aircraft  
FOKKER 50,  
registration PH-FZE,  
at Melilla Airport  
(Spain), on 17  
January 2003

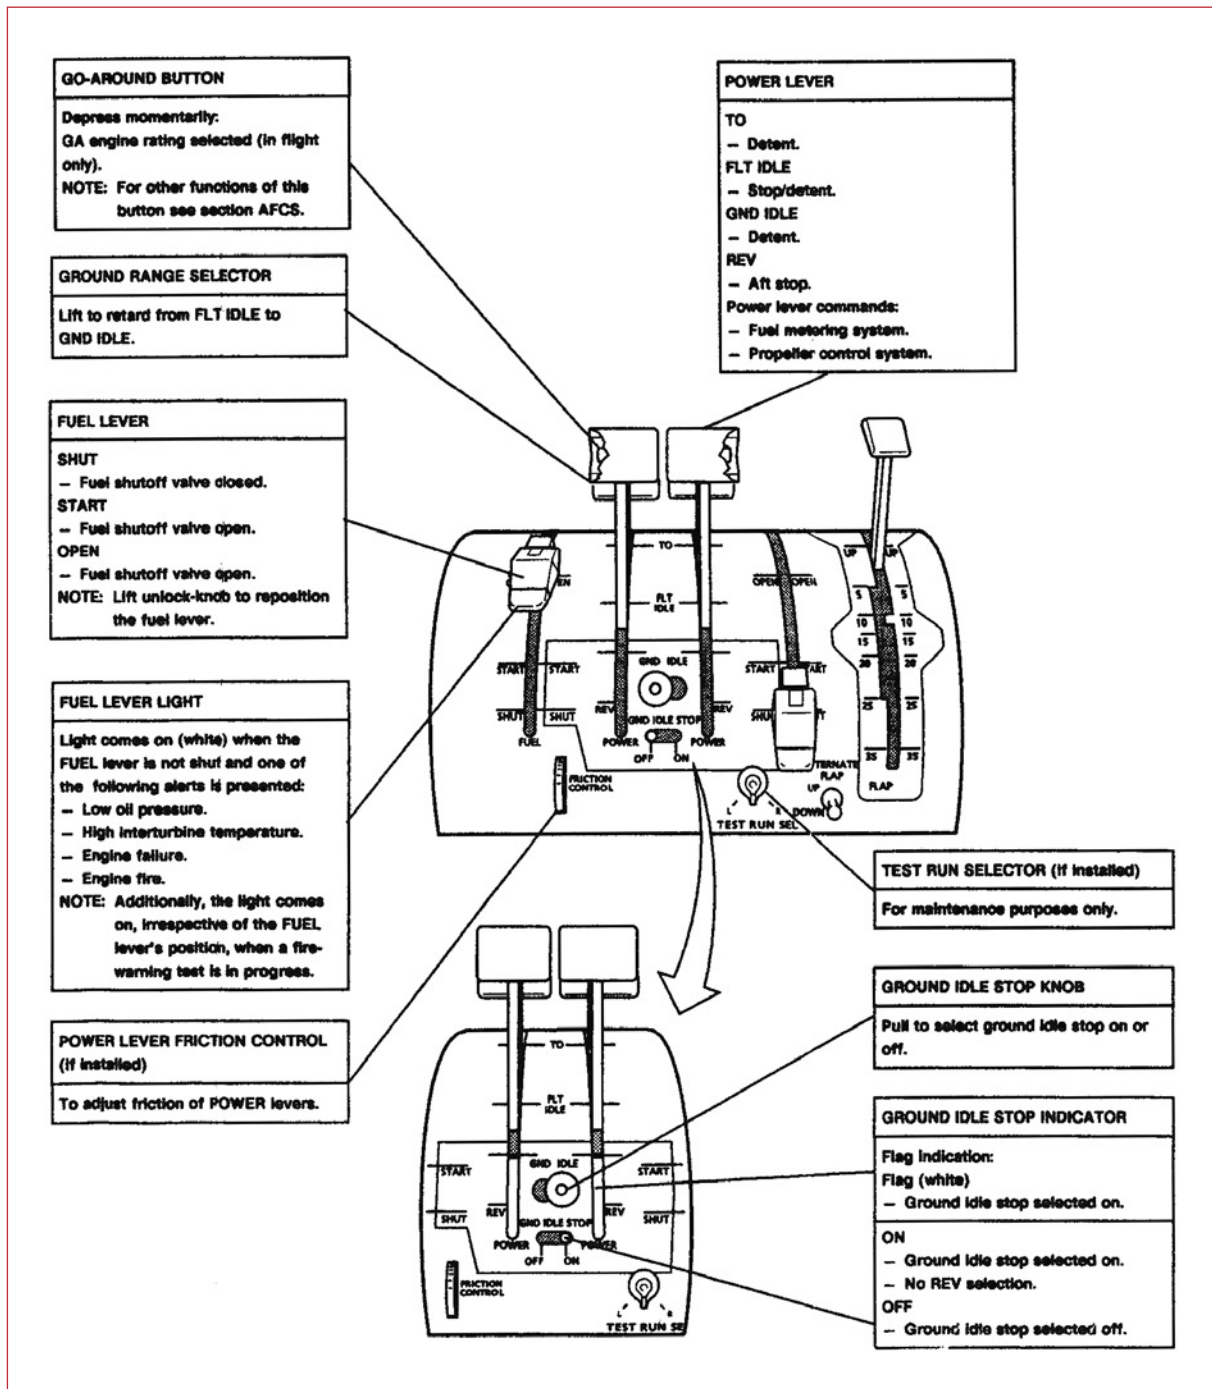
Figure 1.6.3.1. Power lever quadrant (from the Aircraft Operating Manual prepared by Fokker)

To move the power levers below the flight idle detent, the pilot must lift by hand a piggyback lever called the «ground range selector» that is also mounted on the power lever (see Figures 1.6.3.1 and 1.6.3.2).

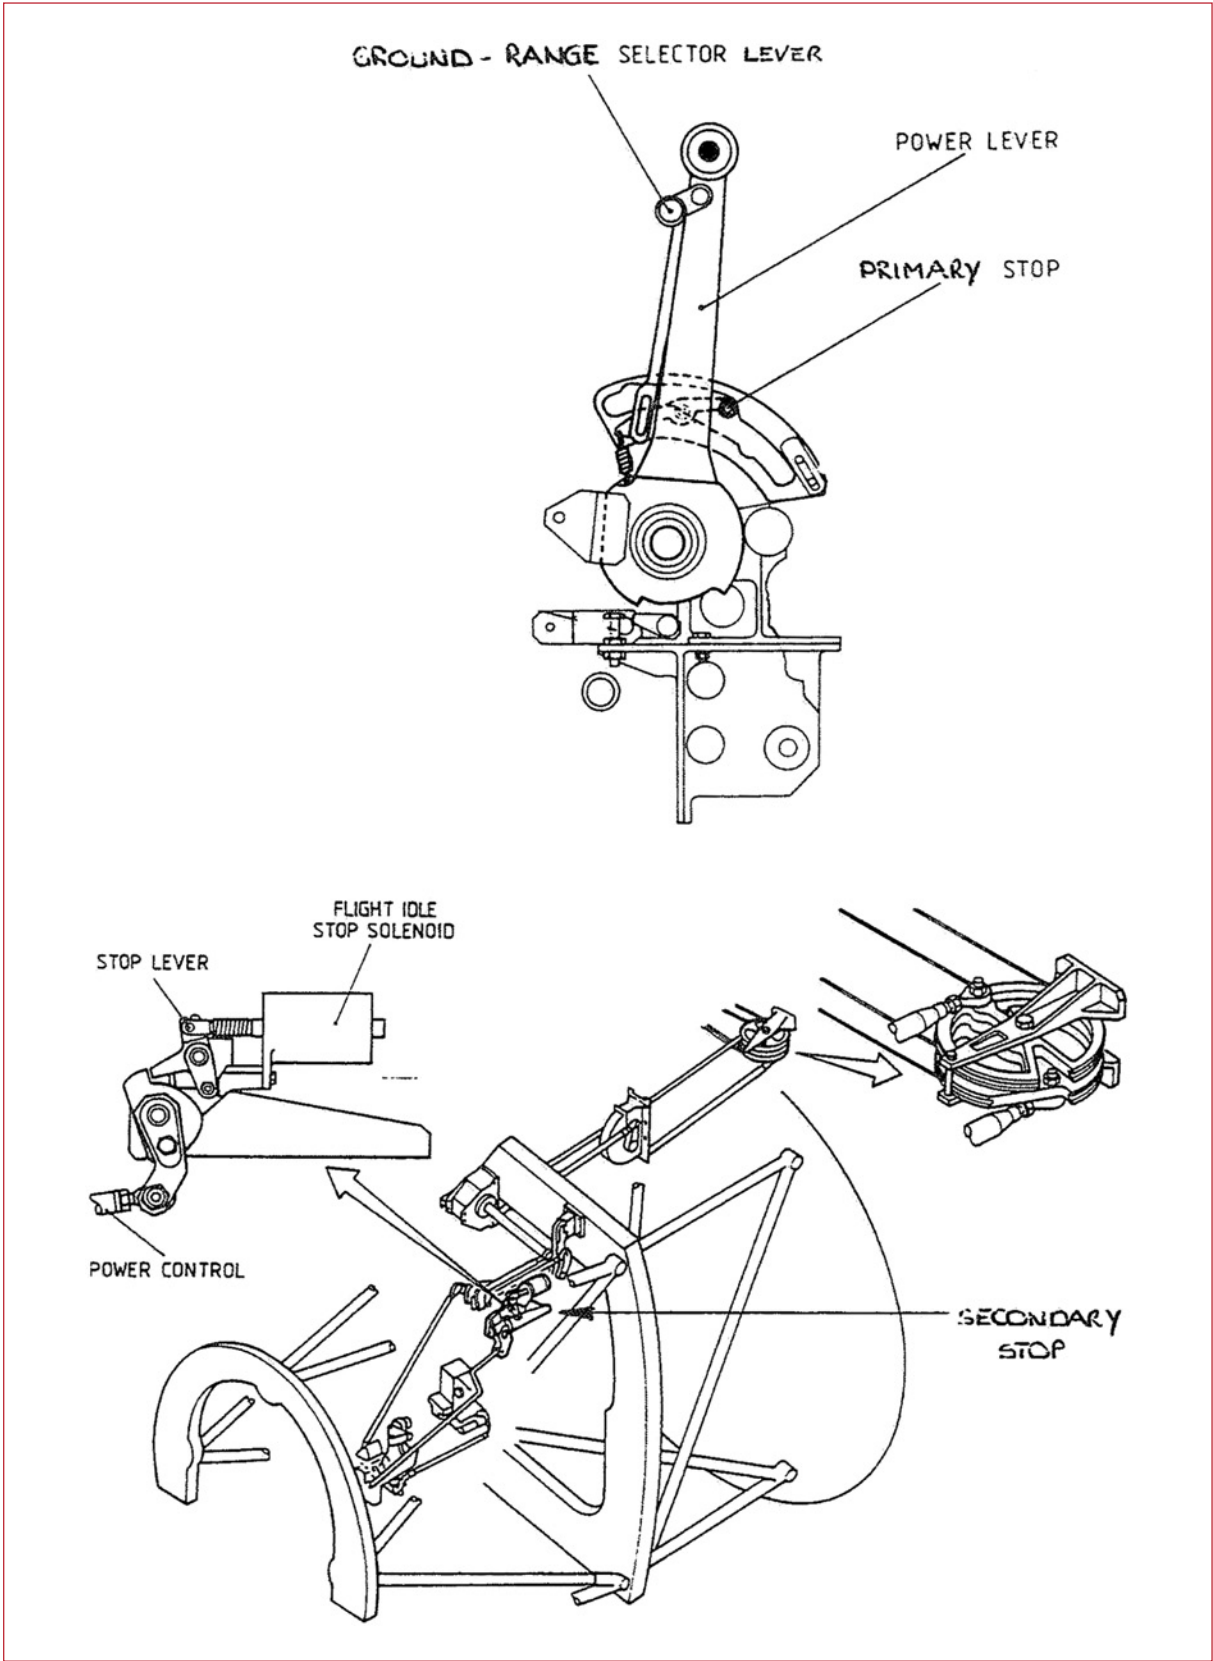
Figure 1.6.3.2. Detail of the automatic flight idle stop assembly (from Fokker SL 137)

respectively. Unless certain conditions are met (see next paragraph), the corresponding power lever cannot be moved below the flight idle position, even if the pilot raises the «ground range selector». Except in the event of a failure, this is only possible when the aircraft is on the ground and therefore the solenoid is energized and retracts the automatic flight idle stop.

However, the contrary is also true: if certain failures happen, and the solenoid is not energized on the ground, the automatic flight idle stop is not removed and ground idle or thrust reverse cannot be selected when desired by the pilot. There is no «override» feature on the cockpit to overcome this possible fault.

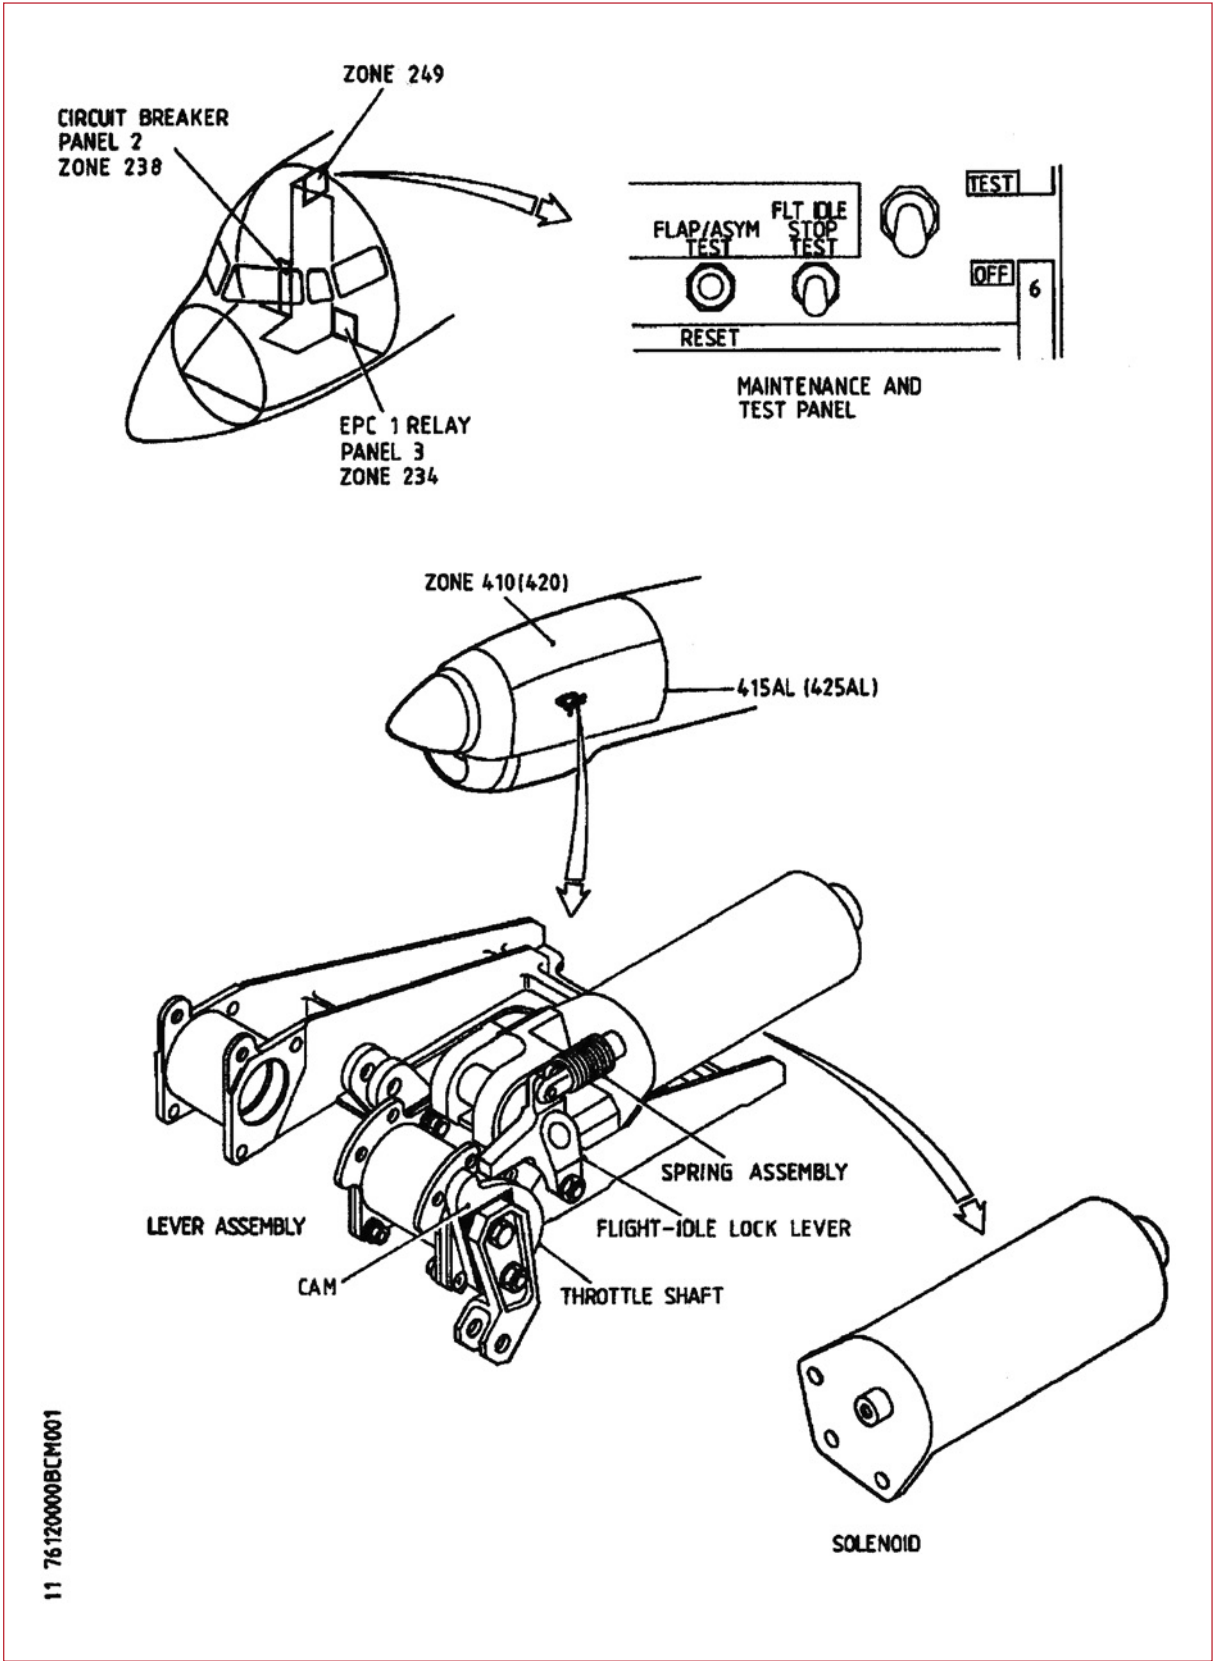
Figure 1.6.3.3. Detail of the automatic flight idle stop assembly (from Fokker Maintenance Manual)

According to the information provided by the Aircraft Maintenance Manual (AMM), the automatic flight idle stop has two solenoids that operate a movable lock lever on the engine throttle controls. The solenoids are attached to a lever assembly on each engine (see Figure 1.6.3.3).

The solenoids are de-energized in flight to engage the lock lever and to prevent movement of the controls to a position below flight idle.

When the aircraft is on the ground, the solenoids are energized either by the wheel spin-up signals or by the ground/flight switches to disengage the lock lever and permit full movement of the power levers.

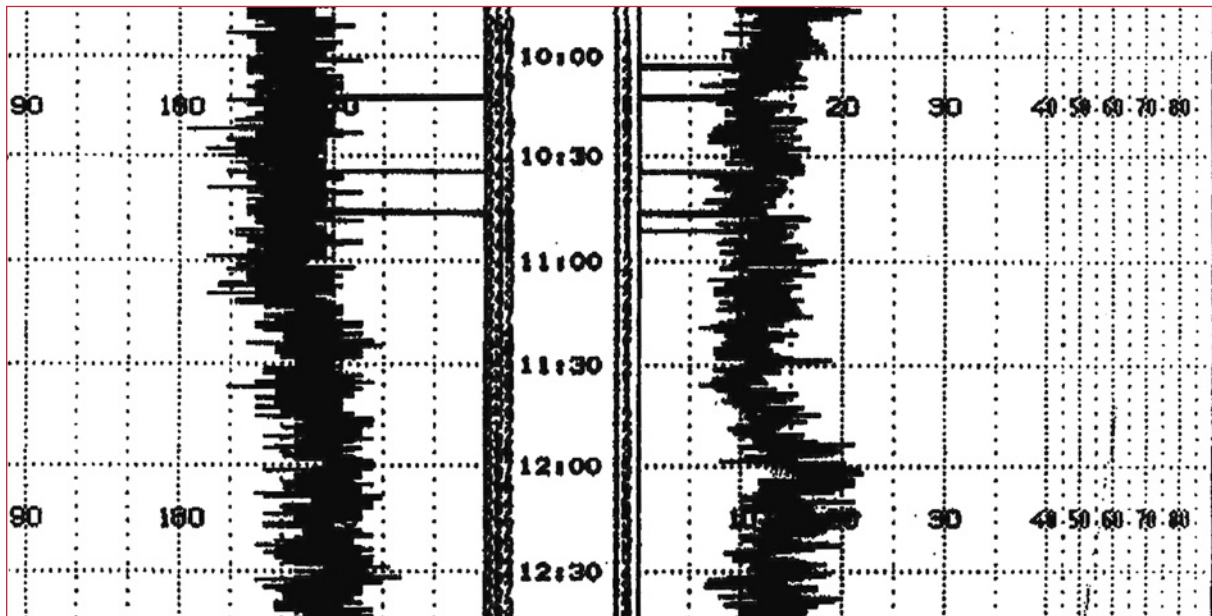
Figure 1.7.1. Instantaneous wind record runway 15 of Melilla Airport on 17-1-2003 between 10:00 h and 12:30 h UTC. On the left the wind direction in degrees is shown. On the right part of the graph, the wind speed in kt is recorded

The runway 15 threshold instantaneous wind record taken by the Meteorological Office of Melilla was reviewed. At 11:00 h, no instantaneous example of wind speed was above 18 kt and the mean value was around 13 kt. The mean value of the recorded wind direction was around 240° (see Figure 1.7.1). This meant almost pure crosswind. Wind direction above 240° meant some component of tailwind. It can be seen that around 11:00 h the wind direction mean value is 240° or less.

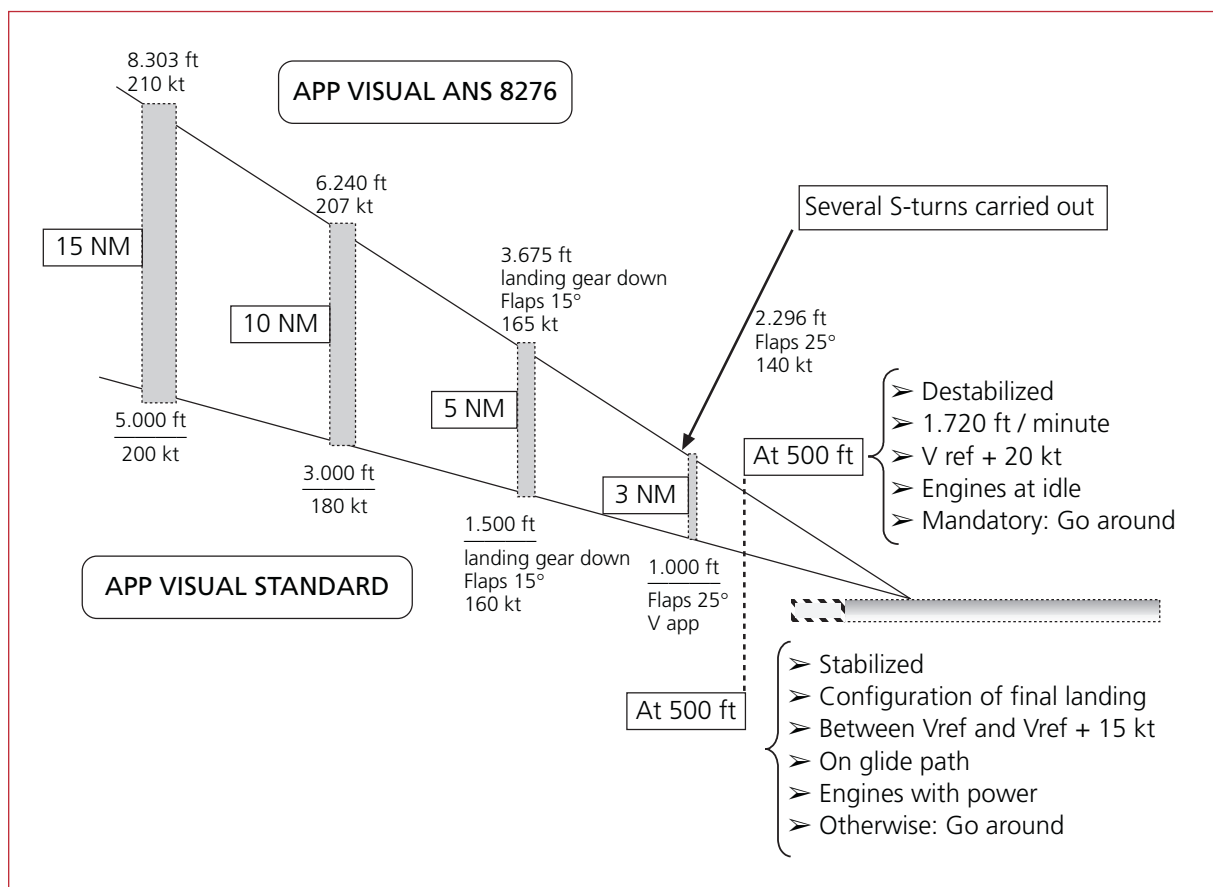
In fact, at 500 ft above the ground, the aircraft was still destabilized, with 1,720 ft/min of descent speed, at Vref plus 20 kt, not at 3° of glide path, and with engines at idle. This compares with the stabilized approach policy of ICAO (below 1,000 ft/min, between Vref and Vref plus 15 kt, engines with power, etc.) to give the conclusion that a go around should have been initiated immediately. The following graph compares a standard approach with the approach conditions faced by aeroplane PH-FZE.

Twenty seconds before touchdown the speed was 147 kt (i.e. 52 kt above the maximum recommended touchdown of 95 kt).

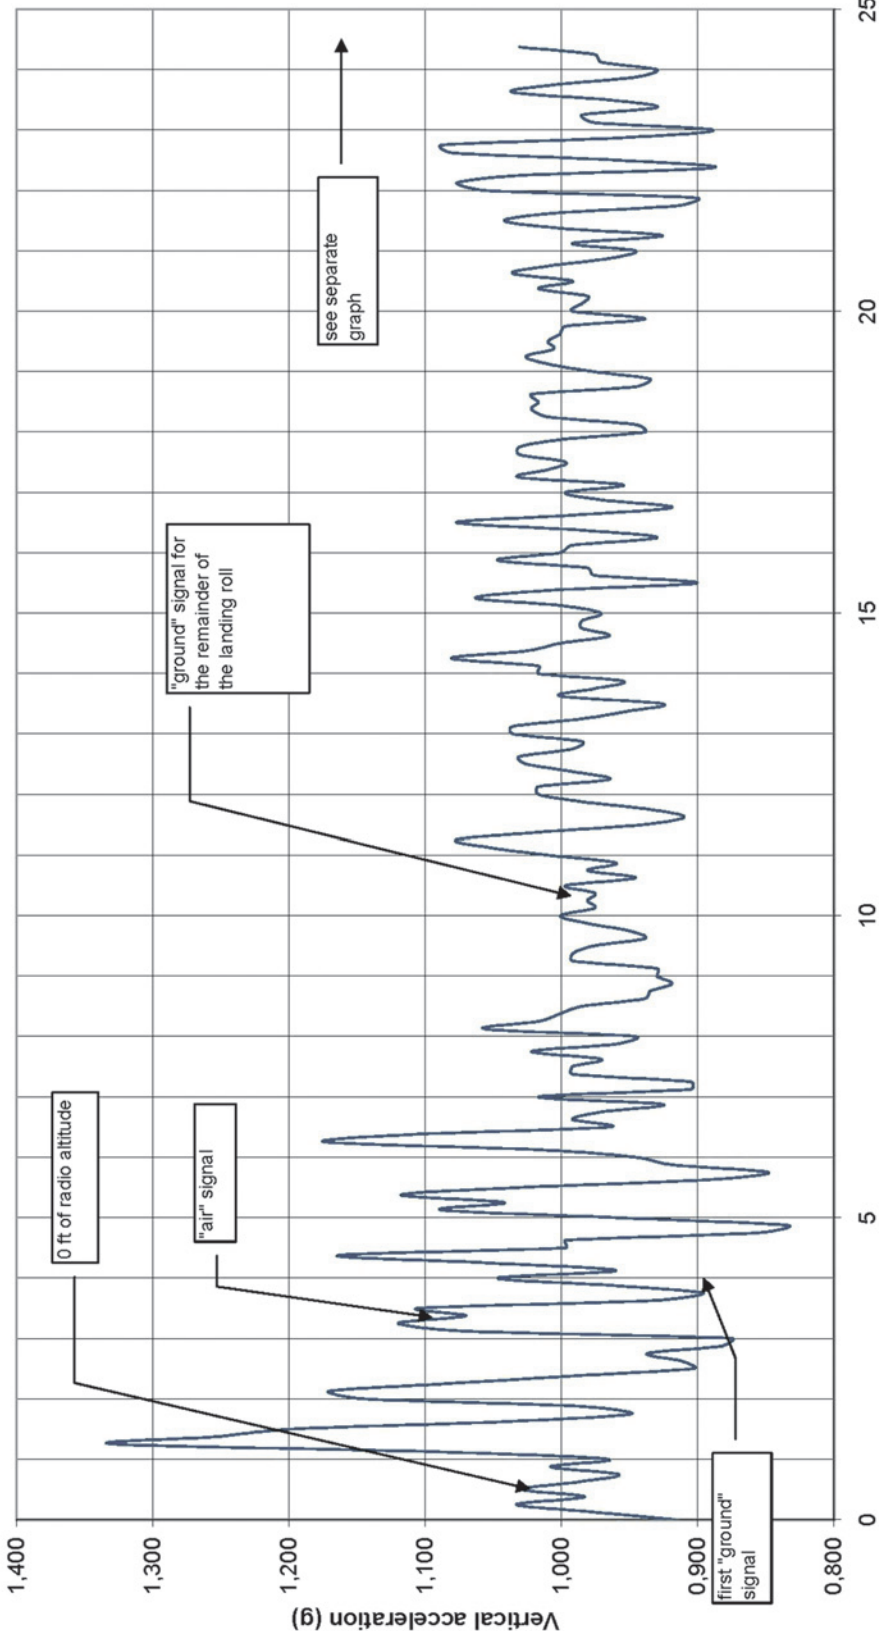
Vertical acceleration during touchdown and landing roll  
(the last 5 tenths of a second corresponding to the fall through  
the downslope are included in a separate graph)

Seconds elapsed since 11:00:35 h, when the aircraft was 3.8 ft above the runway
