Report A-001/2004

Accident to glider Glaser Dirks
DG-600, registration EC-FIZ,
in Otero de Herreros (Segovia)
on January 2, 2004

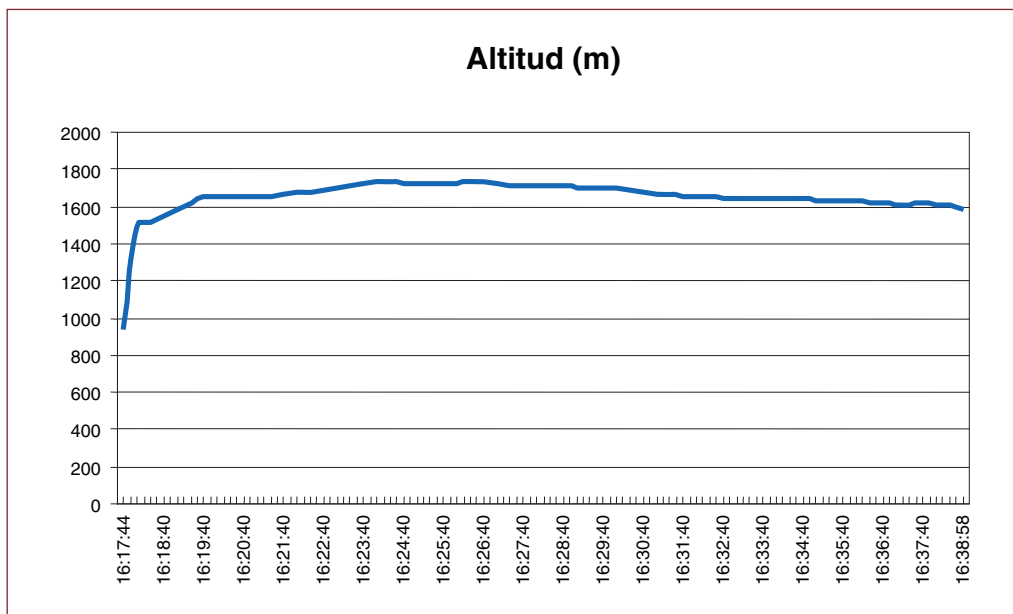
On the other hand, the data corresponding to the last 8 flights stored in the calculator SR 940 was recovered, and the date of the last flight registered was the accident flight on 2 January 2004.

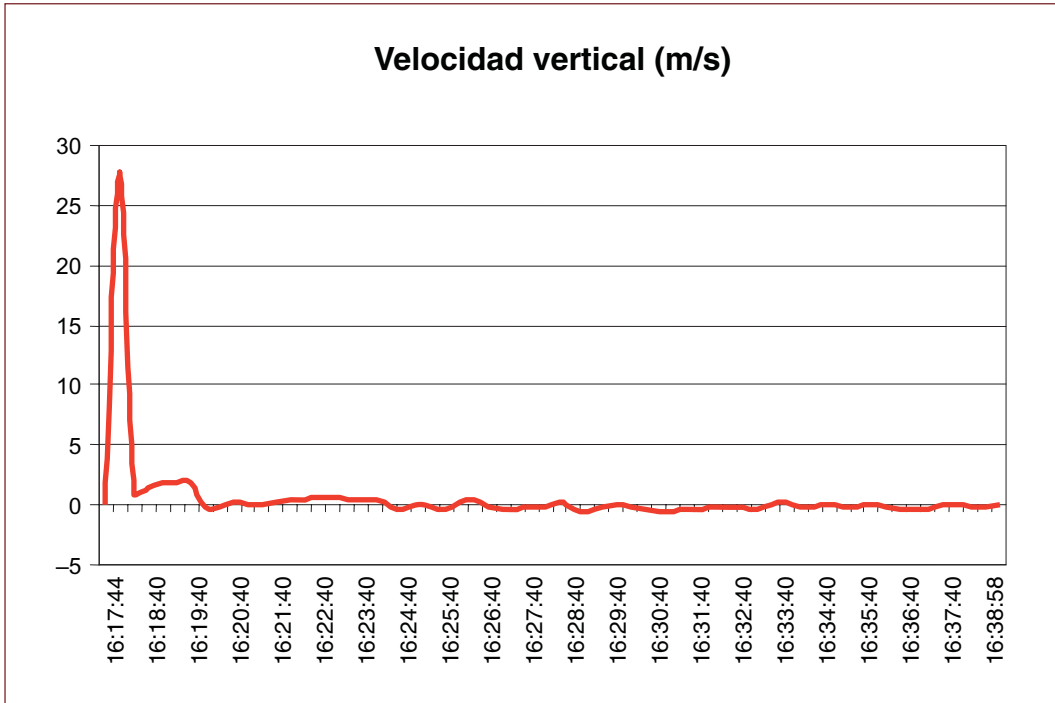
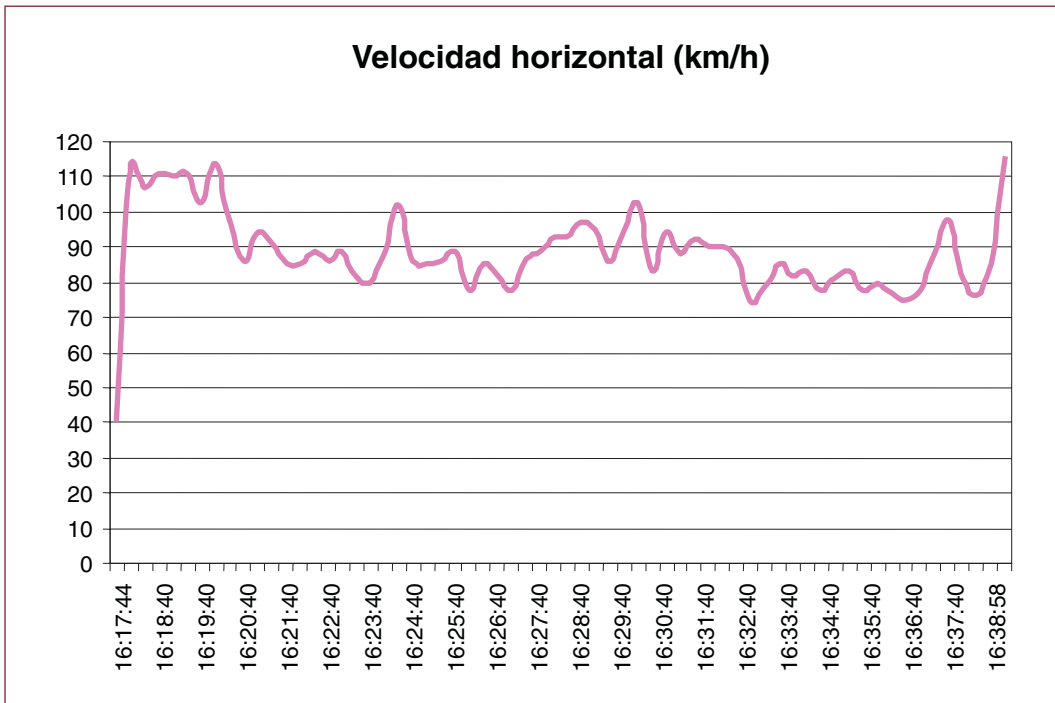
Both devices, GP 940 (logger) and SR 940 (calculator), operate in combination with each other. The logger obtains and stores the position data from the GPS and at the same time sends them to the calculator, where the indicated airspeed, barometric altitude and vertical speed are also registered, taken from other instruments of the aircraft. This set of data is recorded in the calculator SR940 every 20 seconds.

It was confirmed that during the flight in question the logger GP 940 was not connected, i.e. the switch had not been actioned, and as a result there was no data recorded in the logger corresponding to the flight, as the calculator SR 940 had not received any position data. However, the information from the last flight stored in the calculator was available.

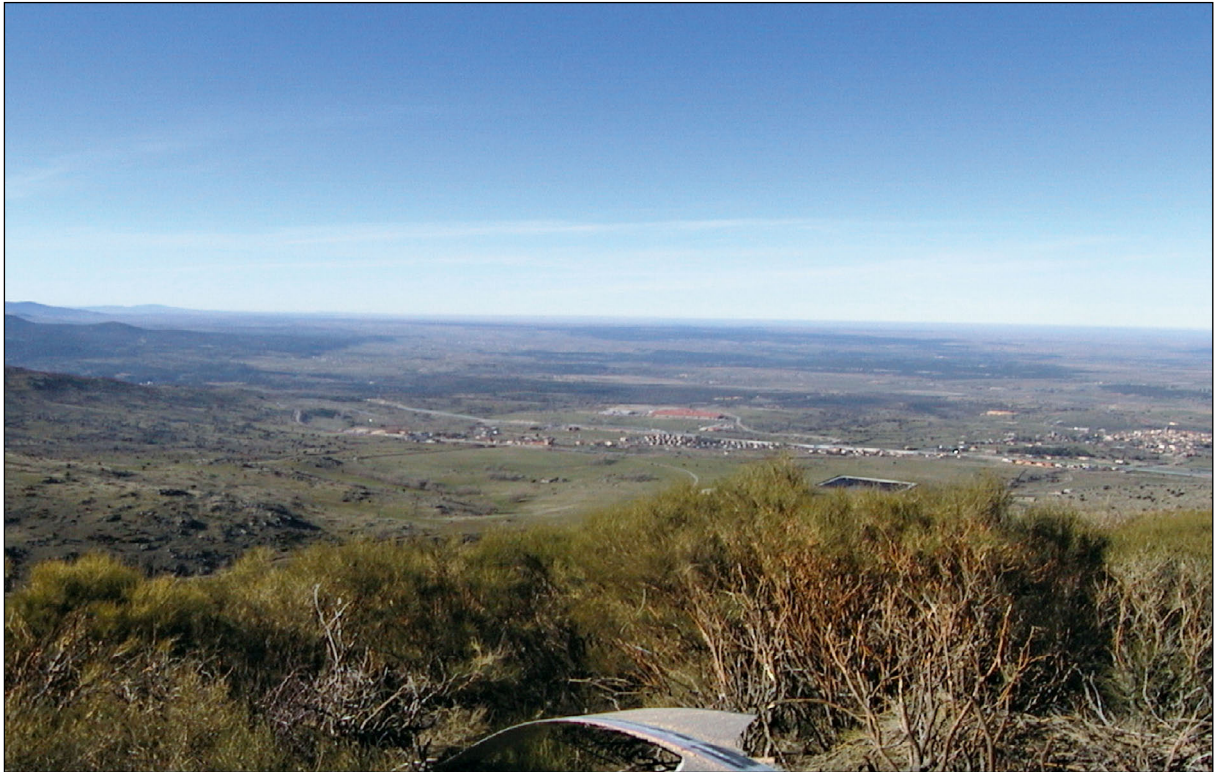
D1. *View towards the West from the point of impact*

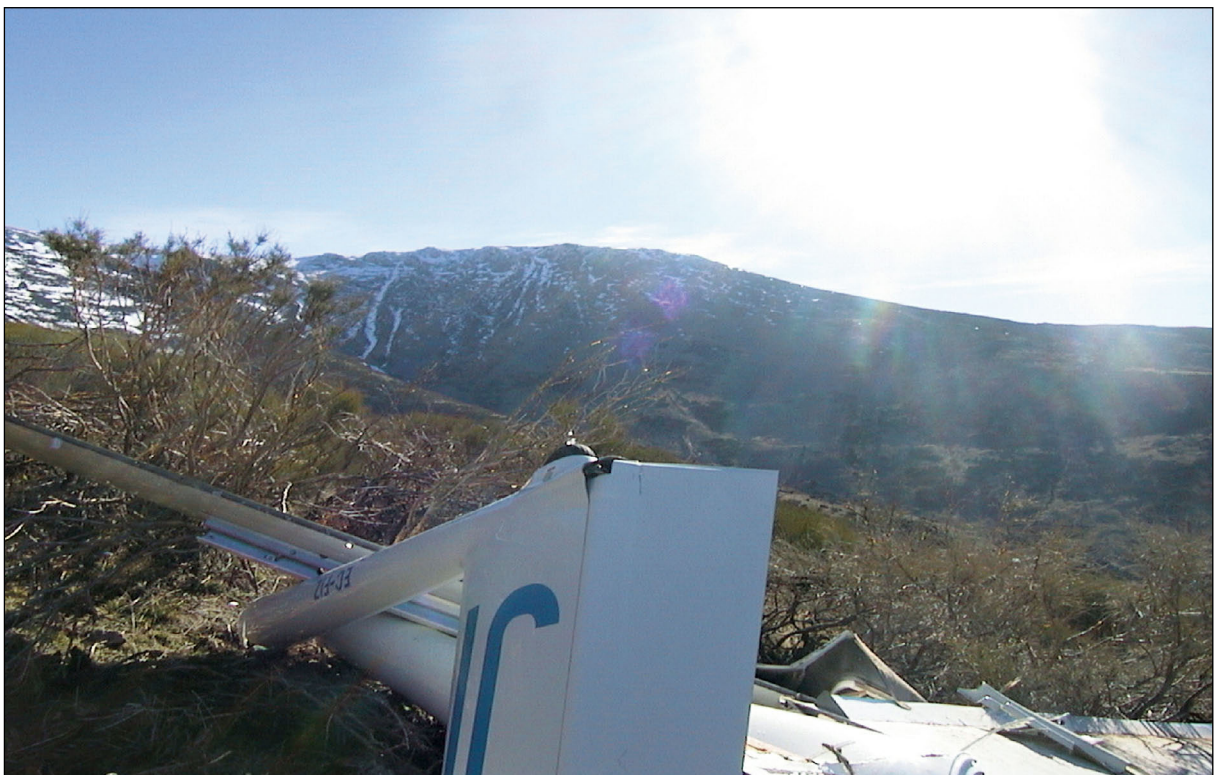
D2. *View towards the Southeast – Hoya de Otero*
