CIAIAC

TECHNICAL REPORT

A-016/2004

Accident of aircraft
Eurocopter SA-365-N1,
registration EC-GJE,
in San Bartolomé de
Tirajana (Las Palmas),
on 30 March 2004

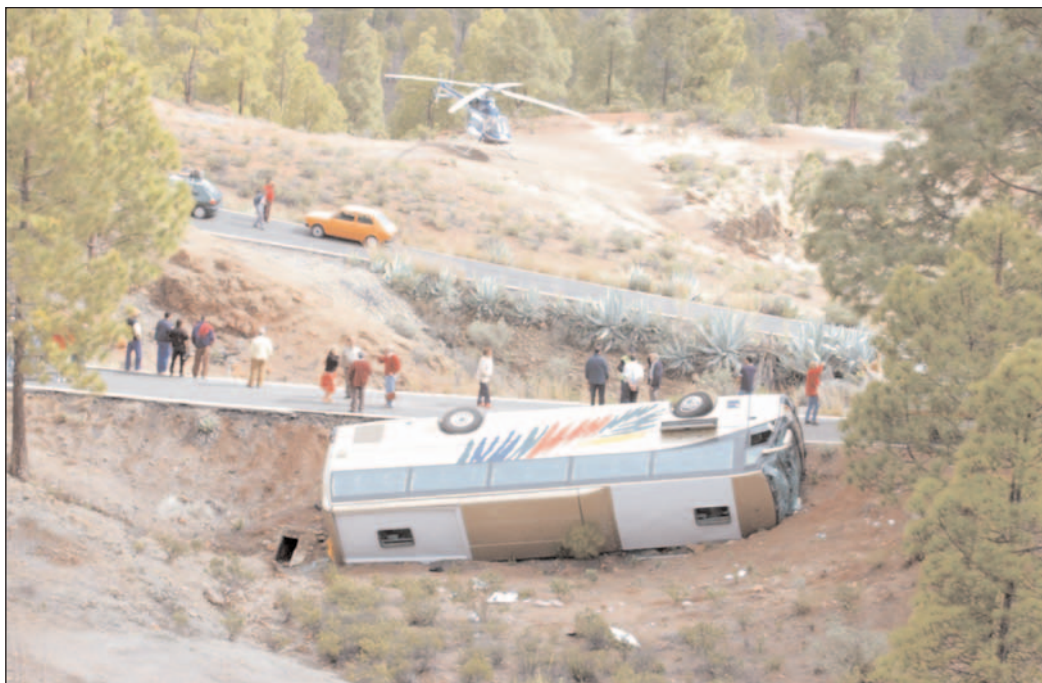
In the meantime, another private helicopter (a Bell 407, registered D-HOMN), which was called by the «Protección Civil» department of the city of San Bartolomé, arrived with three people on board (the pilot, the manager of the private company and a person from the City Hall of San Bartolomé) and landed at 16:10:46 h in a nearby area that was further to the East, beyond the place of the bus wreckage and outside the road (see Figure 1.1.1).

Figure 1.1.1. Private helicopter D-HOMN landed close to the bus wreckage

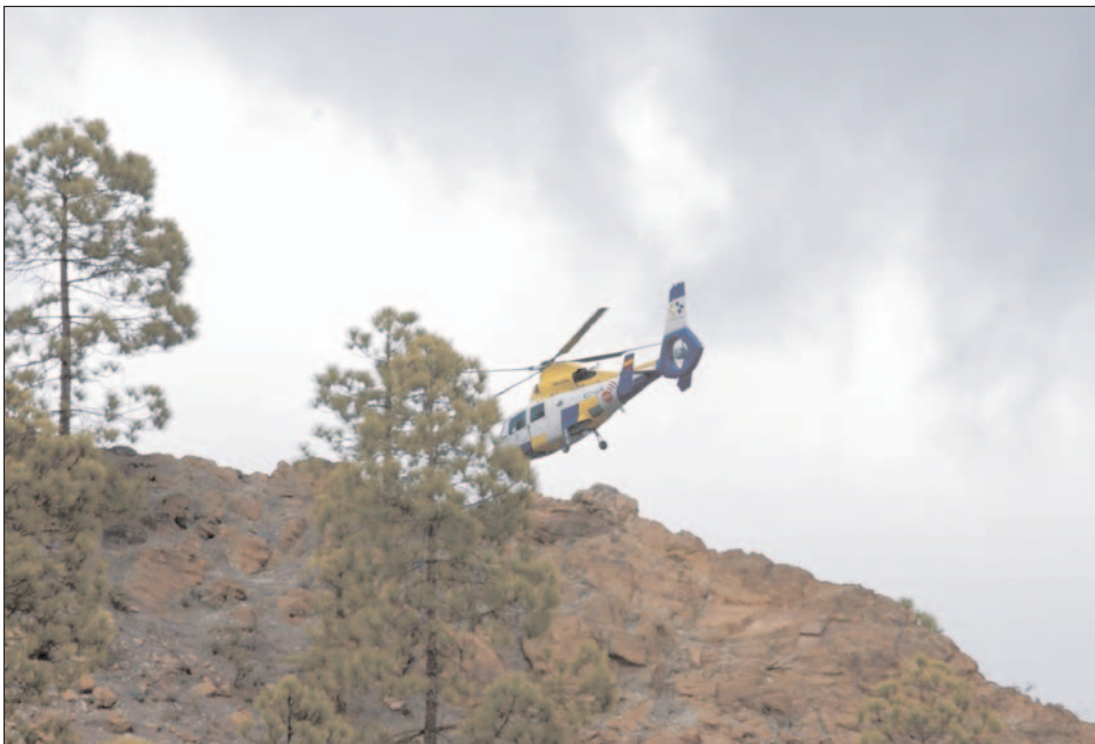
Figure 1.1.4. The helicopter flies over a nearby hill (photo «La Provincia»)

Afterwards, the helicopter flew for around 18 s until it disappeared above a nearby hill (see Figure 1.1.4). The distance from the wires impact point to the hill is approximately 500 m.

The helicopter continued flying and over flew the mentioned hill. From that moment on, a different scenario was probably faced inside the cockpit. The helicopter was stabilized and seemed to be flying with at least some kind of normality but, however, the suitable places to carry out an emergency landing had disappeared, because from that hill to the place where the helicopter finally crashed there was mountainous terrain covered with trees and shrubs for most of its surface. The helicopter seemed to head towards a crossroad for some extend, but then it changed the heading and flew almost in parallel with the road (see Figure 1.1.5).
