**DATA SUMMARY**

Date and time	<b>Wednesday, 12 May 2004; 19:30 h</b>
Site	<b>Cuatro Vientos Airport (Madrid)</b>

Registration	<b>EC-CTO</b>
Type and model	<b>ROCKWELL COMMANDER 680-F</b>
Operator	<b>ARE Aviación</b>

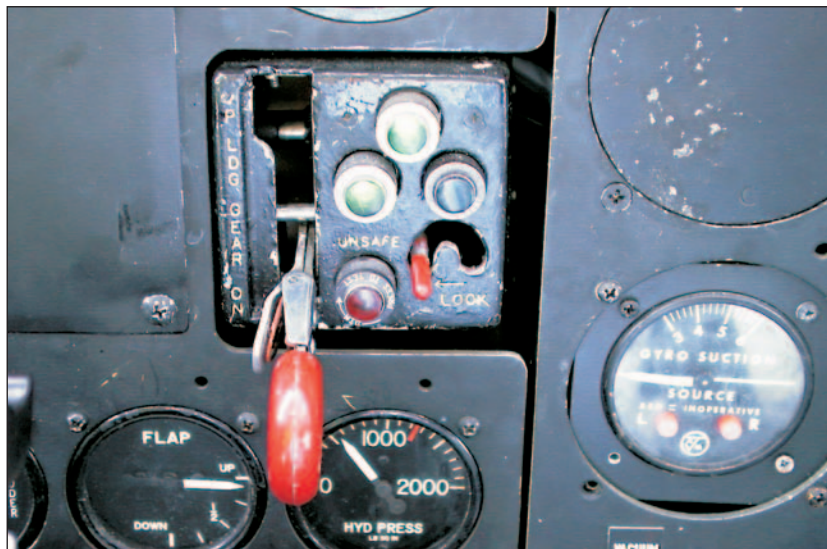
Figure 6. Main landing gear indication switch

No malfunction of the landing gear was observed in this check, except that there was no indication of the right main landing gear extended and locked. It was found that the pin that creates pressure to actuate the switch when the drag braces are extended was not there and for that reason there was no indication.

- Each green light has a down and locked switch associated with it (see Figure 6) situated in the connection area between the gear's upper and lower drag braces.

- According to information made available by an authorized Aerocommander maintenance centre, there is no specific maintenance for pin P/N ED12439. The aircraft's maintenance manual does not specify the correct position of the pin. Only one figure appears which shows the switch-pin assembly in detail, as can be seen in Figure 6.

The final conclusion is that the probable cause of the right main landing gear's retraction in the landing roll was that it was not locked due to the incorrect mounting of the pin P/N ED12439 that exerts pressure on the gear down and locked indicator switch, which prevented the overcenter from being reached.
