Report A-070/2004

Accident to BOEING B-737,
registration PH-BTC, at
Barcelona Airport (Spain),
on 28 November 2004

(Issue 2)

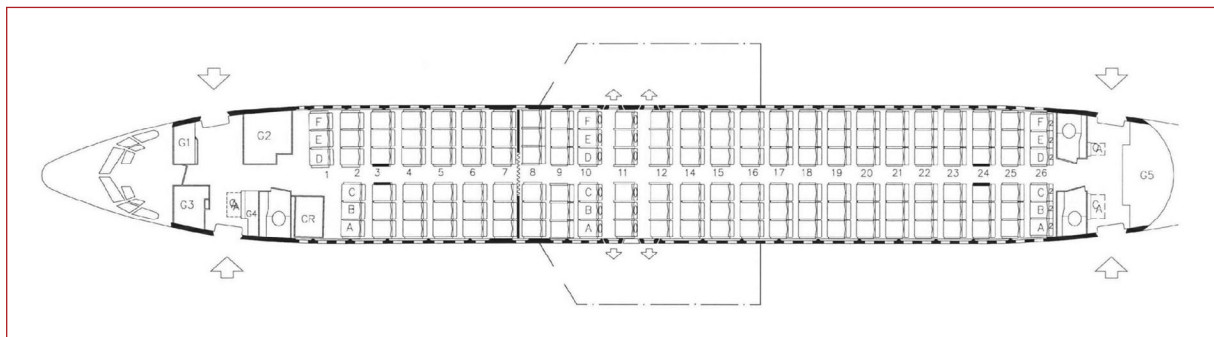
A malfunction had been identified with deployment of the escape slide of the forward service door (1R). This was the subject of an informative letter («fleet team digest») issued by the manufacturer in December 2002. In some cases the slide became twisted (approximately 90 degrees) during deployment and subsequent inflation. This twisted slide condition rendered the slide and exit unusable for egress. The problem was traced to be probably caused by the escape slide being delayed inside the slide compartment. The manufacturer of the aircraft and the vendor were working on a solution at the time of the PH-BTC accident.
