DATA SUMMARY

Date and time	Saturday, 29 October 2005; 10:13 UTC¹
Site	UW100 (FL 260) 50 NM of CJN VOR

Registration	D-AIRL	UR-GAL
Type and model	AIRBUS 321	BOEING 737-300
Operator	Lufthansa German Airlines	Ukraine Intern. Airlines

Date of approval	30 May 2007
------------------	--------------------

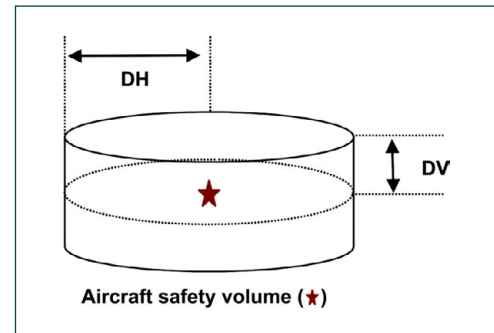
A conflict prediction alert is issued when the system forecasts that an aircraft is going to violate another aircraft's safety volume within a time period below the alarm time (AT). The AT is the predicted time to entering said safety volume and is defined beforehand in the system. The safety volume is delineated by a cylinder, with the aircraft at its center, whose dimensions can be configured within the system. In the current version of this system, the parameters are set as follows:

Vertical level	Horizontal distance (NM) DH	Vertical distance (ft) DV
0-307	7.2	800
307-1,000	7.2	1,700

A conflict violation alert is issued when the system detects the entry by one aircraft into another's defined safety volume.
