Report A-037/2006

Accident involving
a SIKORSKY S-61N
helicopter, registration
EC-FJJ, on 8 July 2006,
in Roque Bermejo
(Tenerife – Canary
Islands – Spain)

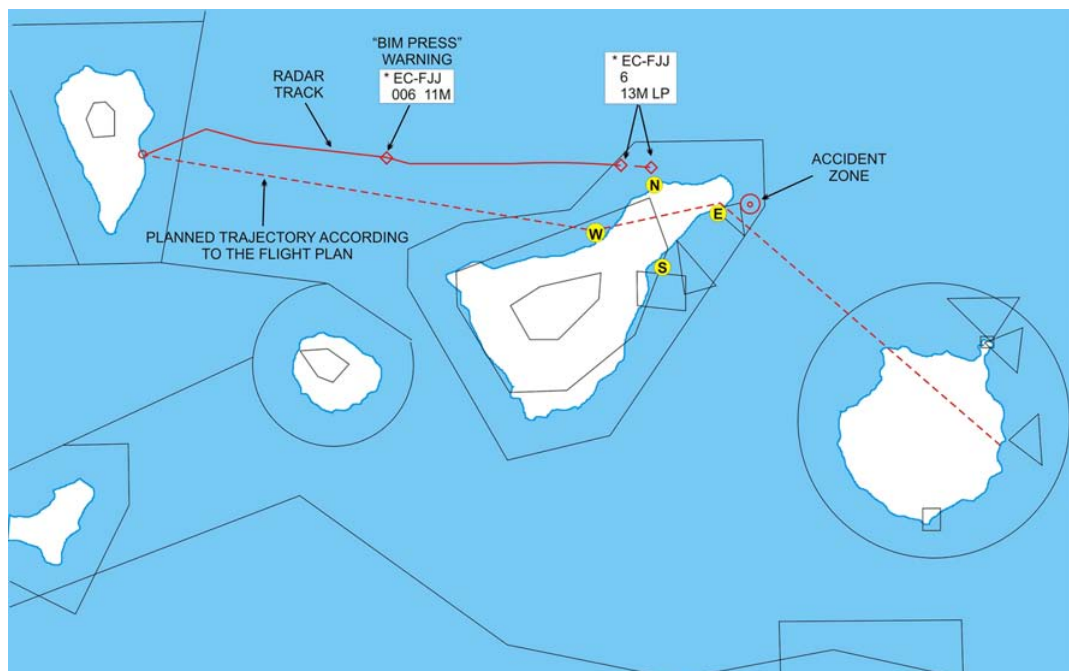
Figure 18. Radar trace

position was detected at 09:00:00, when the aircraft was north of Tenerife North Airport flying from west to east above the ocean at an approximate altitude of 600 ft and a speed of 120 kt.

Figure 18 shows how the aircraft followed a path to the north that was nearly parallel to its planned route until it requested, and was granted, clearance to circle around the northeast side of the island of Tenerife instead of overflying Tenerife North Airport, at which moment it proceeded directly to point N of said airport on a west to east trajectory. While on this path it maintained a ground speed of 110 to 120 kt. Considering that, according to the available weather information, the wind was moderate and variable in direction from the N and NW, it can be deduced that its indicated airspeed was slightly above the 100 kt called for in the flight plan.

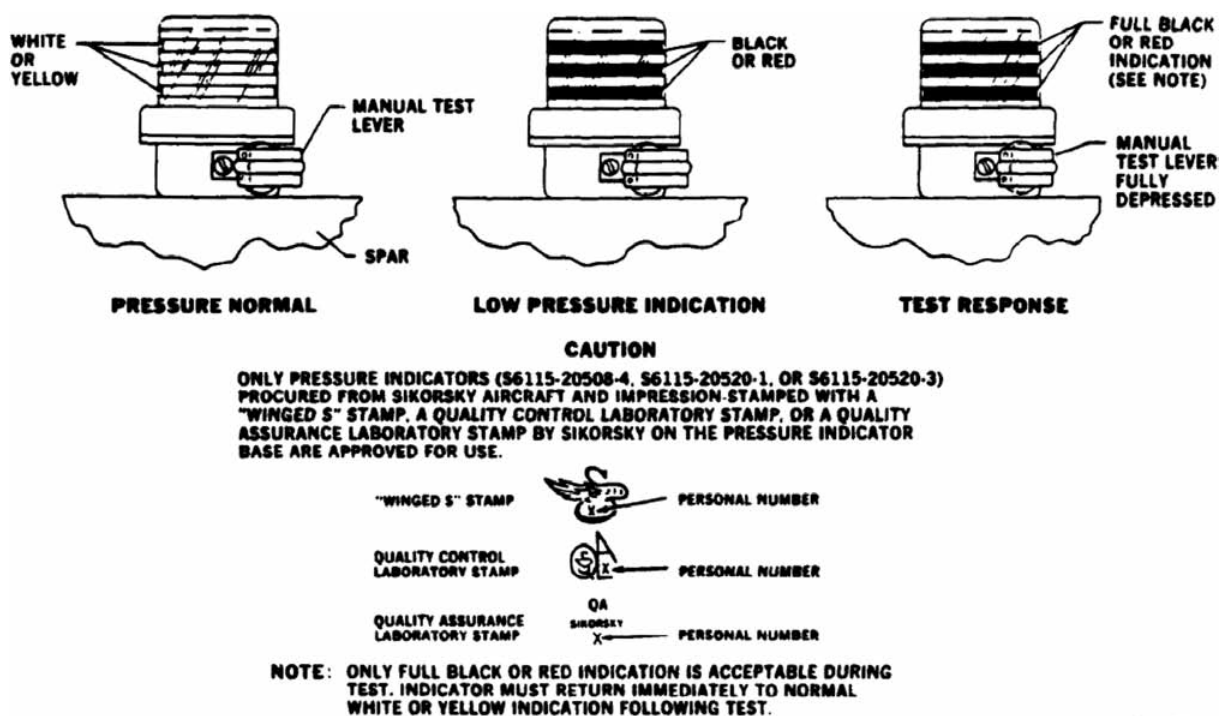
Figure 19. BIM indicator

The indication is based on a comparison between a reference pressure inside the indicator, compensated for temperature changes, and the pressure inside the blade spar. When the pressure inside the spar is within the allowed limits, the indicator displays white or yellow, indicating the blade is operable. If the pressure falls outside the minimum allowed limits, the indicator shows three red or black stripes, meaning the blade's condition is unsafe. The amount of red or black displayed depends on the pressure inside the blade.

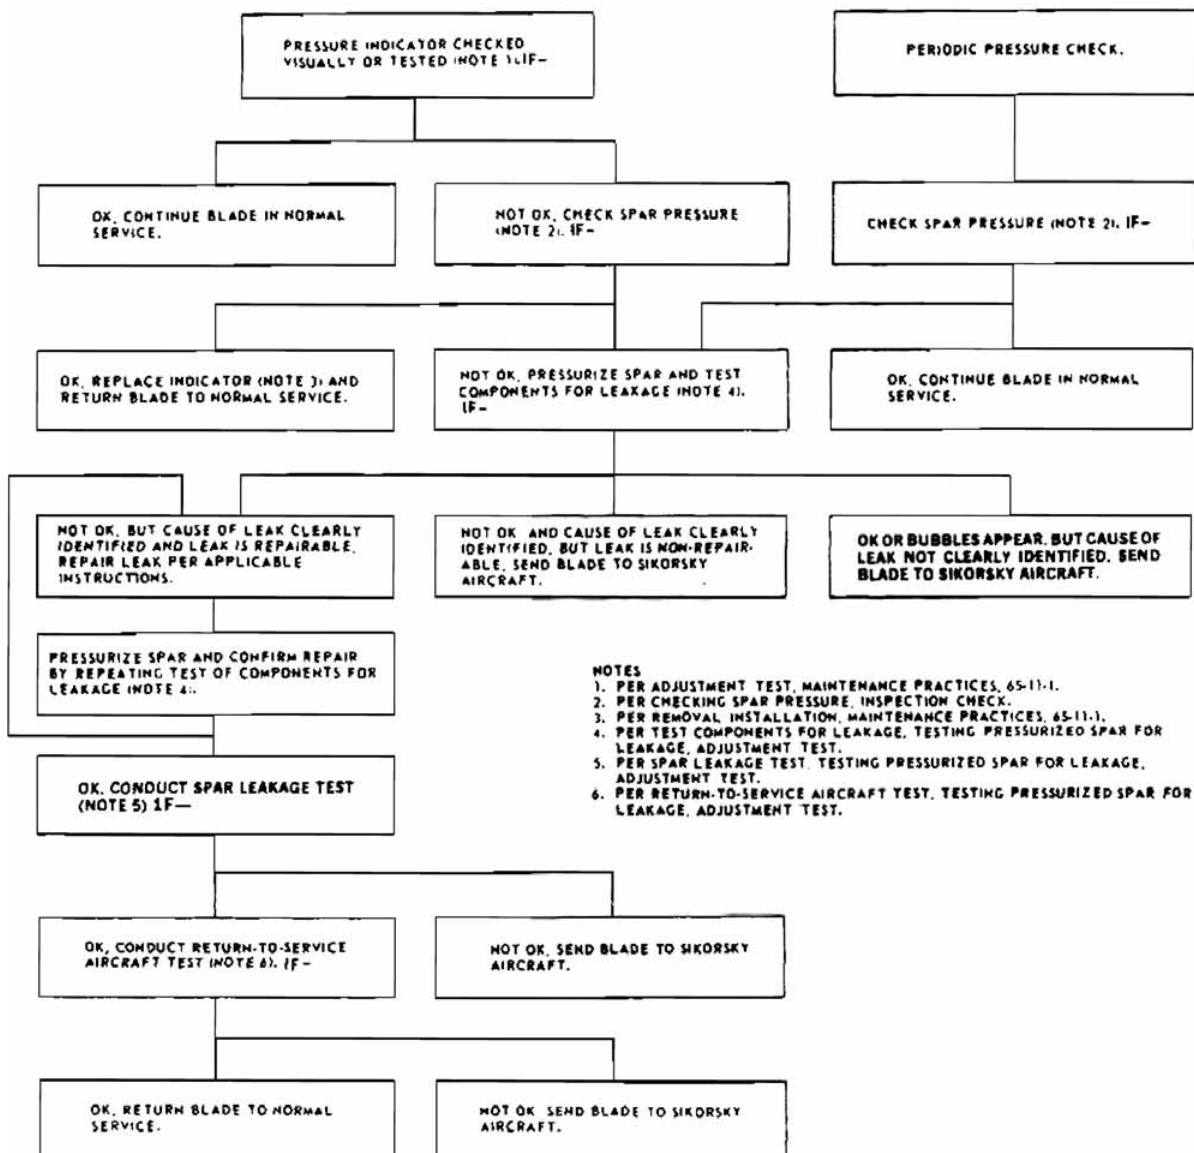
Pressurized Spar - Troubleshooting Chart
Figure 102

ANY BLADE ON WHICH THE PRESSURE INDICATOR SHOWS ANY BLACK OR RED COLOR OR WHOSE PRESSURE TRANSDUCER CAUSES THE COCKPIT BIM SYSTEM WARNING LIGHT TO COME ON MUST BE REMOVED FROM SERVICE UNTIL THE CAUSE OF THE UNSAFE (BLACK OR RED) INDICATION OR WARNING LIGHT COMING ON IS POSITIVELY FOUND AND CORRECTED. IF THE INDICATOR OR TRANSDUCER IS MALFUNCTIONING IT MUST BE REPLACED, BUT ONLY IF SPAR PRESSURE IS WITHIN PERMISSIBLE LIMITS.

- A. If pressure indicator shows any black or red color, determine cause of unsafe indication before any further flight. Follow procedures in figure 102 to determine cause and to make correct disposition of blade.
- B. To check spar pressure, refer to Checking Spar Pressure, Inspection/Check.
- C. To test for a leak at air valve, pressure indicator, pressure transducer, root end plate seal, or cuff/spar bolts, refer to Test Components for Leakage, Testing Pressurized Spar for Leakage, Adjustment/Test.
- D. To do a spar leakage test, refer to Spar Leakage Test, Testing Pressurized Spar for Leakage, Adjustment/Test.
- E. To do a return-to-service aircraft test, refer to Return-to-Service Aircraft Test, Testing Pressurized Spar for Leakage, Adjustment/Test.
