Report A-061/2006

**Accident involving a Lancair FB320 aircraft,
registration OO-136, in Puértolas (Huesca),
on 17 October 2006**

COMISIÓN DE INVESTIGACIÓN
DE ACCIDENTES E INCIDENTES
DE AVIACIÓN CIVIL

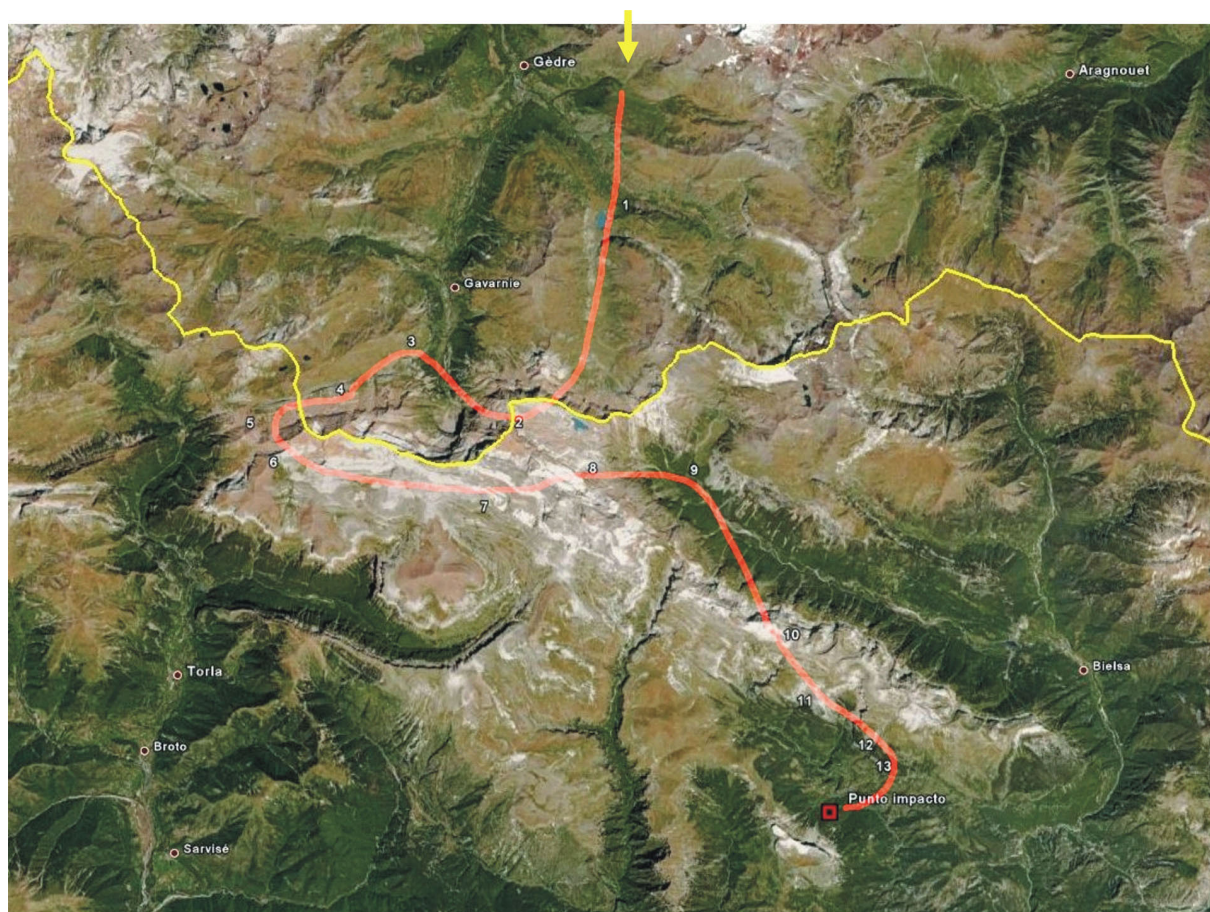
Figure 2. Flight path taken by the aircraft

During the flight, as the aircraft crossed over the Pyrenees, the pilot deviated from his course to loop to the west and then back to the east, following the Pineta Valley in Ordesa National Park. After flying over a part of the valley, he proceeded to the Escuaín Gorge, where the aircraft crashed to the ground at 13:31 (see flight path below).
