Report A-003/2007

Landing in gear-up
configuration involving
a Bombardier CL 600-2B19,
registration EC-IBM, operated
by Air Nostrum, at Barcelona
Airport, on 24 January 2007

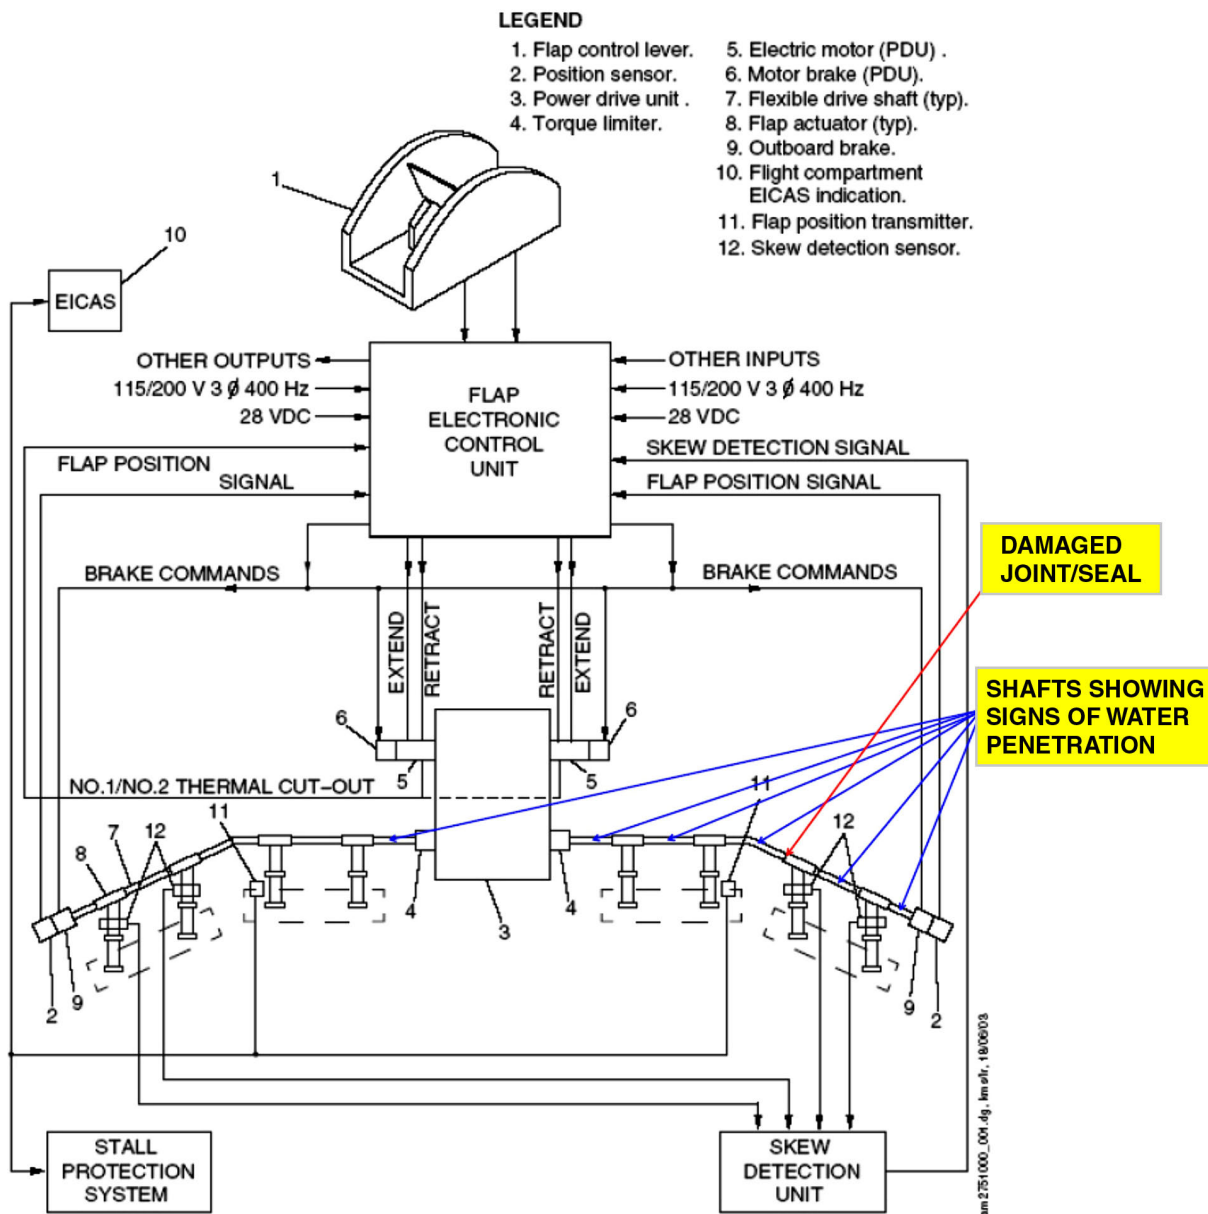
1.16.2. *History of flaps system malfunctions on aircraft EC-IBM*

The AIR NOSTRUM maintenance records indicate that in the first two weeks of May 2002, there were nine (9) ‘FLAP FAIL’ incidents and two landings without flaps. After these malfunctions, another fifteen (15) cases of flaps faults were noted for that frame until the eve of the day of this accident. On 9 January 2007, a ‘FLAP FAIL’ was logged and fixed after cleaning, greasing and checking for proper operation. Ten days later the anomaly was repeated and listed as corrected after checking the operation on the ground. After a new entry of the same fault the day before the accident, the system was noted as operative after cleaning the actuator spindles and checking the operation of the flaps several times.
