DATA SUMMARY

Date and time	Sunday, 11 March 2007; 08:30 h UTC
Site	Cuatro Vientos Airport (Madrid)

Registration	EC-EZY
Type and model	PIPER PA-28RT 201T
Operator	Aeromadrid

REPORT

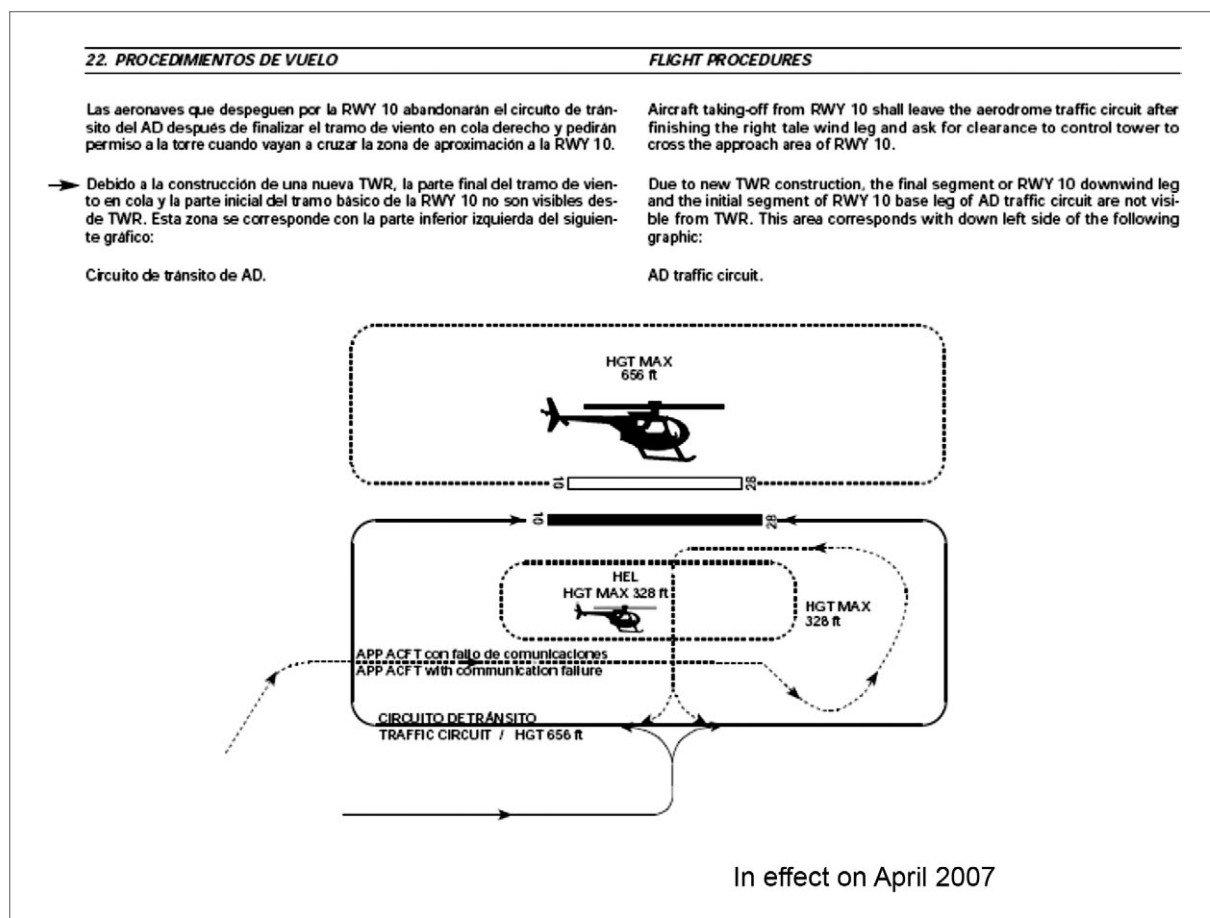
Figure 3. Traffic circuit with communications failure at Cuatro Vientos

The communications failure procedure published in the AIP for the airport specifies that aircraft must always proceed from point S on the visual approach chart and enter the circuit as described in the diagram below:

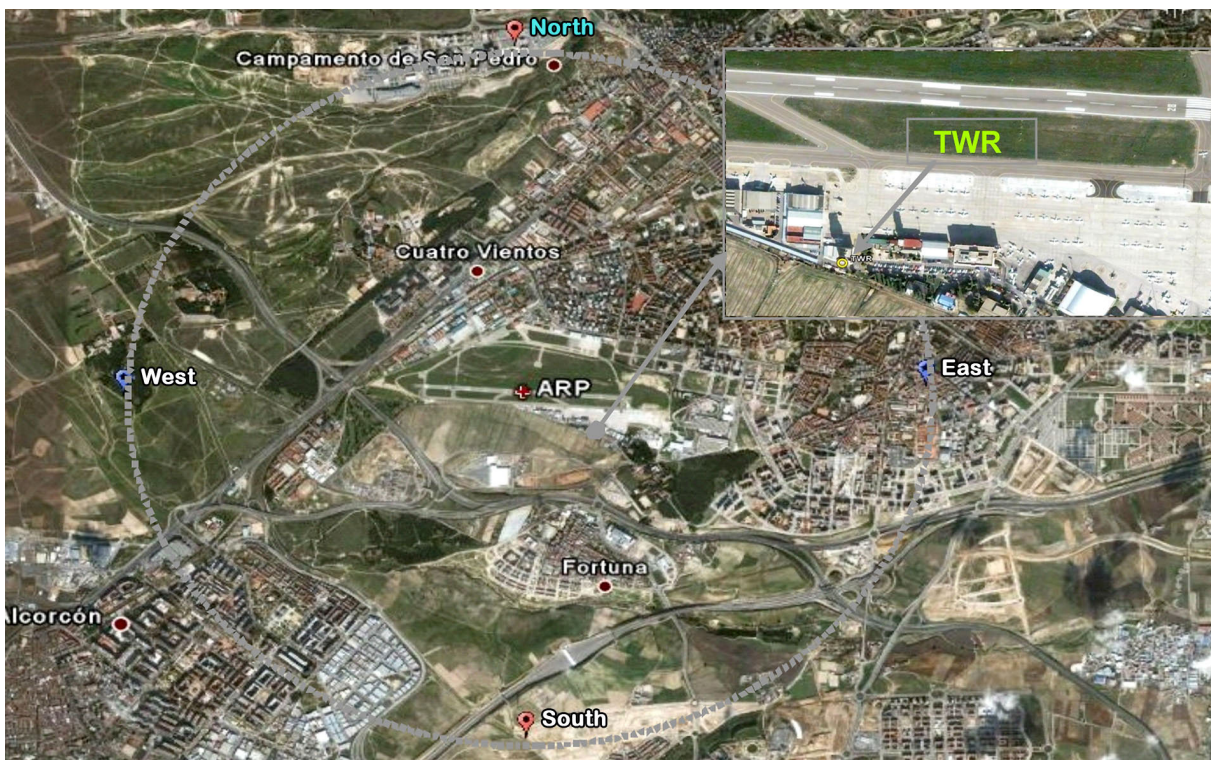
Figure 4. Location of Cuatro Vientos Airport

The control room provides 360° views of the entire ATZ, though in order to see parts of the circuits to the south of the field, the controller must turn and look in a direction opposite to that which he would face when at his post and in which approach, takeoff and landing movements usually take place.

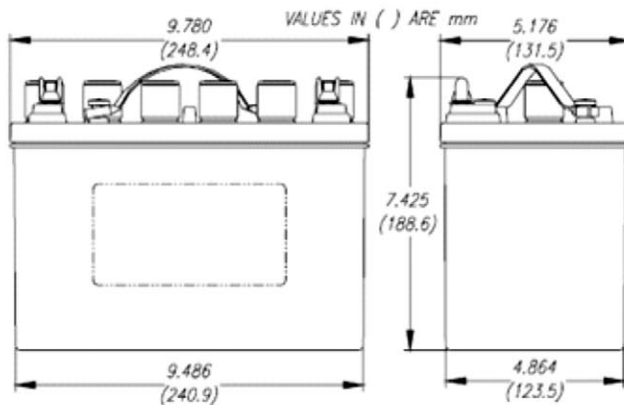
G-35 Performance Data

- **Battery.** A visual inspection revealed defects such as: a dent in one of the lower corners; sulfate build-up on one of the ventilation plugs; a bent positive post and cloudy electrolyte in one of the cells. The battery was subjected to a controlled charge and discharge process to test its operability. The result of the test was unsatisfactory, since the battery could only maintain a 20A discharge rate for 15 minutes before the voltage dropped below 10V. In order to consider the battery airworthy, it should have been able to supply that current for at least 60 minutes.
