DATA SUMMARY

Registration	G-BYIC
Type and model	CESSNA TU206G
Operator	Private

Type and model	TELEDYNE CONTINENTAL MOTORS TSIO 520 M7
Number	1

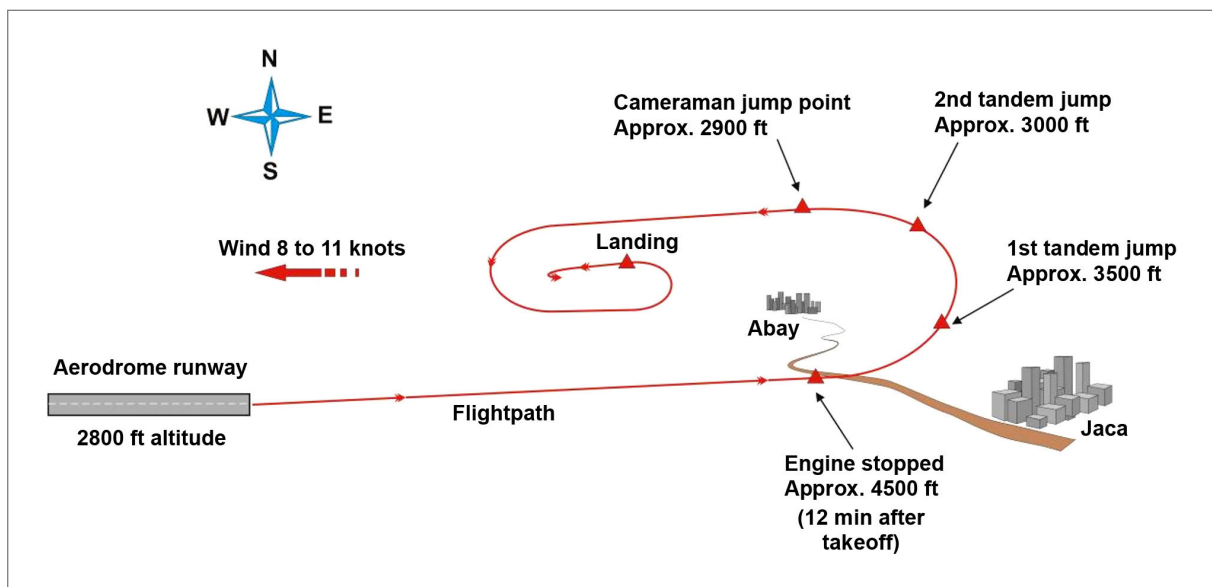
Figure 2. Path taken by the aircraft (not to scale)

When the engine failed, the aircraft was 2,500 ft above the takeoff point, which itself was at 2,250 ft MSL (mean sea level), and west of the town of Jaca. After the parachutists jumped from the aircraft, the pilot reported this fact by radio.

The aircraft landed in a muddy area west of Abay, a town near Jaca. The nose gear detached during the landing, leaving the aircraft resting on the propeller blades, the bottom engine cowl and the main gear. The coordinates of the aircraft's stopping point were 42°34'18.6"N 000°37'14.16"W.
