CIAIAC

Report A-012/2009

Accident involving a P-68
OBSERVER II aircraft,
registration EC-IPG, in Sant
Pere de Vilamajor (Barcelona),
on 23 June 2009

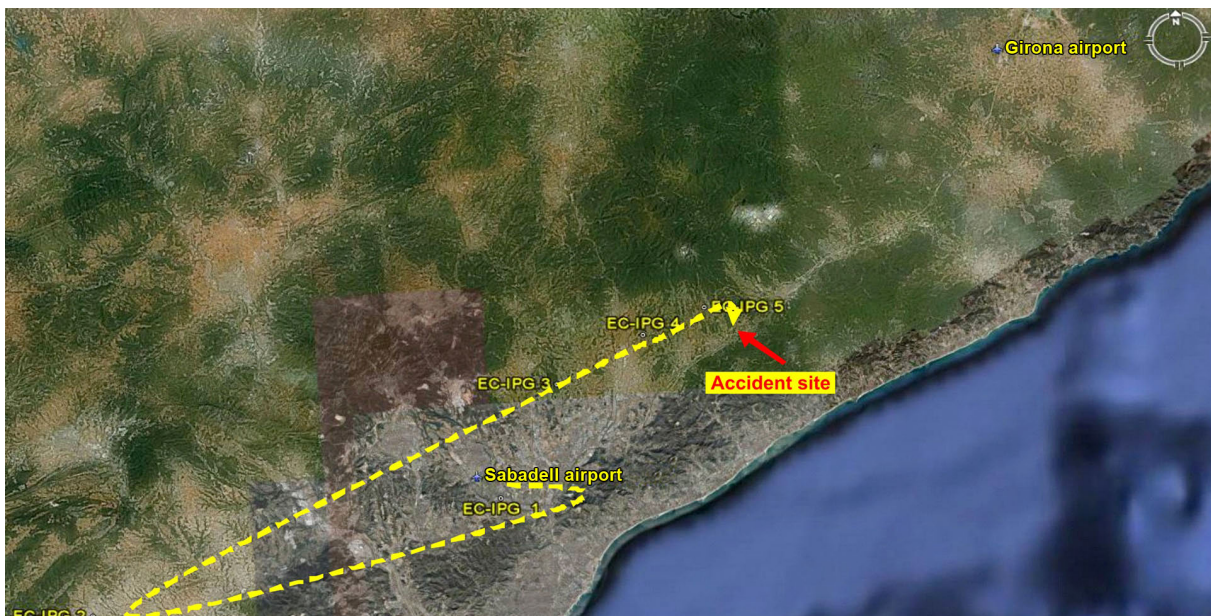
As they were flying over the town of Sant Pere de Vilamajor (Barcelona), the aircraft plunged to the ground near kilometer marker 45 on road BP-5107, falling inside the property of an individual dwelling at coordinates 41° 40' 28" N – 2° 23' 16" E and an elevation of 281 m. The airplane's longitudinal axis was oriented at 40° with respect to magnetic north.

Several eyewitnesses stated that they saw the airplane flying at a low altitude, and how they suddenly stopped hearing the engine sounds. They then saw the airplane spin in a nose down attitude.

Figure 1. Airplane trajectory and accident site³

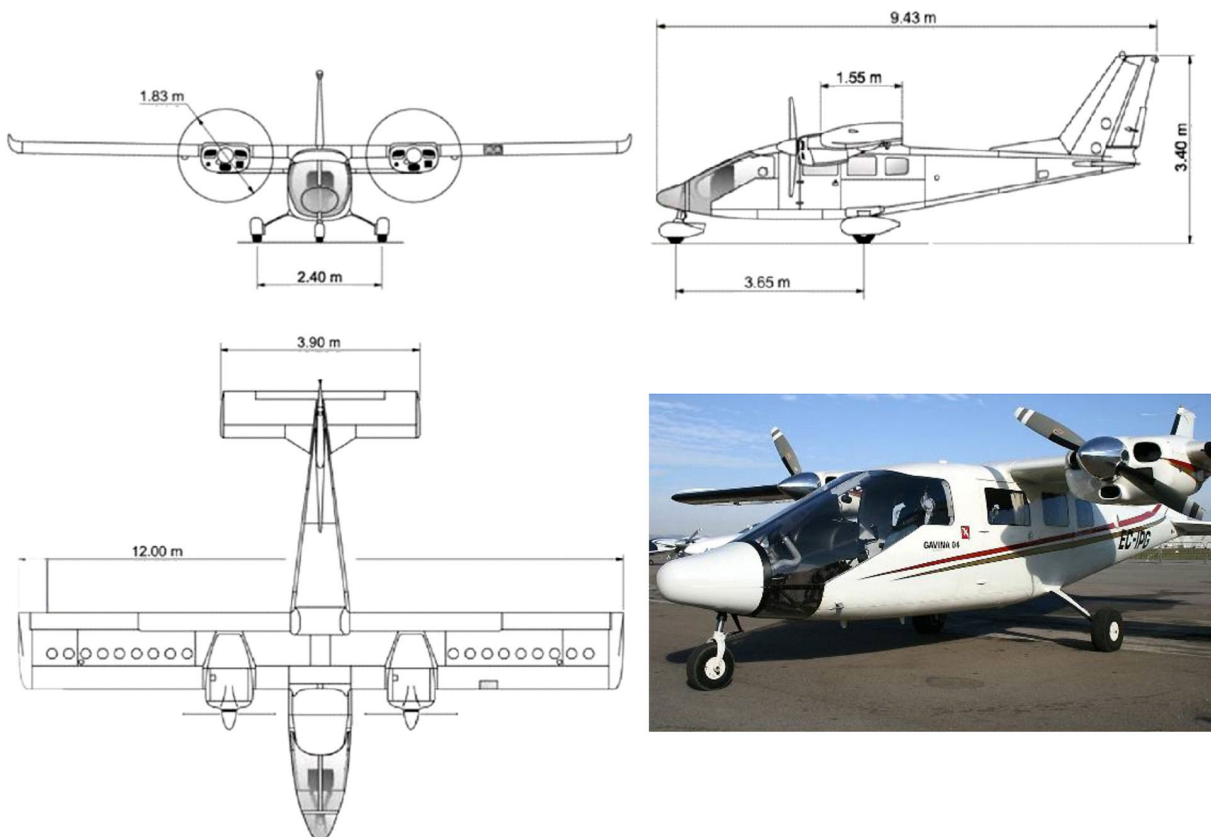
Figure 3. Views of airplane and photograph prior to accident

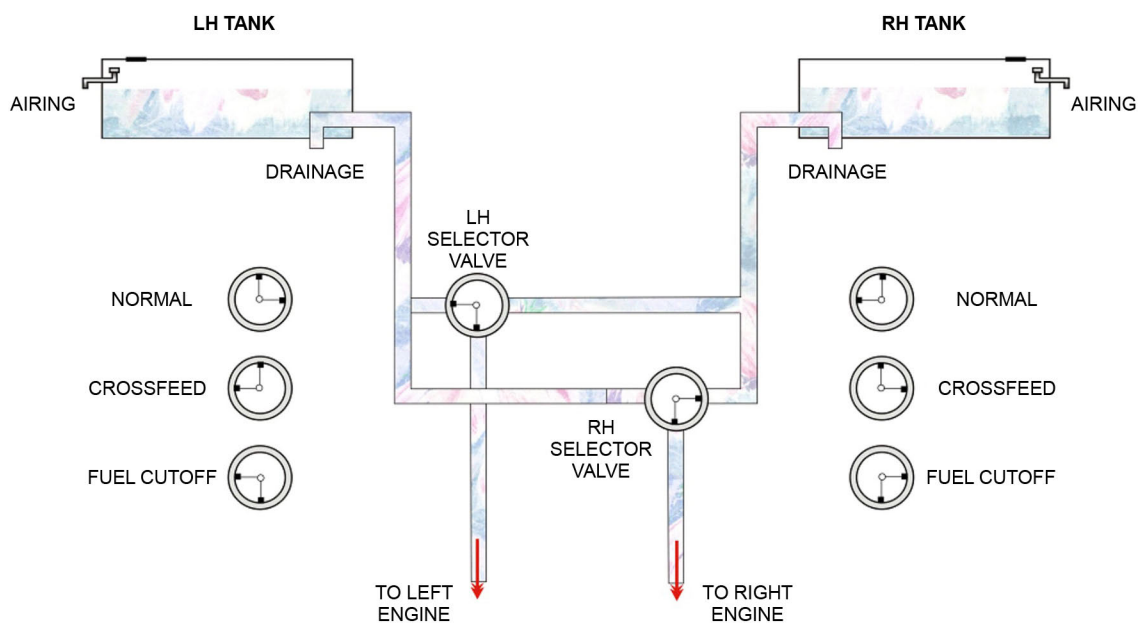
The fuel flows from the tanks to the engine by way of two selector valves that govern the direction of flow. Each valve has three positions, one to cut off the fuel, a normal position (with each engine being supplied from its same-side tank) and a crossfeed position (in which the engine is supplied by the opposite-side tank), as shown in Figure 4.

Figure 4. Fuel system diagram

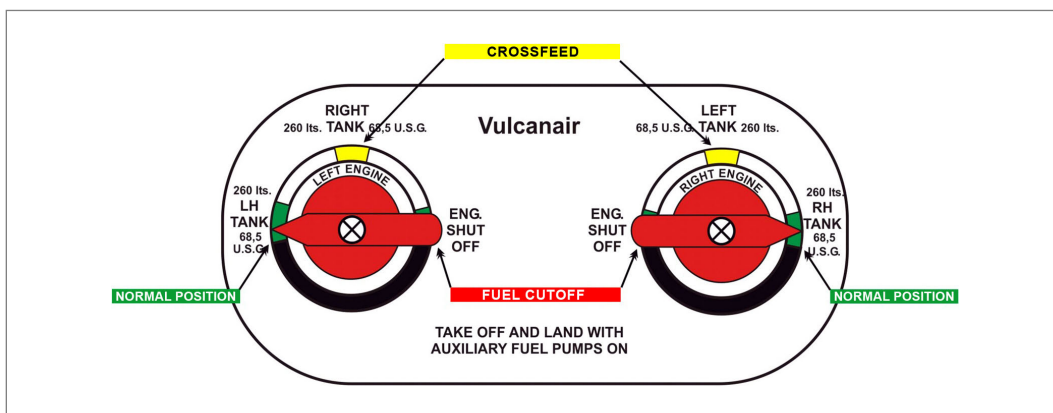
The fuel flow mode is selected in the cockpit through the use of two knobs located in the overhead panel, which can be set to any of the three positions described above (see Figure 6).

Figure 6. Fuel selected knob

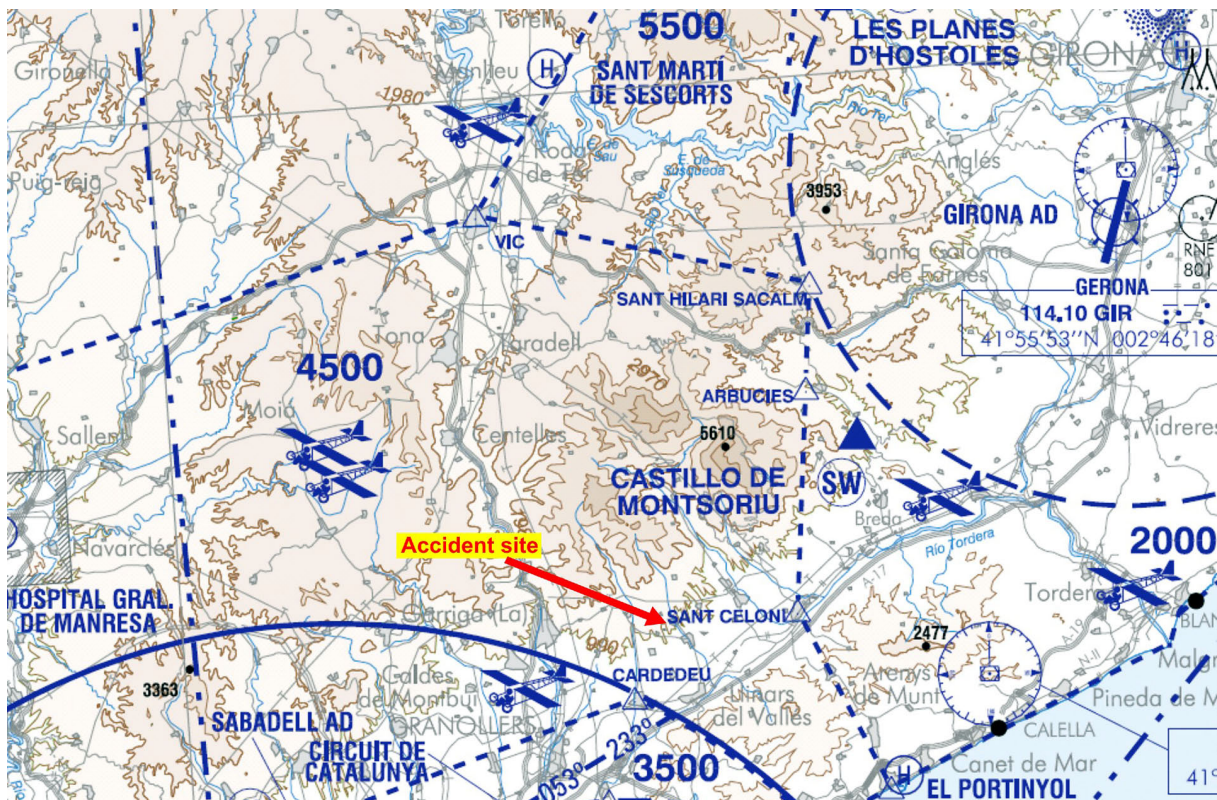
The VFR procedures for the Barcelona TMA as specified in the AIP published by AENA establish a flight altitude limit of 4,500 ft in the area where the accident took place. In the area to which the crew reported they were heading (Granollers), this limit was even lower, specifically, 3,500 ft.

Figure 14. VFR procedures chart for the Barcelona TMA
