DATA SUMMARY

Date and time	Thursday, 14 January 2010; 10:09 UTC
Site	Girona Airport (Girona, Spain)

Registration	EI-EBL	EI-DWT
Type and model	BOEING 737-800	BOEING 737-800
Operator	Ryanair	Ryanair

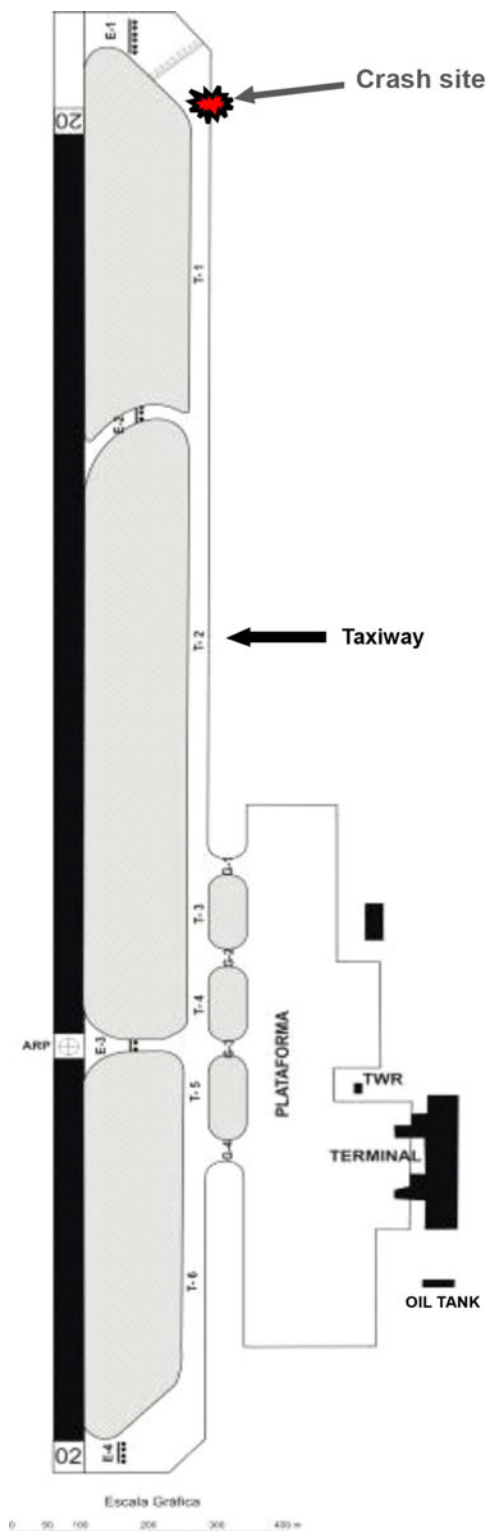
Figure 3. Diagram of aerodrome part of the change in ILS category, after the incident a new survey was commissioned to determine the actual dimensions of the taxiway and the exact position of the stop bar (see Figure 6).

The aerodrome map for ground movements shown in the AIP on the day of the incident had the stop bar for runway 20 in a position different from its actual location. The same was true for the other threshold.

As a result of the above, the Commission believes a recommendation is in order for AENA to inform of changes to markings affecting airport operations as soon as possible via the method deemed most suitable, such as the issuing of a NOTAM, whenever the publication of the AIP that details said changes is delayed.

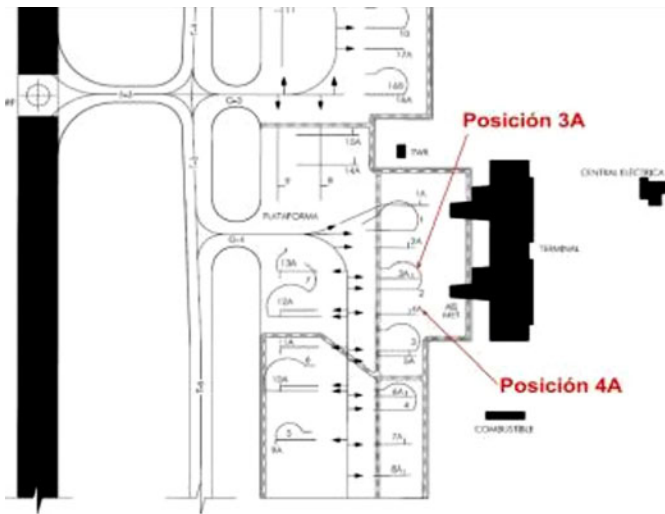
Figure 4. Parking area

Figure 4 shows a close-up of the parking area with the stands occupied by the two aircraft prior to start-up. Aircraft EI-EBL was in stand 3A and taxied first, followed by EI-DWT, which left from 4A.

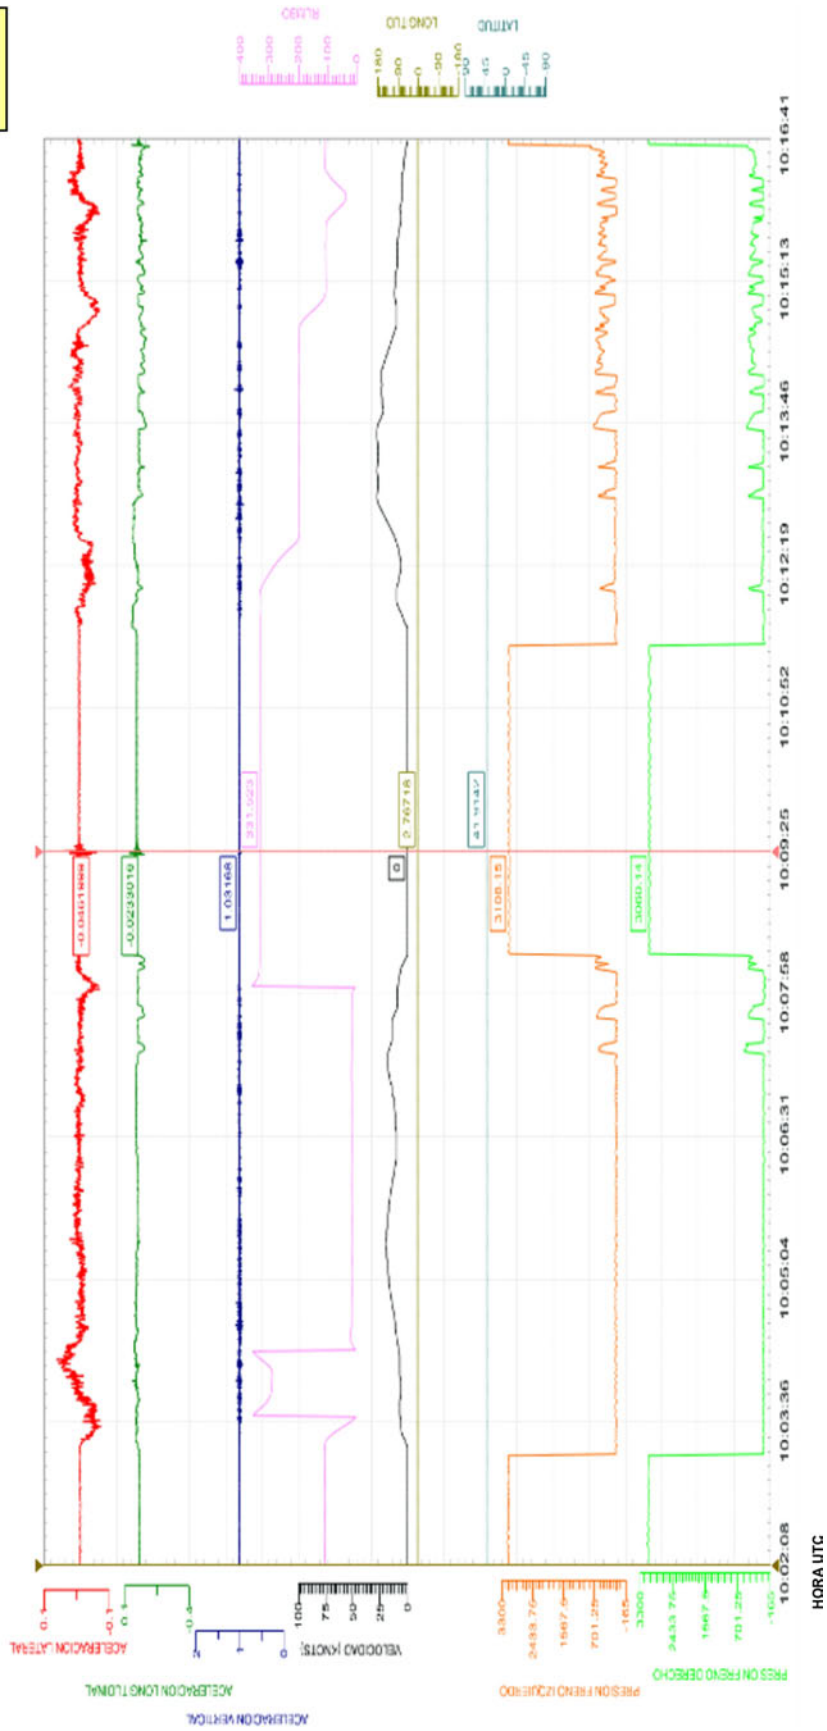
EI-EBL

APPENDIX A
**Graphical representation of various
parameters for airplane EI-EBL**

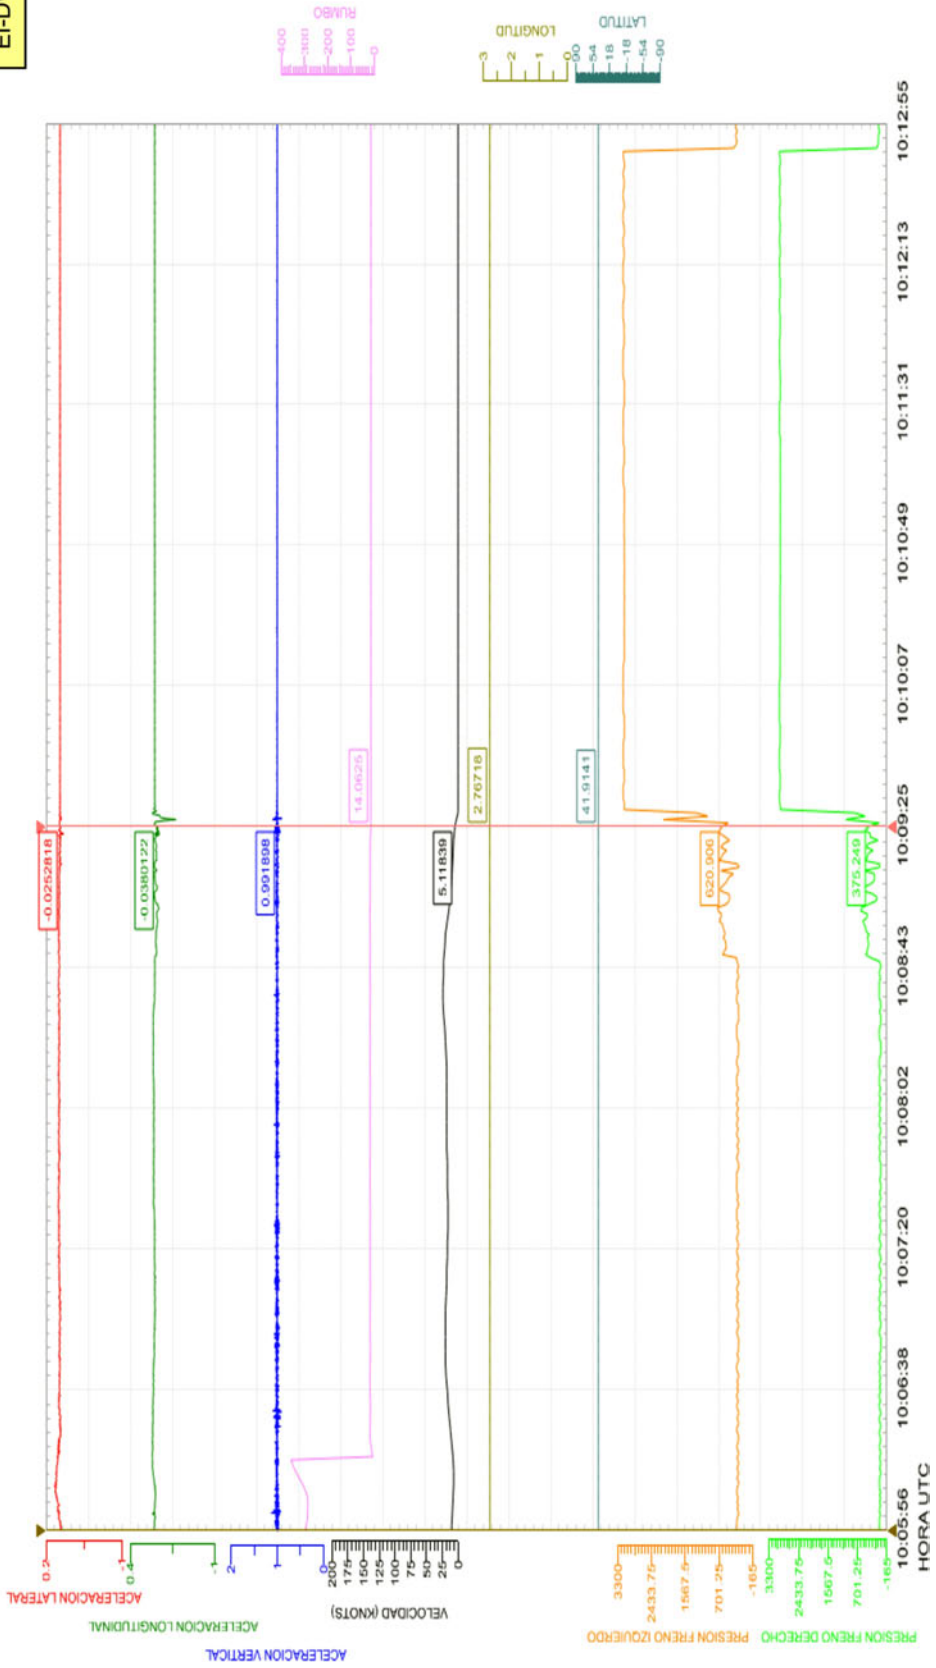
EI-DWT

APPENDIX B
**Graphical representation of various
parameters for airplane EI-DWT**
