Report A-002/2010

Accident involving an
AgustaWestland AW139 helicoter,
registration EC-KYR, operated
by INAER HELICÓPTEROS
OFF-SHORE off the coast
of Almeria, on 21 January
2010 at 20:16 local time

**Accident involving an AgustaWestland AW139
helicopter, registration EC-KYR, operated
by INAER HELICÓPTEROS OFF-SHORE
off the coast of Almeria, on 21 January 2010
at 20:16 local time**

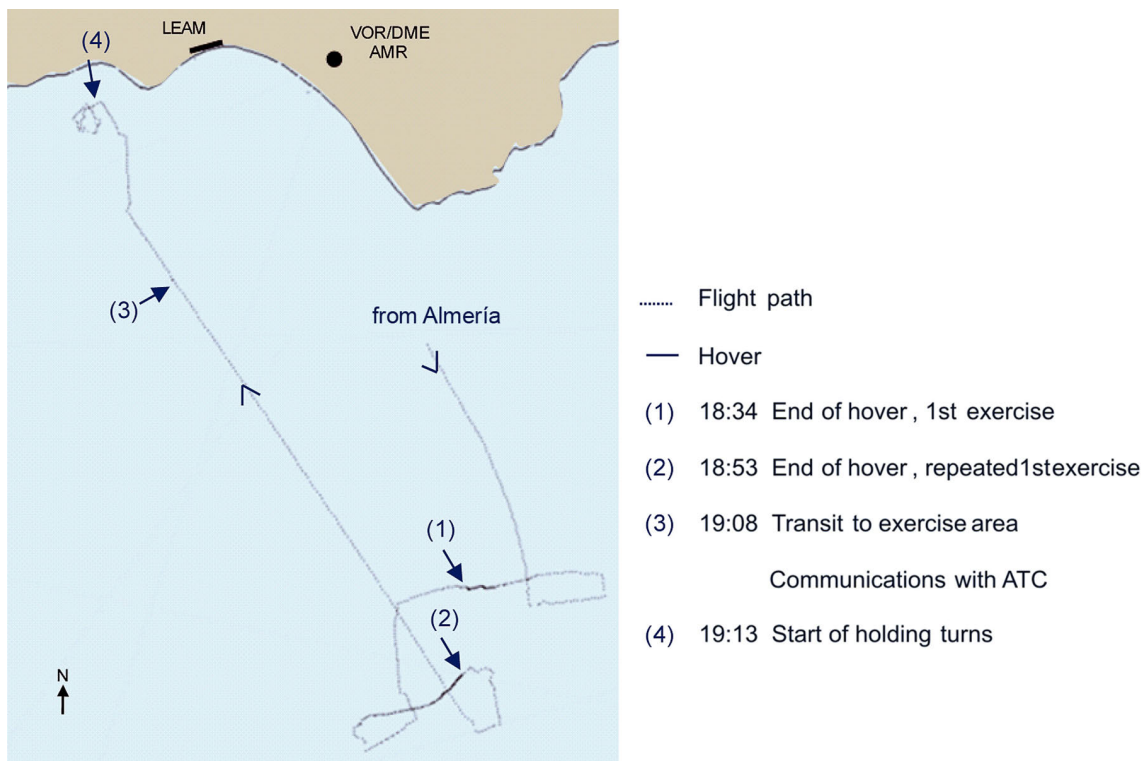
Figure 1. Radar flight path for exercise 1 and en route to the area for exercises 2 and 3

favorable, so they decided to terminate the hovering maneuver at 18:34 h and select another vessel to repeat the maneuver. The copilot climbed in manual to 500 ft and by 18:36:54 h had picked another vessel close to the first.

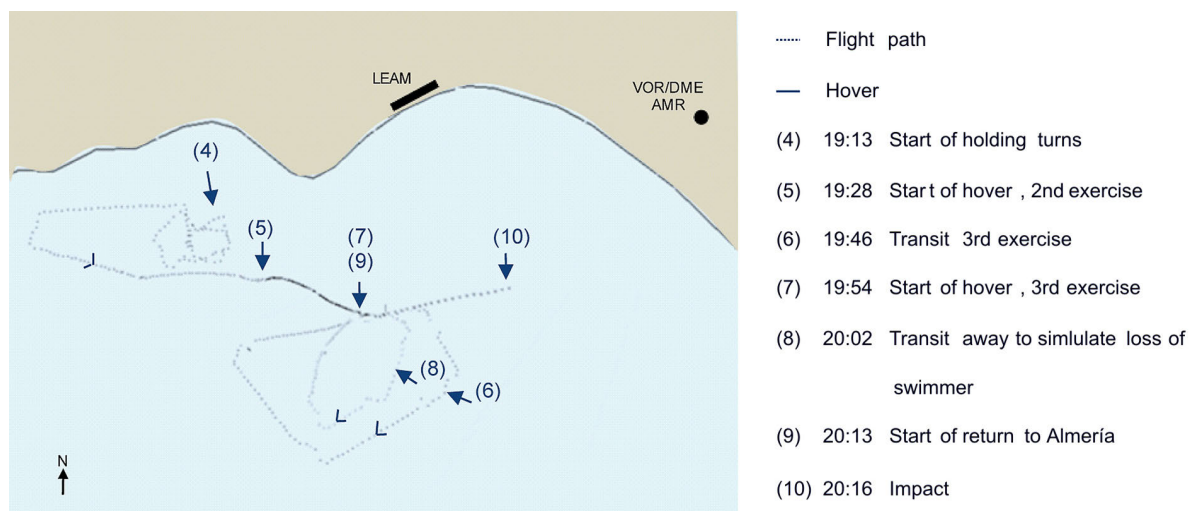
Figure 2. Radar flight paths for exercises 2 and 3 and return flight to Almería

establish realistic SAR conditions. The captain was the pilot flying. He made the approach to the ship in manual. The LANDING GEAR and ONE FIFTY FEET warnings sounded. At 19:54 h he started to hover using the HOVER and RHT modes. They lowered the rescue swimmer into the water and six minutes later, at 20:00:25 h, with the swimmer in the water and from a hover, the captain climbed in Transition Up mode, informing the swimmer that they were moving away in order to commence the search. They flew 2 NM away following an elliptical pattern and on the approach back, the LANDING GEAR and ONE FIFTY FEET warnings sounded again. By 20:06:32 h they had located the swimmer and were preparing to hoist him onboard.

The efforts to locate the wreckage begun on the day of the accident and relied on the signal transmitted by the beacon on the helicopter's FDR, the fuel slick, structural components that floated to the surface (rafts, helmets, doors and the winch operator's vest) and the last radar returns. The emergency locator transmitter (ELT) on the helicopter did not function, but the transmitter on the left raft and the swimmer's personal transmitter did. The helicopter was found at coordinates 36° 46.6145' N 002° 21.1665' W, approximately 4.5 NM south of the Almeria Airport at a depth of 91 m (item (10) in figure 2).

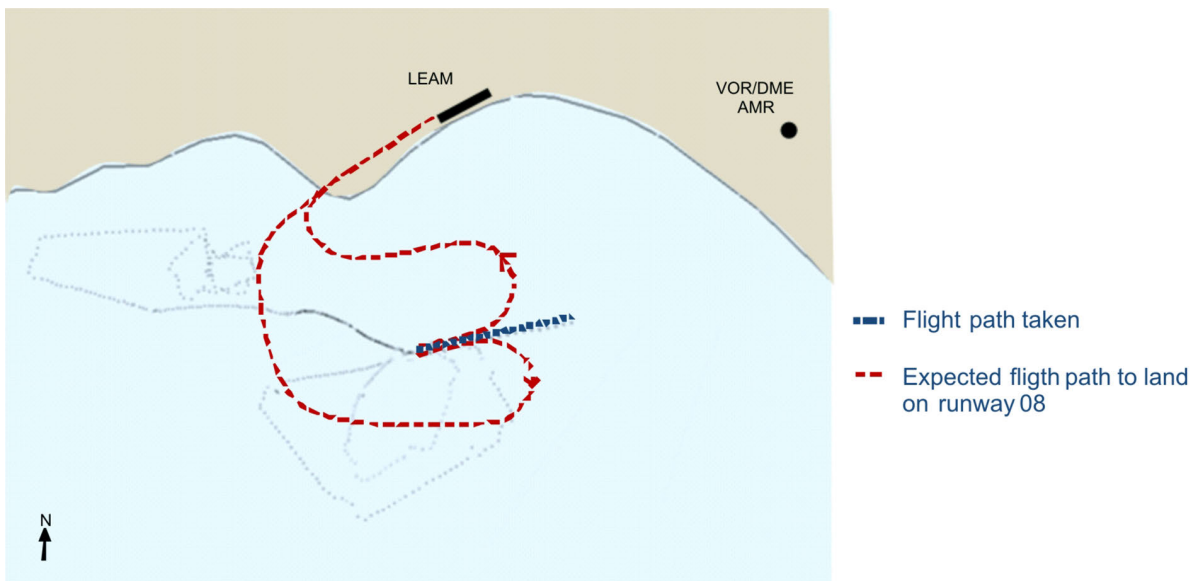
At the conclusion of the exercise, aircraft EC-KYR received instructions from the control tower to land on runway 08 at the Almeria Airport. The expected flight path should have been one of the two shown in figure 7 in which, after climbing to a safe altitude, the crew should have initiated a turn to line up with the runway. Whether the turn was to the right or left depended on the amount of time needed to configure the helicopter for landing. A turn to the right would have allowed more time.

Figure 7. Expected return path to Almeria

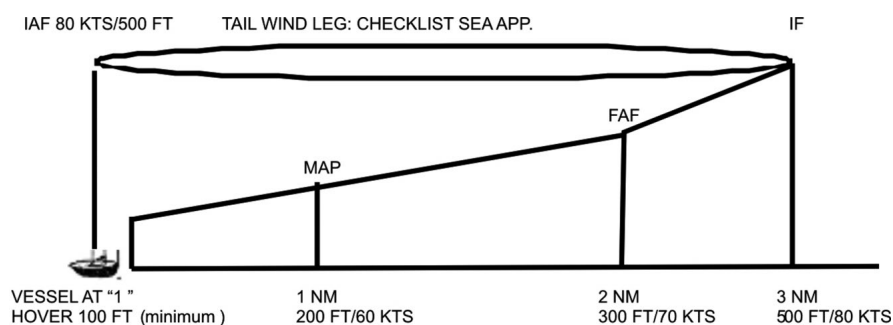
The hover is described in Section 5.3.3, Recovery of survivors from a vessel, which specifies setting the DH at the minimum hovering altitude planned (e.g. 60 ft). This disagrees with figure 8, which lists a minimum hovering altitude of 100 ft.

Figure 8. Approach to hover (Almeria base SAR SOM)

- The list includes the hover. The SAR SOM specifies that to hover, the crew will set the DH at the minimum hovering altitude planned. This value, which varies depending on the dimensions of the target, does not match that in the list, which specifies a preset value of 40 ft, or that in figure 8 of the manual, which sets a minimum value of 100 ft.
