CIAIAC

Report A-022/2010

Accident involving
an Alexander Schleicher
ASW 27-18E, registration
D-KANR, in Castejón de Sos
(Huesca), on 7 July 2010

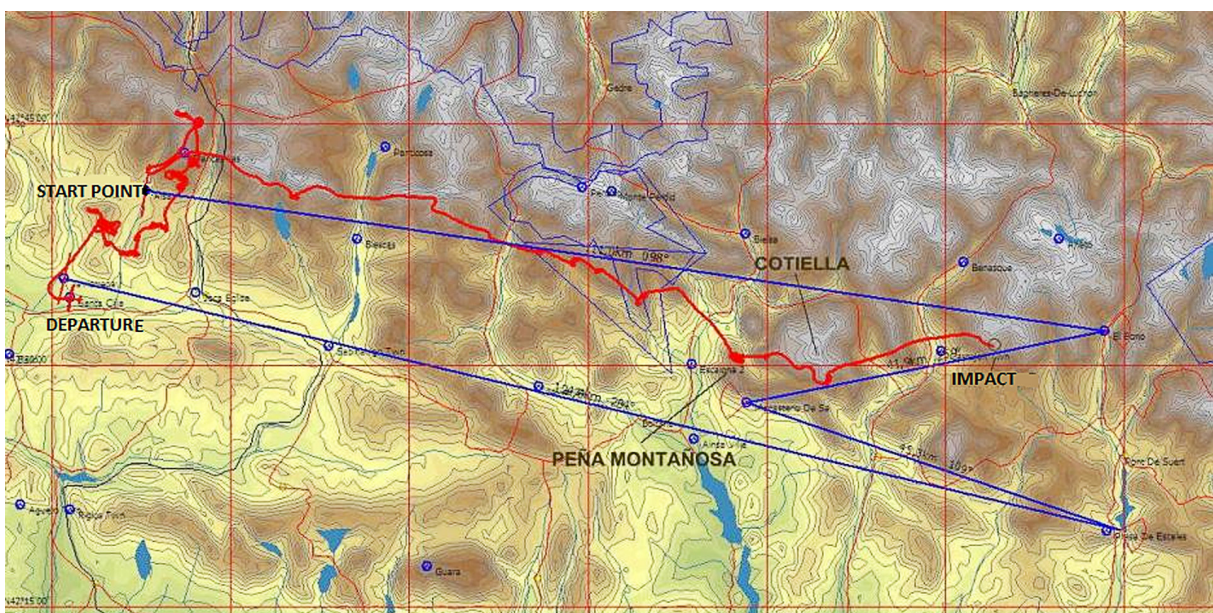
Figure 2. Aircraft flight path

Figure 2 shows in red the flight path taken by the glider as outlined by the points recorded until just before the end of the flight. Also shown is the route specified for this flight.

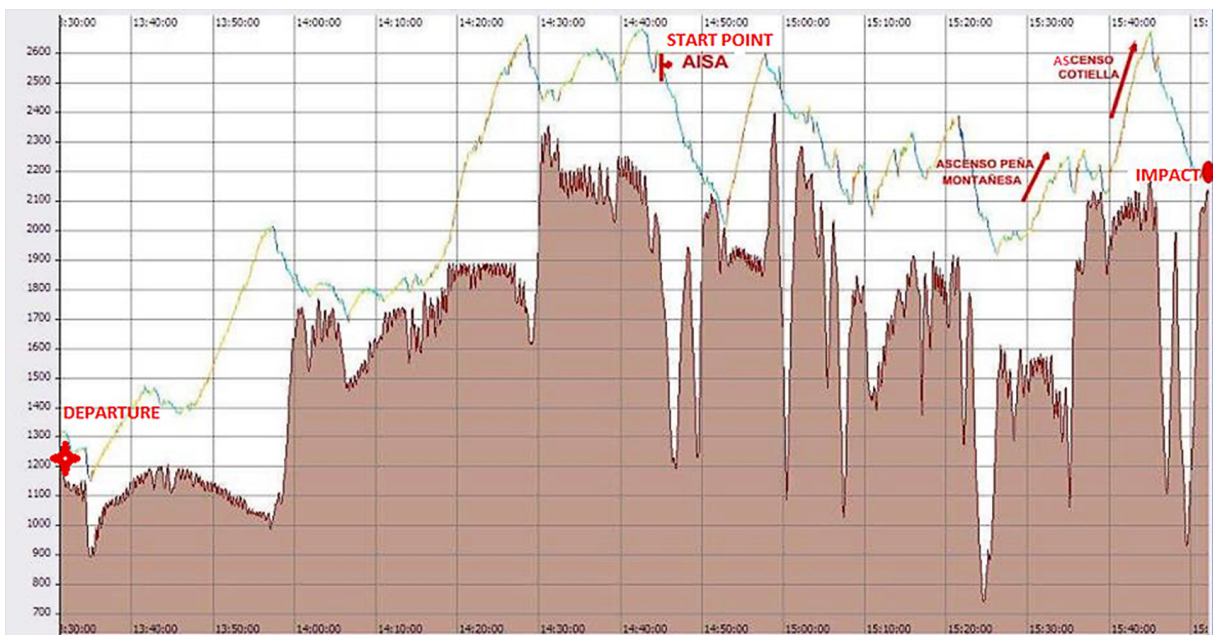
Figure 3. Barogram of the flight

The barographic diagram in Figure 3 shows the altitude profile in time with an approximate indication of the elevation of the terrain being flown over by the glider.

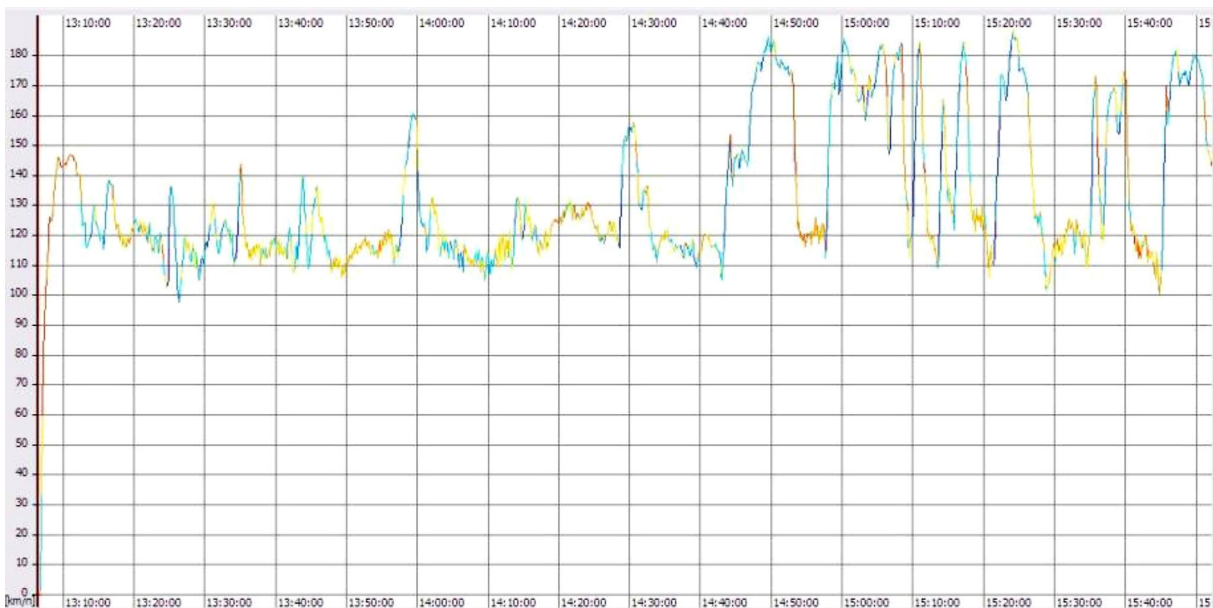
Figure 4. Diagram of the aircraft's GS

The graph below shows the trend in the glider's ground speed (GS) during the successive circular flight phases and while transitioning between thermals (Figure 4).
