DATA SUMMARY

Date and time	Saturday, 12 November 2011, at 11:12 local time ¹
Site	Andratx, wooded area in La Trapa (Balearic Islands)

Registration	G-WOOW
Type and model	HUGHES 369E
Operator	Private

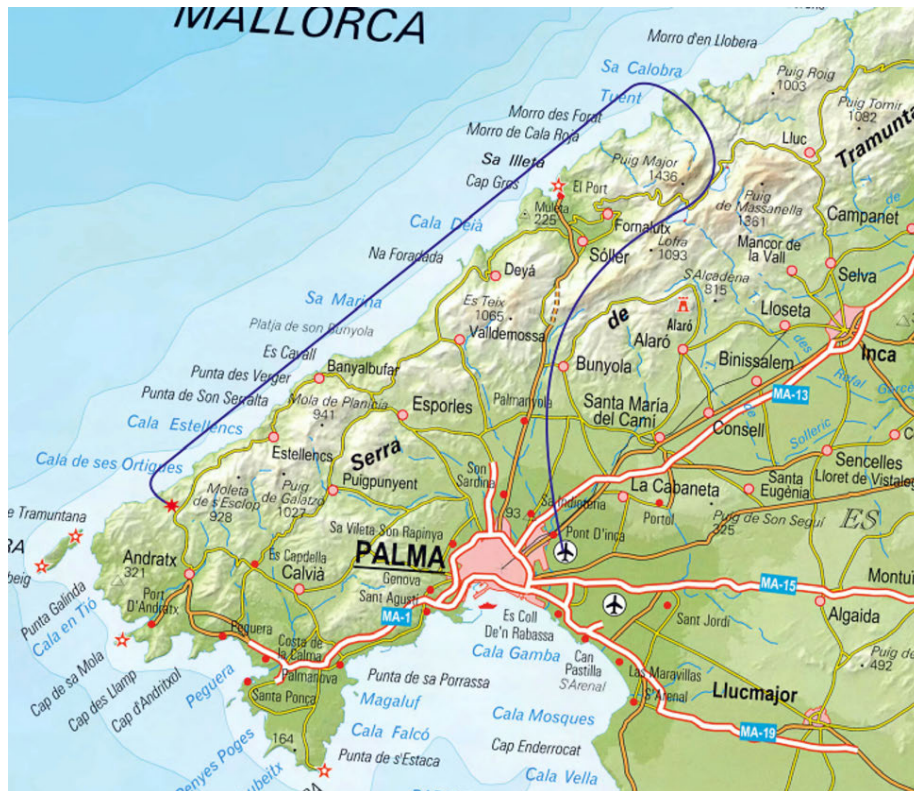
Figure 1. General overview of the flight path

The flight's initial course was to the north of the island, leaving the town of Soller to the left, before heading northeast to Puig Mayor mountain, which they passed on their left side (see Figure 1). Further ahead the pilot made a 90° left turn and continued heading toward the sea, flying over the coastline in the vicinity of Sa Calobra. Once over the coast the course was parallel to the coastline on a southwesterly heading until the pilot turned inland on a southeasterly course over the valley of Es Ratjoli (north of Andratx).

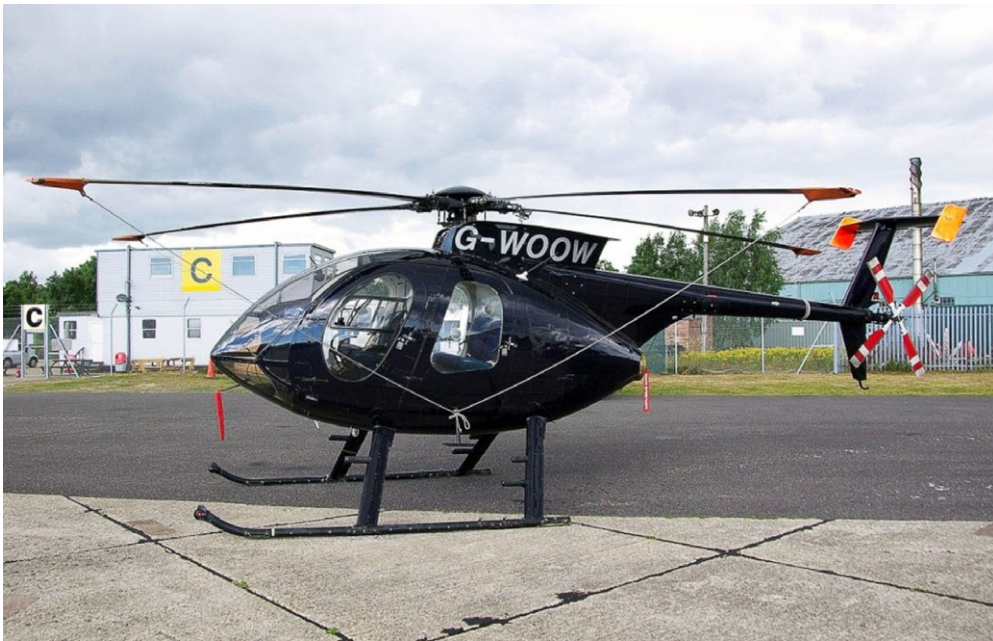
Figure 2. Picture of the accident aircraft

The Hughes 369E helicopter (also known as the MD 369E), registration G-WOOW, was manufactured in 1989 with serial number 0344E. It was outfitted with a Rolls Royce 250-C20 engine, serial number CAE 835726, that had a maximum takeoff power of 420 SHp².
