Report A-022/2012

Accident involving a Bell 412
aircraft, registration EC-KSJ,
operated by Inaer, at La Forata
reservoir (Valencia, Spain),
on 2 July 2012

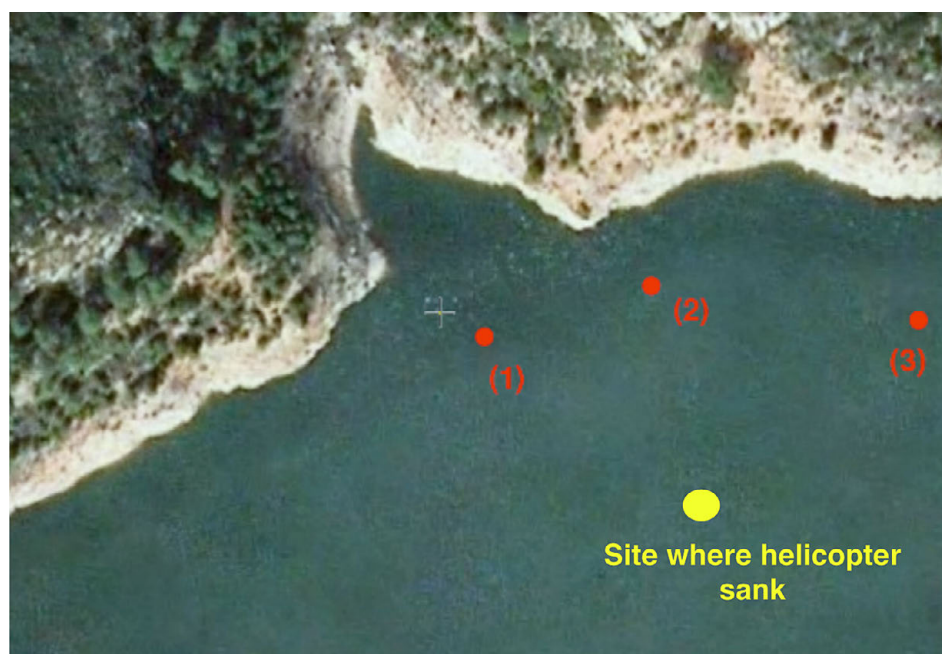
Figure 3. Points located with the proton magnetometer

On 5 September 2012, this same company started a new search using an underwater proton magnetometer⁴, which narrowed down the search area even more, as shown by the three points in Figure 3.

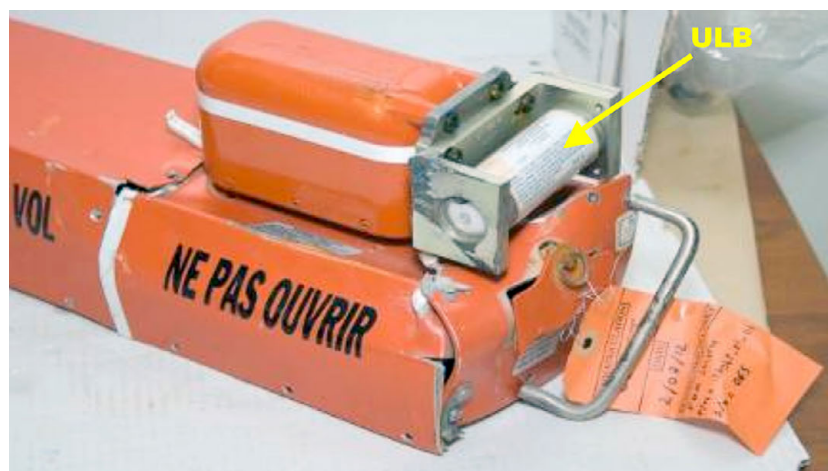
Figure 4. FDR memory in its normal position

The helicopter was refloated nine days after the accident. The flight recorders (Digital Flight Data Recorder - DFDR and Cockpit Voice Recorder - CVR) were recovered, though parts were noted to be missing, since the part housing the memories had detached in both cases after being struck by one of the blades.

Recovered from the wreckage were the two flight recorders. Missing on both units was the part that housed the memories, which had detached on impact.
