Report A-023/2012

Accident involving a Sokol
PZL SWIDNIK W-3A aircraft,
registration EC-JUN,
operated by INAER,
at Yátova (Valencia),
on 2 July 2012

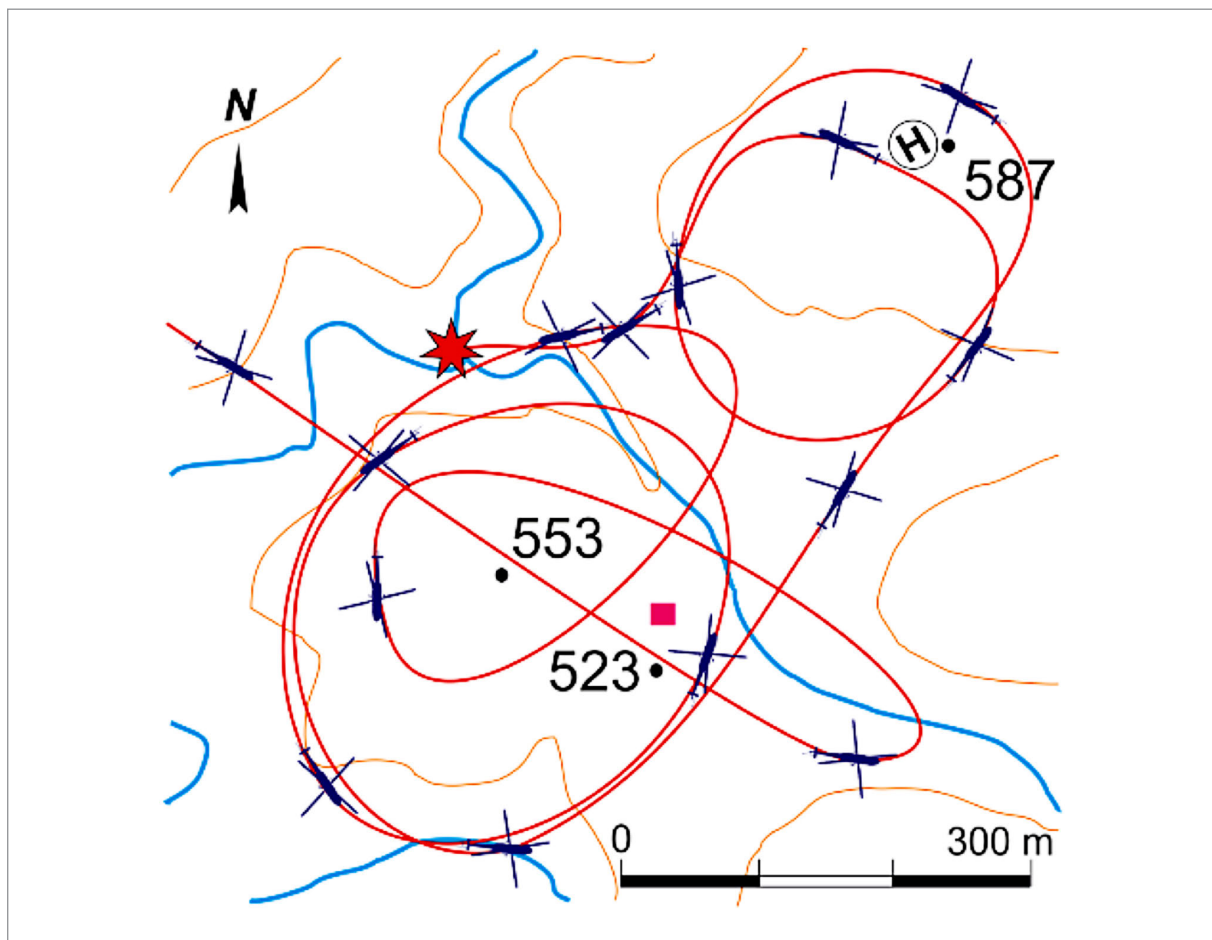
Figure 3. Planned landing site, circling area and impact site

The members of the BRIF were scattered along two small hills that rose to elevations of 587 and 553 m. They were next to each other but separated by a ravine (see figure below).

The supervisor in charge of the BRIF informed the helicopter crew that they could land in the hill to the northeast, where other helicopters had landed previously. The hill was at an elevation of 587 m and its summit was covered in rocks and shrubs.

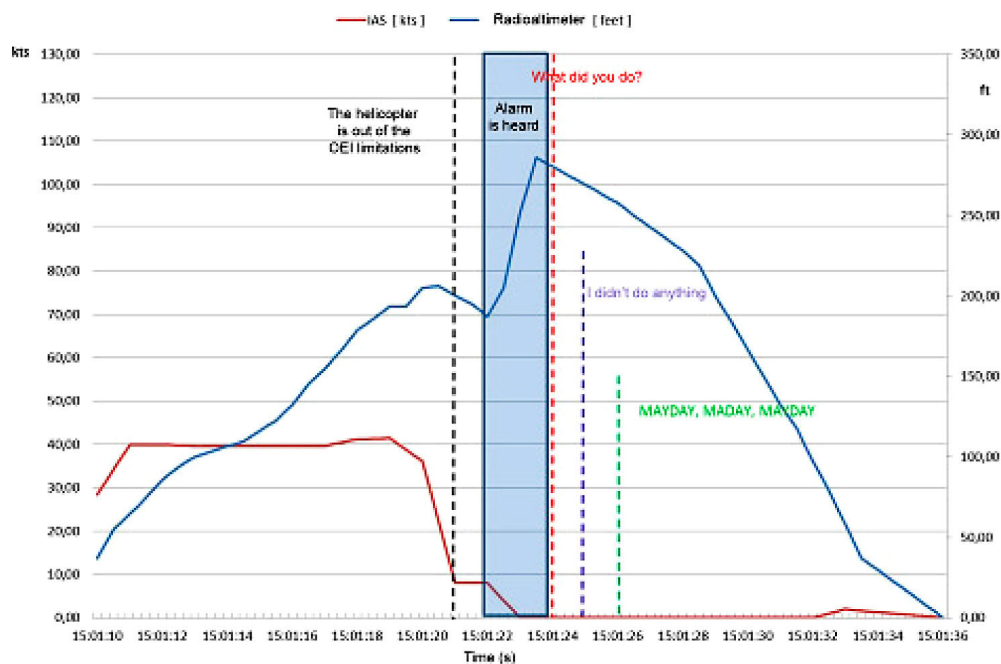
Figure 7. IAS, radio altimeter reading, and voices in the cockpit after the emergency

Continuing with the same phases of flight noted earlier, the details of the CVR are described next (figure 7).

Upon entering the fire area, the pilot under supervision radioed the coordination helicopter in the fire area without receiving a response. He tried repeatedly but with the same result.

The BRIF supervisor told him that the area where he was located, on the hill to the southwest at an elevation of 553 m, was not suitable for landing since the area was burned, and he instructed the pilot to proceed to the other hilltop, which was then at the pilot's 12 o'clock position.
