REPORT IN-037/2012

Date and time	Friday, 21 September 2012; 19:16 UTC ¹					
Site	On approach to runway 06 at the Ibiza Airport (LEIB) (Spain)					
AIRCRAFT						
Registration	EC-JIL			CS-DNP		
Type and model	BOMBARDIER Inc. BD-700-1A10			DASSAULT FALCON 2000		
Operator	Punto-FA, S.L.			Netjets Europe		
Engines						
Type and model	ROLLS & R	OYCE BR70	0-710A2-20	HONEYWEI	L CFE 738-	1-1B
Number	2			2		
CREVV	Cantain	First	officer	Cantain	First	officer
Δαρ	38	46	omeer	48	38	onneer
Licence	ΔΤΡΙ	CPI			CPI	
Total flight hours	6.600 h	3.600	h	7.570 h	5.000	h
Flight hours on the type	2,900 h	1,900	h	1,767 h	1,000	h
	Fatal	Serious	Minor/None	Fatal	Serious	Minor/None
Crew			2			3
Passengers			9			/
Inird persons						
DAMAGE						
Aircraft	None			None		
Third parties	None			None		
FLIGHT DATA						
Tipo de operación	General aviation – Business Commercial Air Transport – Charter –			rt – Charter – r		
Phase of flight	Approach			Approach	i i ussenge

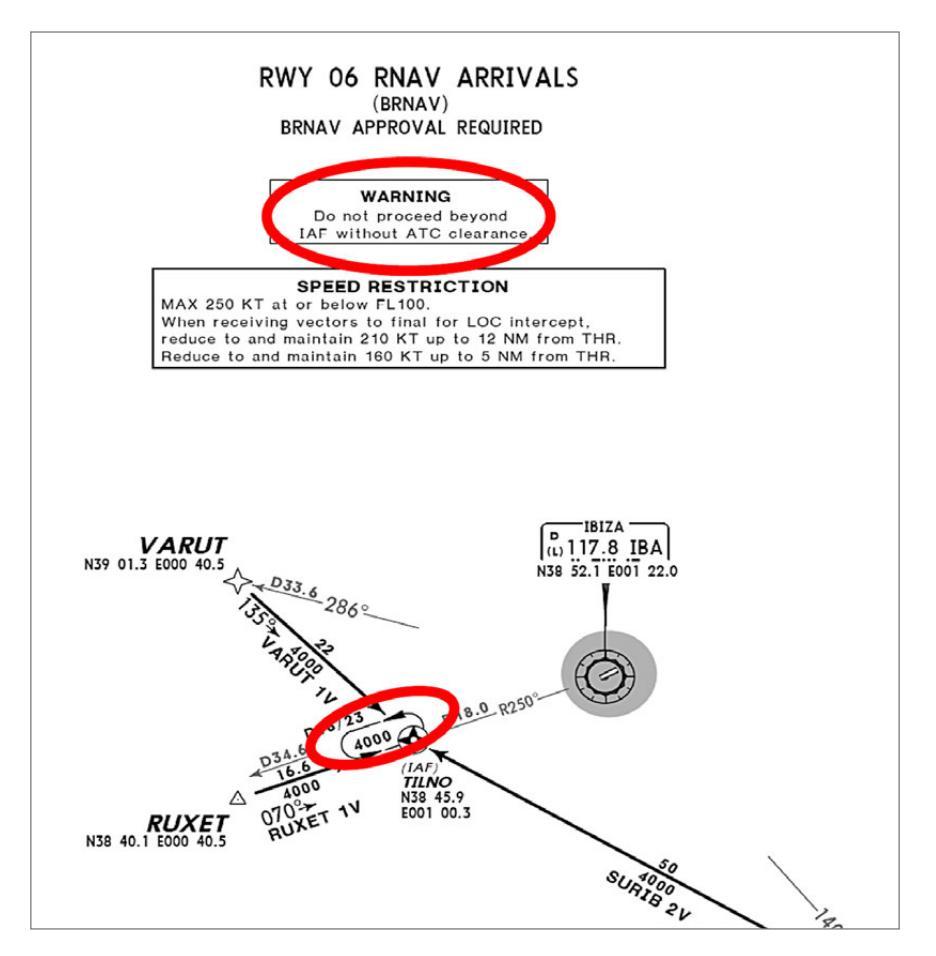
Figure 2. Portion of Jeppesen chart 10-2G

As indicated on the flight plan for aircraft CS-DNP, the standard arrival (STAR) planned for the day of the incident was STAR VARUT1V, published in the AIP Spain in chart AD2-LEIB STAR 1.2. Onboard the aircraft was the Jeppesen 10-02G chart for Ibiza, corresponding to the instrumental standard terminal arrival route for runway 06 at the Ibiza Airport. This chart warns not to proceed beyond the IAF without ATC clearance. It also lists the minimum hold altitude over IAF TILNO as 4,000 ft.

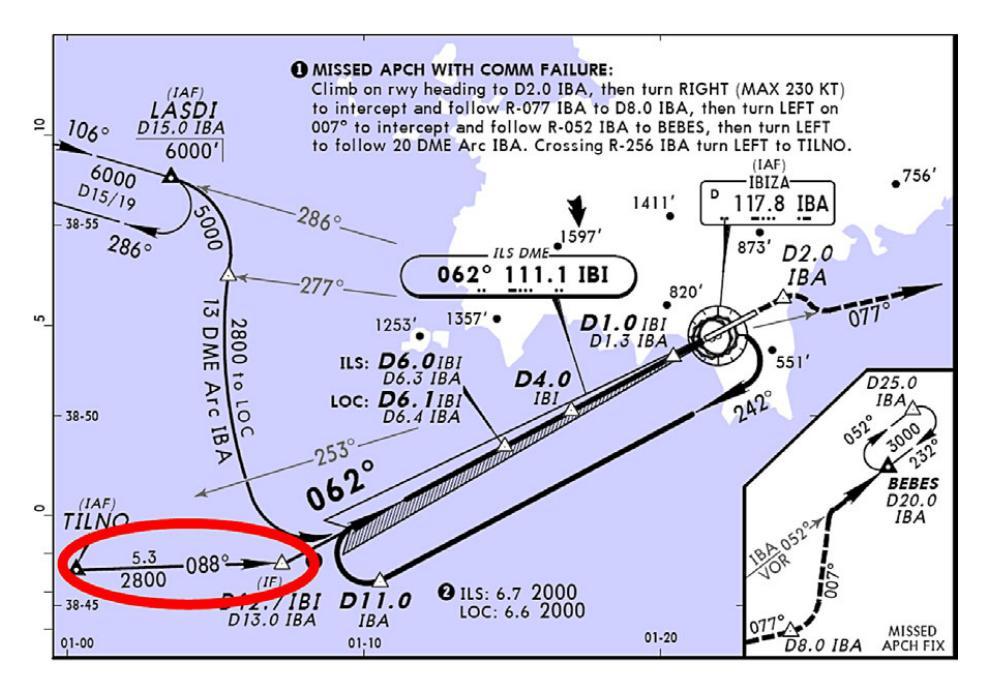
Figure 3. Portion of Jeppesen chart 11-1

The ILS instrument approach procedure for runway 06 at LEIB is published in chart AD 2-LEIB IAC/1 of the AIP Spain. Aircraft CS-DNP had onboard Jeppesen chart 11-1, corresponding to the IAC for runway 06 at Ibiza. Both charts establish the heading to fly after leaving the IAF TILNO as 088° until the intermediate fix (IF) is reached.
