**RESUMEN DE DATOS**

| Lugar | <b>Pista 28 del aeropuerto de Cuatro Vientos (Madrid)</b> |

| Matrícula | <b>EC-ICG</b> |
| Tipo y modelo | <b>PA-60-601P (Aerostar 601P)</b> |

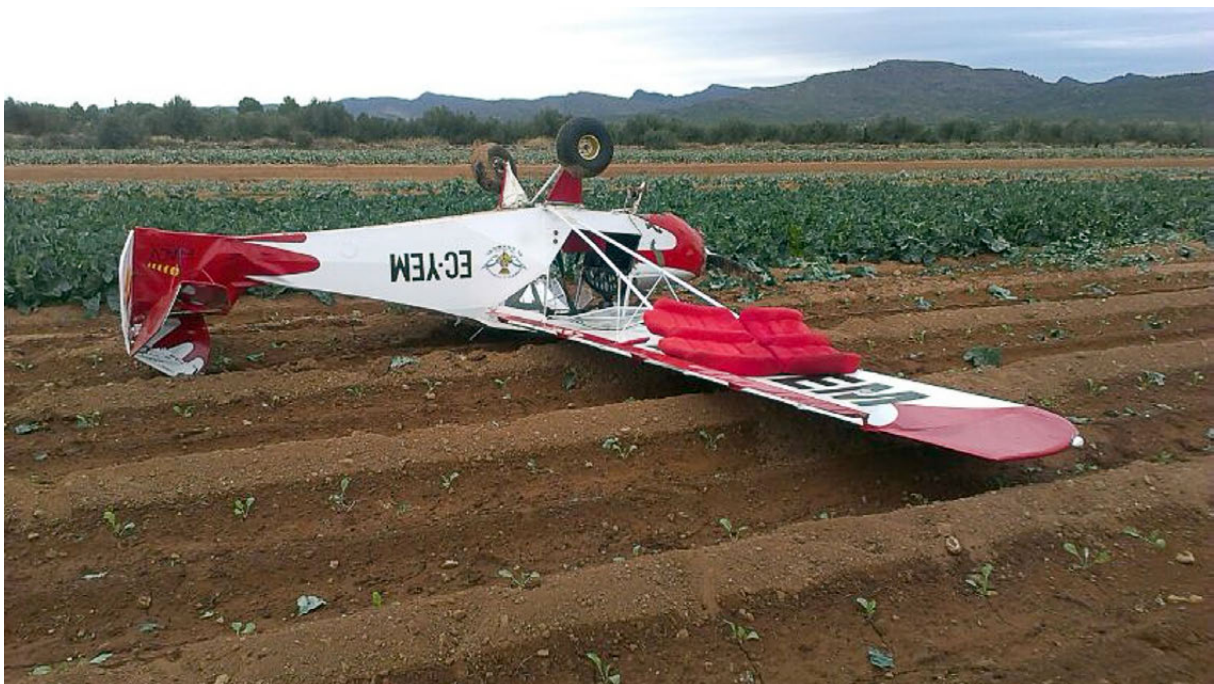
Figura 1. Fotografía de la aeronave después del accidente

La aeronave resultó con daños en el ala, en el tren, en la cola y en la parte delantera, rompiéndose la hélice por su mitad<sup>4</sup>.

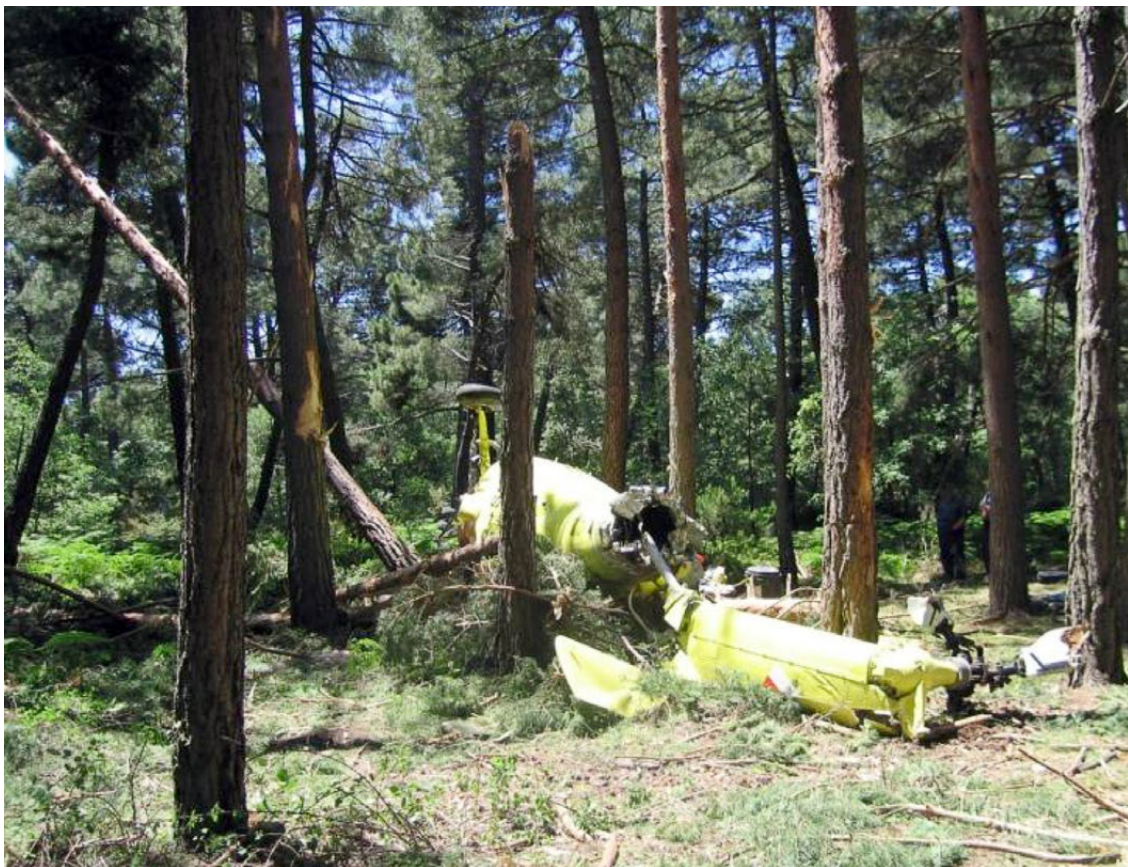
Figure 1. Aircraft wreckage

The aircraft fell on its right side. Its main rotor blades broke and the tail cone separated from the central part of the frame, which had been pierced by a tree trunk (Figure 1).

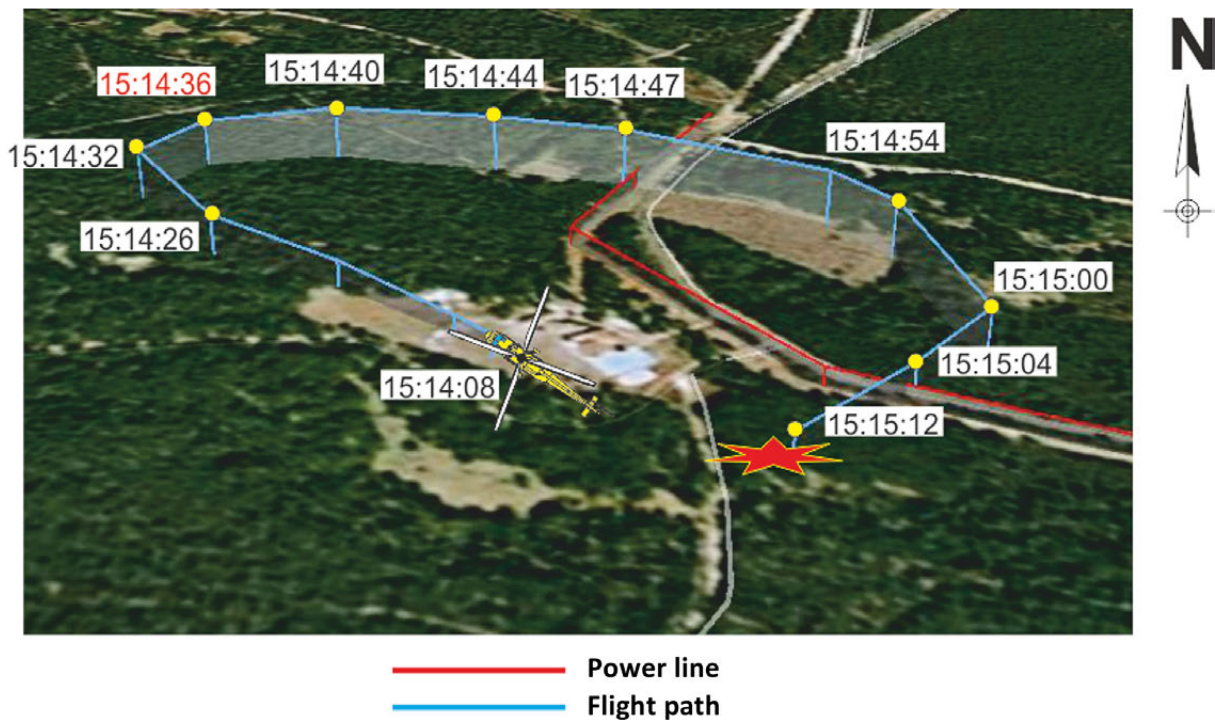
Figure 2. Path taken by the aircraft

Figure 2 shows the path taken by the aircraft as determined from global positioning system (GPS) data. The timestamps are those recorded by the GPS.

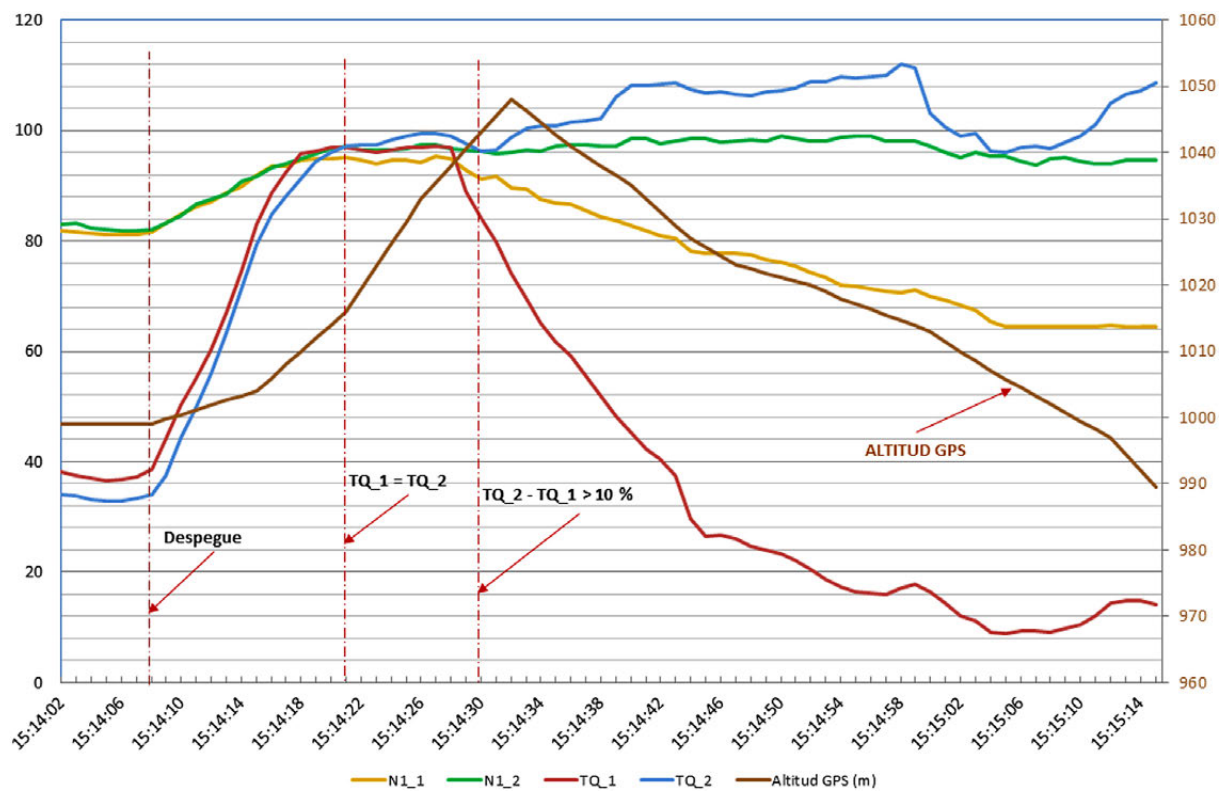
Figure 3. Flight data recorder parameters

The aircraft was outfitted with flight data and cockpit voice recorders. Figure 3 shows the values for torque (TQ\_1 and TQ\_2 in percent) and compressor RPMs (N1\_1 and N1\_2 in percent) for both engines, along with GPS altitude<sup>6</sup>. The values for main rotor RPMs could not be validated.

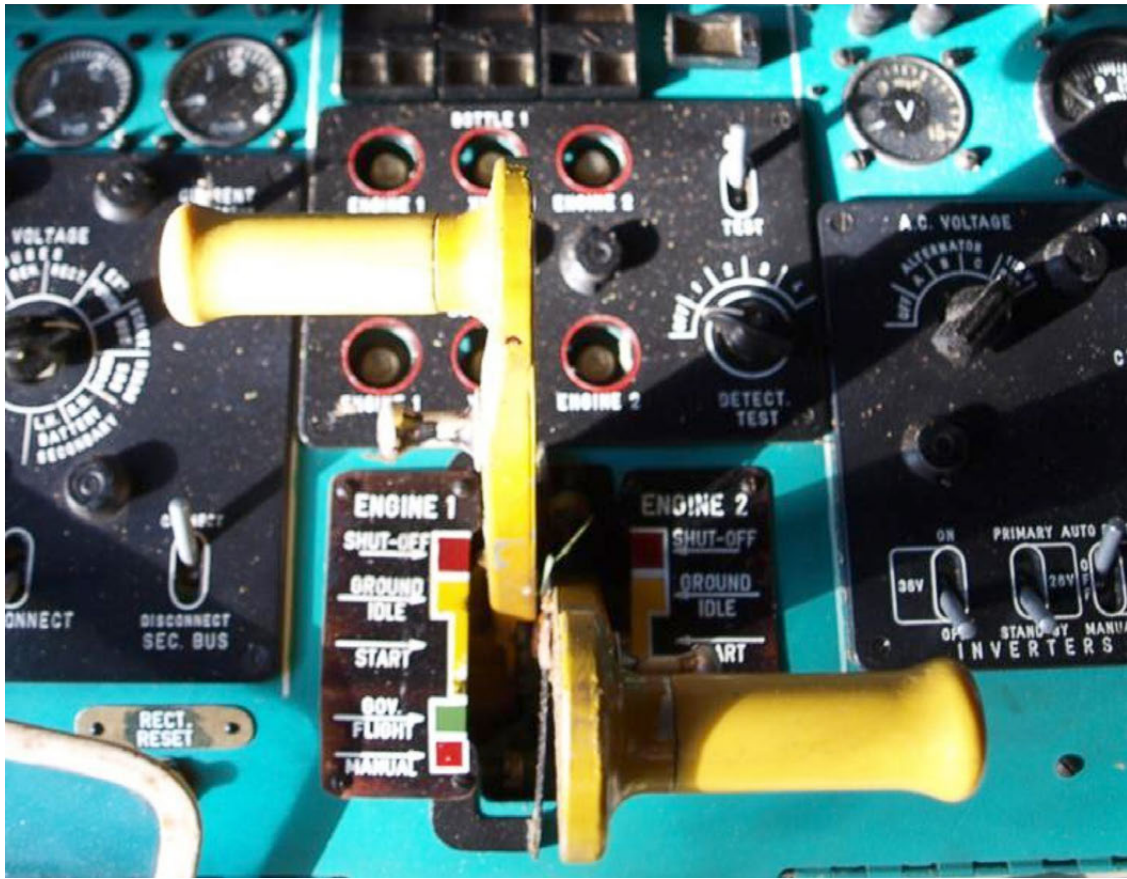
Figure 4. As-found positions of the engine power control levers

- There were small tree branches in the ventilation system ducts for the engine and accessories, as well as firefighting powder residue, which had been sprayed by the responders who reported to aid the aircraft's occupants.
- The hydromechanical turbine RPM limiter (ALRT-2B) and the fuel control pump (ALRP-5) on the #1 (left) engine showed that the engine power control lever was placed in manual control during the flight. This indication could not be checked in the right engine, which could not be accessed during the onsite inspection.
- The right engine power control lever was jammed at about the 60% position. The lever for the left engine was in the SHUT-OFF (fuel cutoff) position. See Figure 4.

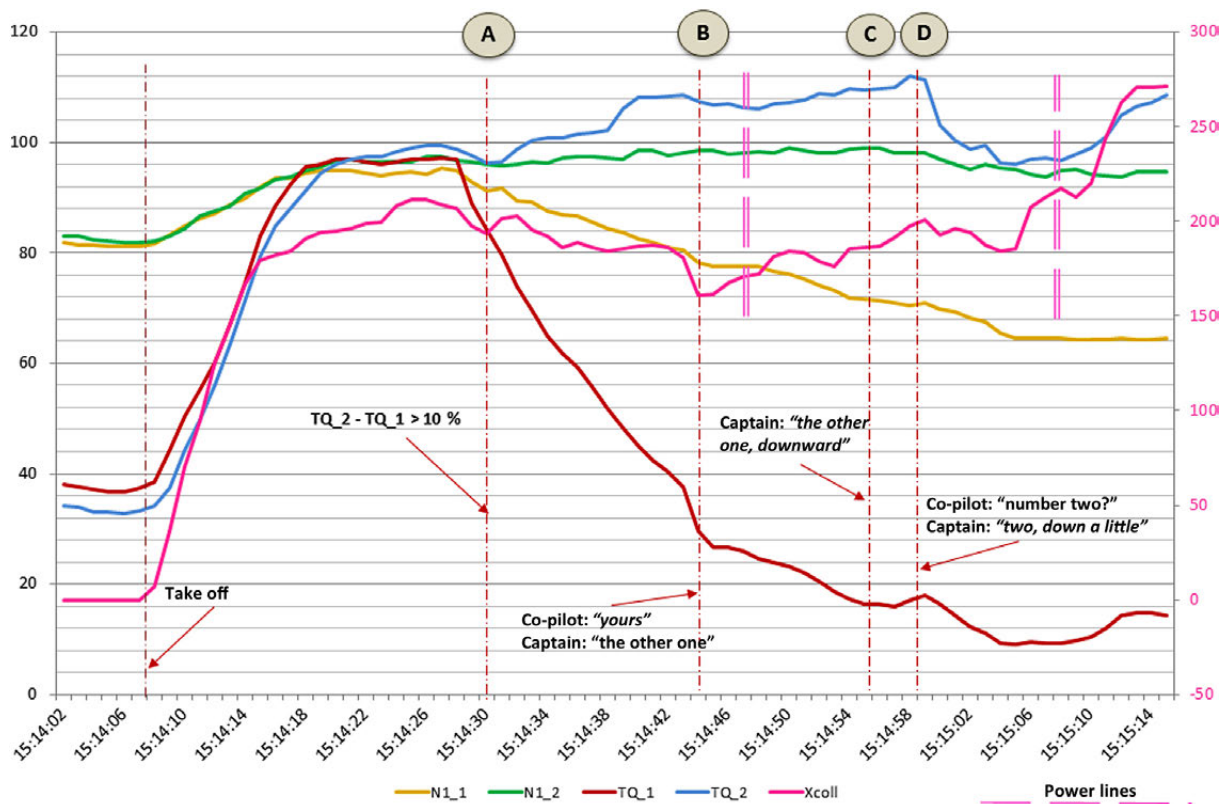
Figure 5. Significant flight events

Figure 5 shows the communications that took place in the cockpit and the flight data recorded.

Once the torque TQ\_1 dropped to point A, the crew recognized the emergency, though no dialogue took place between the crewmembers. The pilot flying stated seeing yellow warning lights on the instrument panel, possibly involving GOV MAX.

The torque on the #2 engine (TQ\_2) increased gradually and automatically to a value of 109%, point B, in keeping with the design characteristics of its control system. The pilot in the «1» position transferred control to the captain. The N1 value continued to fall on the #1 engine.

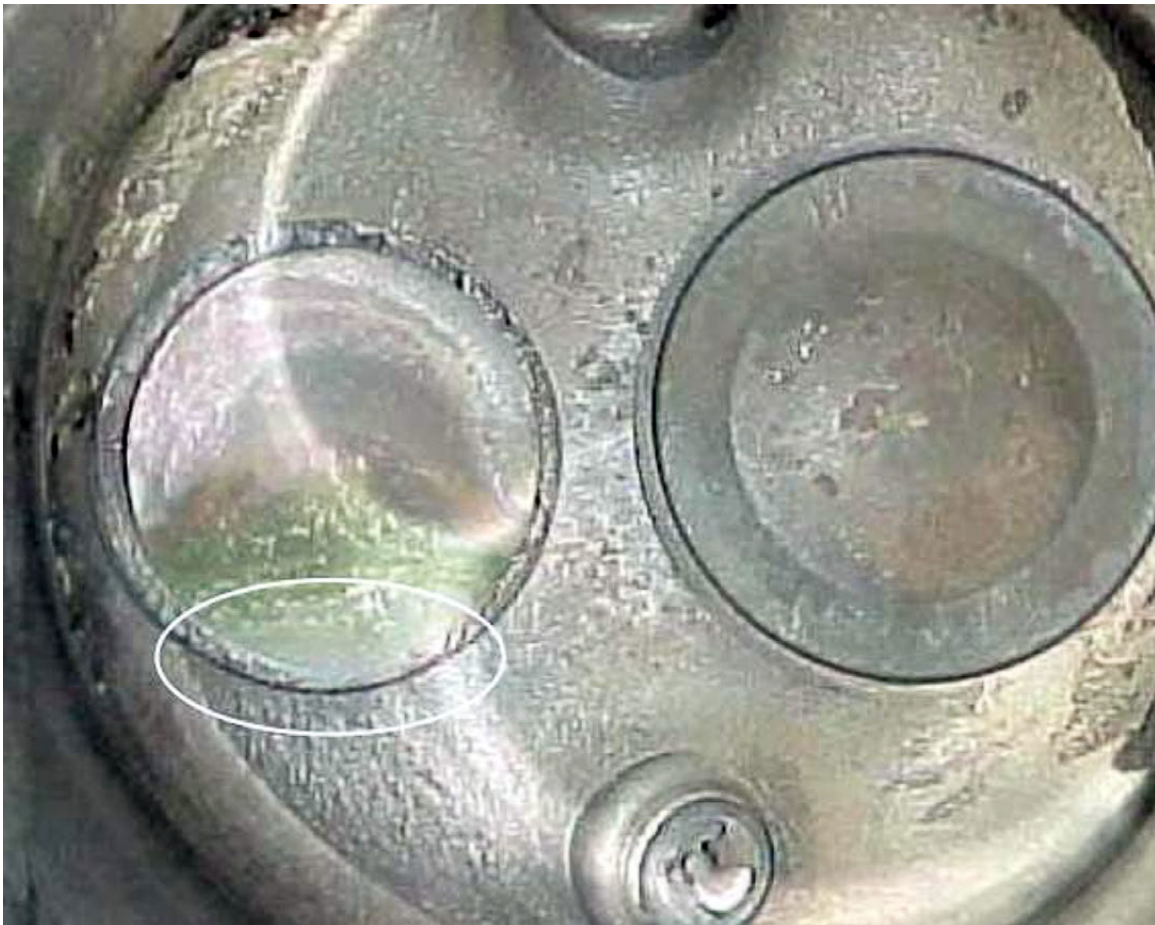
TCM's metallurgical analysis confirmed that the engine, a Teledyne Continental Motors TSIO 520-M7B, S/N 532404, failed due to thermal fatigue of the fractured valve. Several conditions can contribute to this fatigue if they are repeated over a prolonged period of time:

Figure 7. Taken from SB03-03 by TCM. Shows a burned exhaust valve with signs of leakage and damage

Even without knowing exactly how the failure initiated, it can be surmised that since it only affected one cylinder, the cause must be related to a unique feature of that cylinder and its assembly or adjustments. In light of the evidence found, it is very likely that an improperly seated exhaust valve causing leakage through that valve (see Figure 7) resulted in the initial degradation and loss of material around the perimeter of that valve's head (see Figure 3).

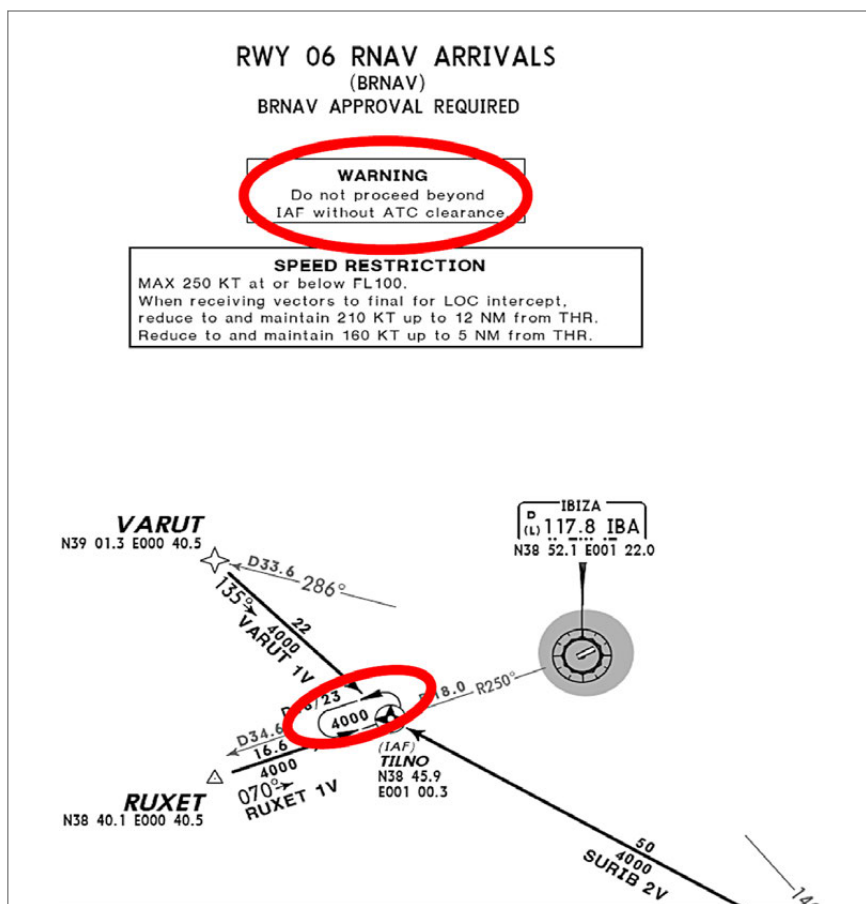
Figure 2. Portion of Jeppesen chart 10-2G

As indicated on the flight plan for aircraft CS-DNP, the standard arrival (STAR) planned for the day of the incident was STAR VARUT1V, published in the AIP Spain in chart AD2-LEIB STAR 1.2. Onboard the aircraft was the Jeppesen 10-02G chart for Ibiza, corresponding to the instrumental standard terminal arrival route for runway 06 at the Ibiza Airport. This chart warns not to proceed beyond the IAF without ATC clearance. It also lists the minimum hold altitude over IAF TILNO as 4,000 ft.

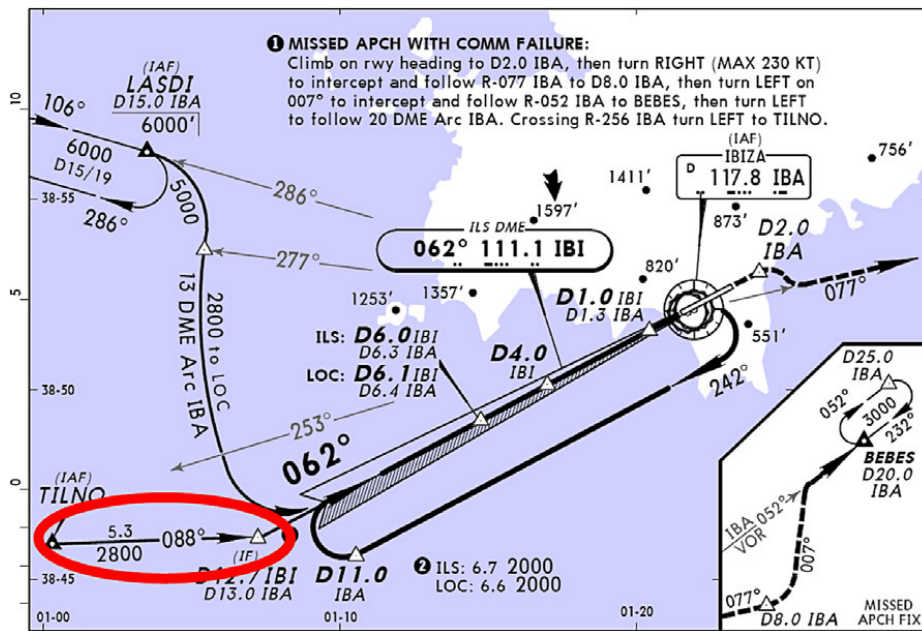
Figure 3. Portion of Jeppesen chart 11-1

The ILS instrument approach procedure for runway 06 at LEIB is published in chart AD 2-LEIB IAC/1 of the AIP Spain. Aircraft CS-DNP had onboard Jeppesen chart 11-1, corresponding to the IAC for runway 06 at Ibiza. Both charts establish the heading to fly after leaving the IAF TILNO as 088° until the intermediate fix (IF) is reached.

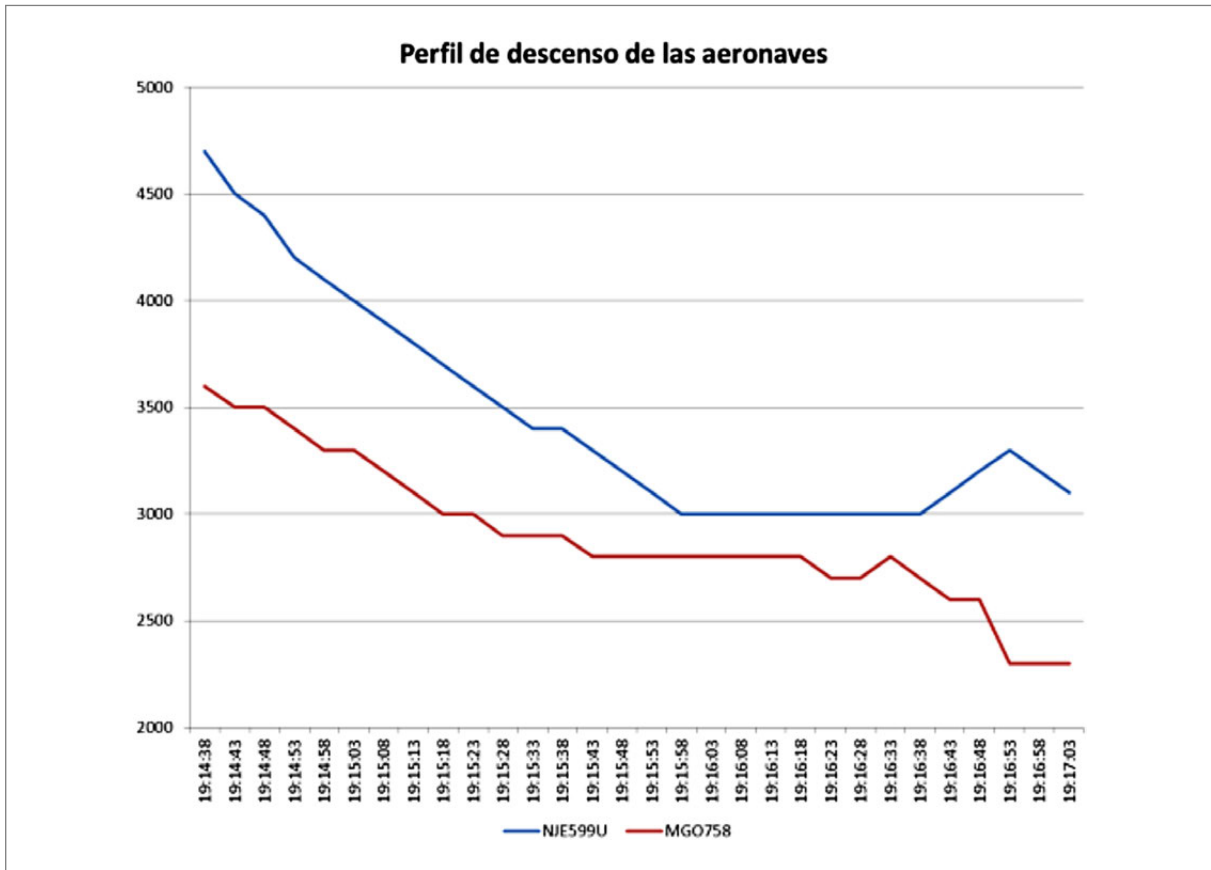
Figure 4. Descent profiles of aircraft NIE599U and MGO758

The closest point of approach was at 19:16:38, with the two aircraft closing to within 1.2 NM horizontally and 300 ft vertically of each other. Aircraft CS-DNP was at an altitude of 3,000 ft on an easterly heading while turning to HDG 160° as instructed, and aircraft EC-JIL was descending through 2,700 ft heading west.

Five seconds later, aircraft EC-JIL was turning right and descending through 2,600 ft, while aircraft CS-DNP was climbing through 3,100 ft.

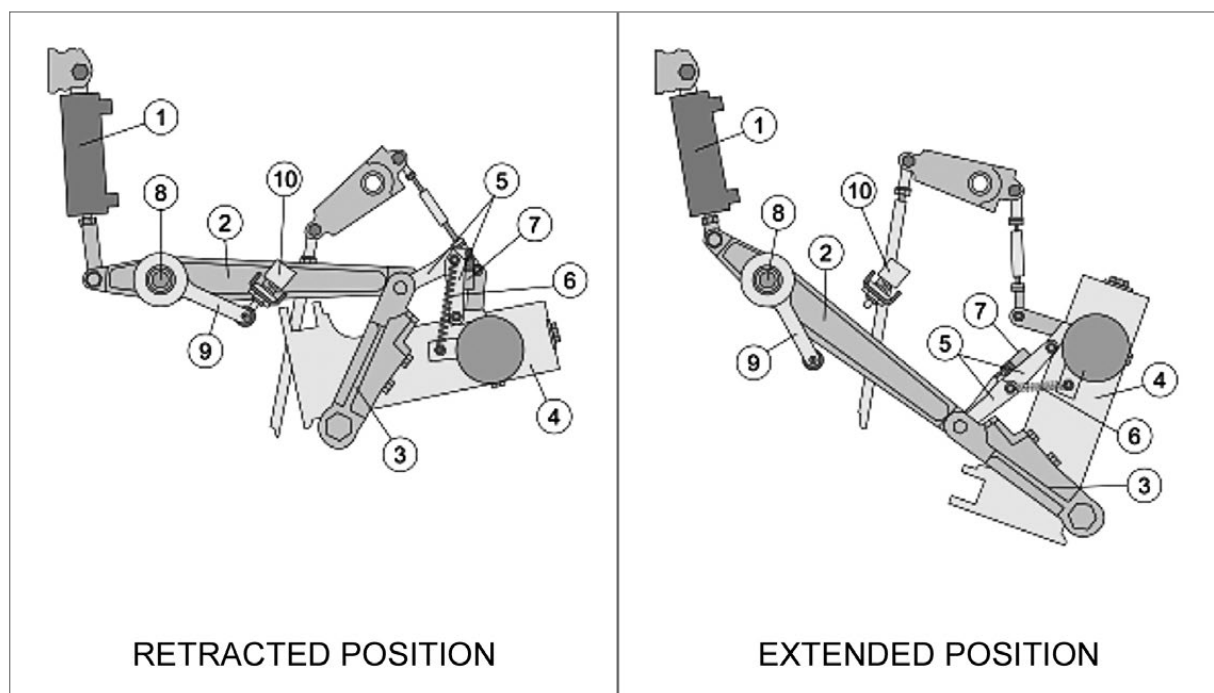
Figure 1. Diagram of the nose gear

The landing gear is hydraulically operated. The nose gear (Figure 1) is retracted by the action of a hydraulic actuator (item 1) which, when it extends, swing the upper drag link (item 2), which in turn drags the lower link (item 3), and with it the leg (item 4). There is no way to lock the gear in the retracted position, meaning that a loss of hydraulic pressure will cause it to drop due to gravity. When the hydraulic pressure is released from the cylinder, the weight of the leg compresses the stem on the actuator and the leg extends. Once this happens, an overcenter (item 5) keeps the two drag links aligned, keeping them from folding and the leg from retracting. A spring (item 6) stretches the overcenter to keep it locked.

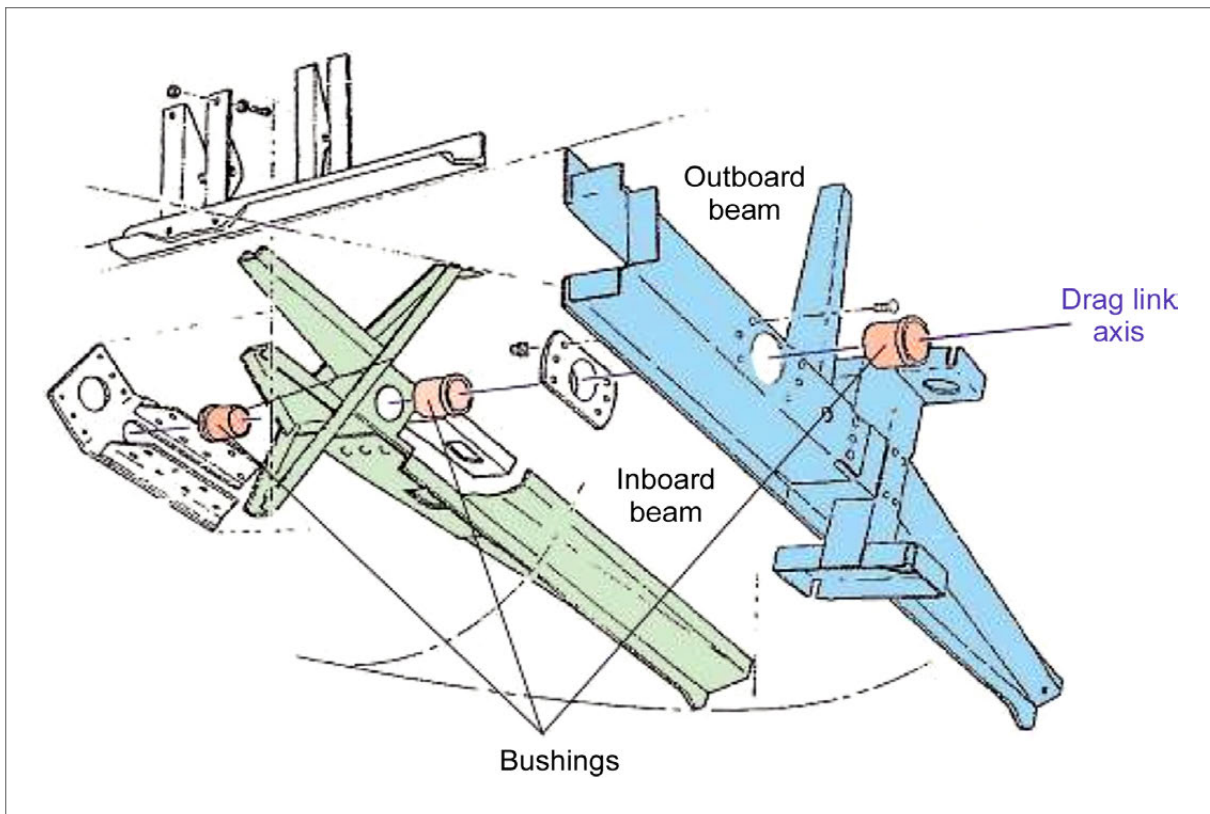
Figure 2. Anchoring beams for the axis of the main drag link

The rotating axis of the upper drag link (item 8) is screwed to the link itself and it rotates inside bushings housed in two U-shaped beams that are fixed on either side of the left landing gear bulkhead by means of rivets (Figure 2). Mounted at the outer end of the axis is a cam (item 9) that, when the gear retracts, makes contact with a micro-switch (item 10) that then sends the gear-up signal.
