Report ULM A-005/2015

Accident involving an Air Creation
Kiss 450 GTE 582S aircraft,
registration EC-LGM, at the
Casarrubios del Monte aerodrome
(LEMT-Toledo, Spain) on 24 April 2015

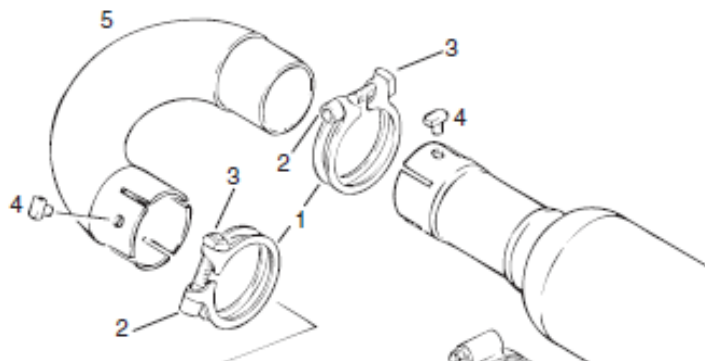
Figure 1. Union elbow assembly

- The union elbow between the muffler and the after-muffler must be attached to these two parts by means of clamps.

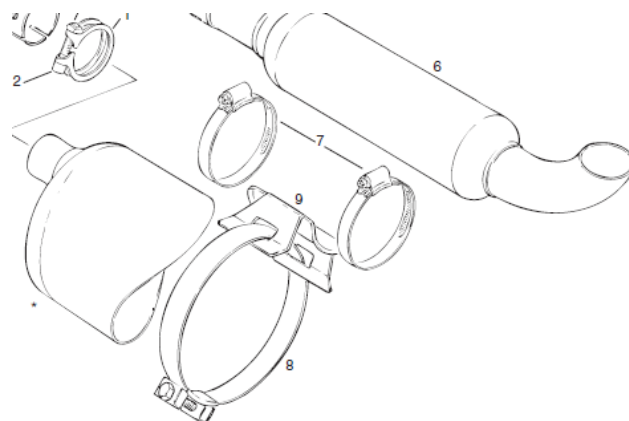
Figure 3. Layout and attachment of muffler and after-muffler

- A butterfly-shaped part supports the muffler and after-muffler to avoid vibrations. This part is attached to each of the components using clamps.
