Report A-017/2015

Accident involving a TECNAM P2002JR
aircraft, registration EC-KQG, at the
Griñón airfield (Madrid) on 30 June 2015

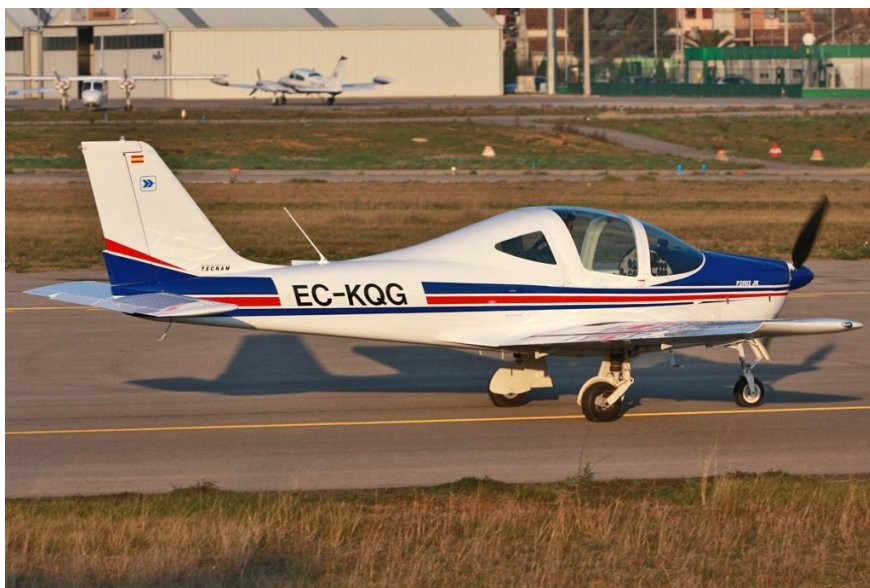
Photograph 2. Photograph of the aircraft⁴

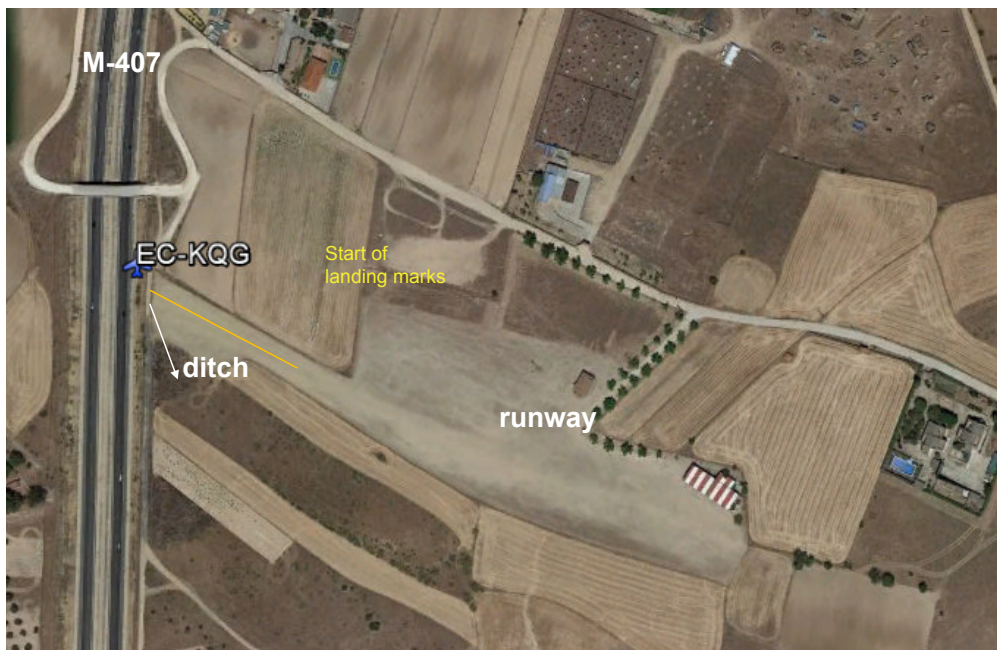
The Griñón airfield (currently closed) is located some 25 km southwest of the city of Madrid, at coordinates N 40°13'31" W 3°51'55". It is at an elevation of 2198 ft. It has one 434-m long runway in a 12/30 orientation (see Figure 4). The accident aircraft landed on runway 30.

Photograph 4. Aerial view of the Griñón airfield
