Report IN-033/2015

Incident involving an Airbus A-330-300,
registration EC-LZX, operated by Iberia,
and a Boeing B-777-200,
registration N758AN, operated by
American Airlines, at the Adolfo Suárez
Madrid-Barajas Airport (Spain)
on 6 December 2015

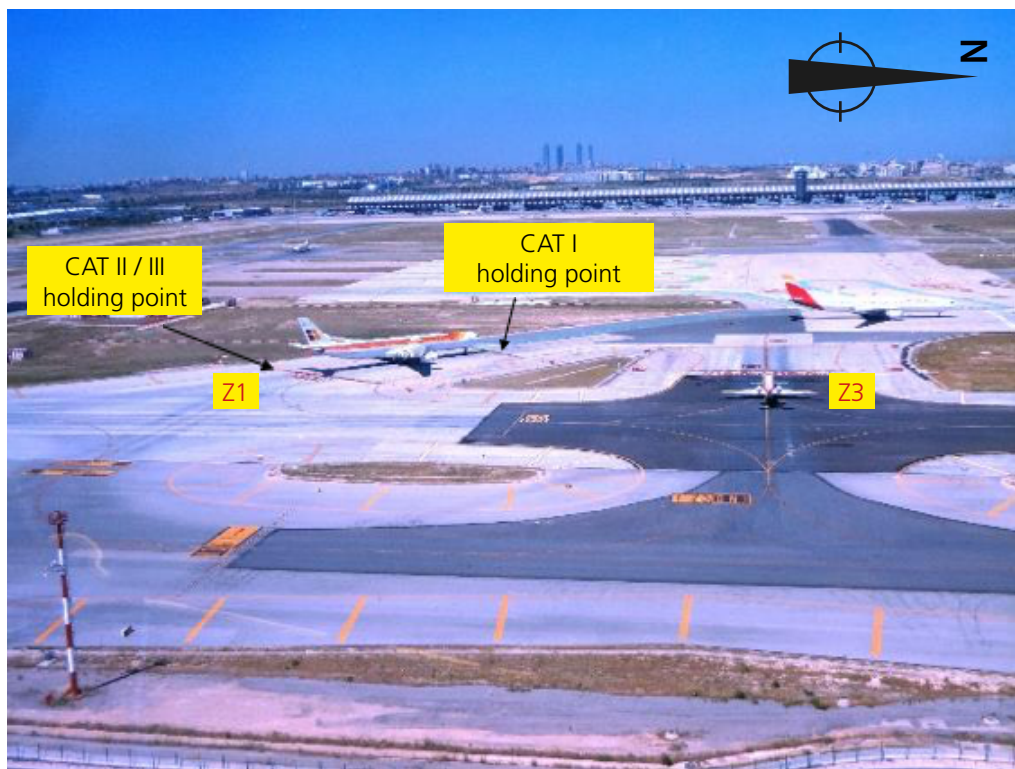
Figure 9. Photograph of taxiways Z1 and Z3, taken from the GMC-EN post in the control tower

Figure 9 shows a photograph of the incident site, taken from the GMC-EN post in the control tower. Labeled on the figure are taxiways Z1 and Z3, as well as the CAT I and CAT II/III holding points on taxiway Z1.

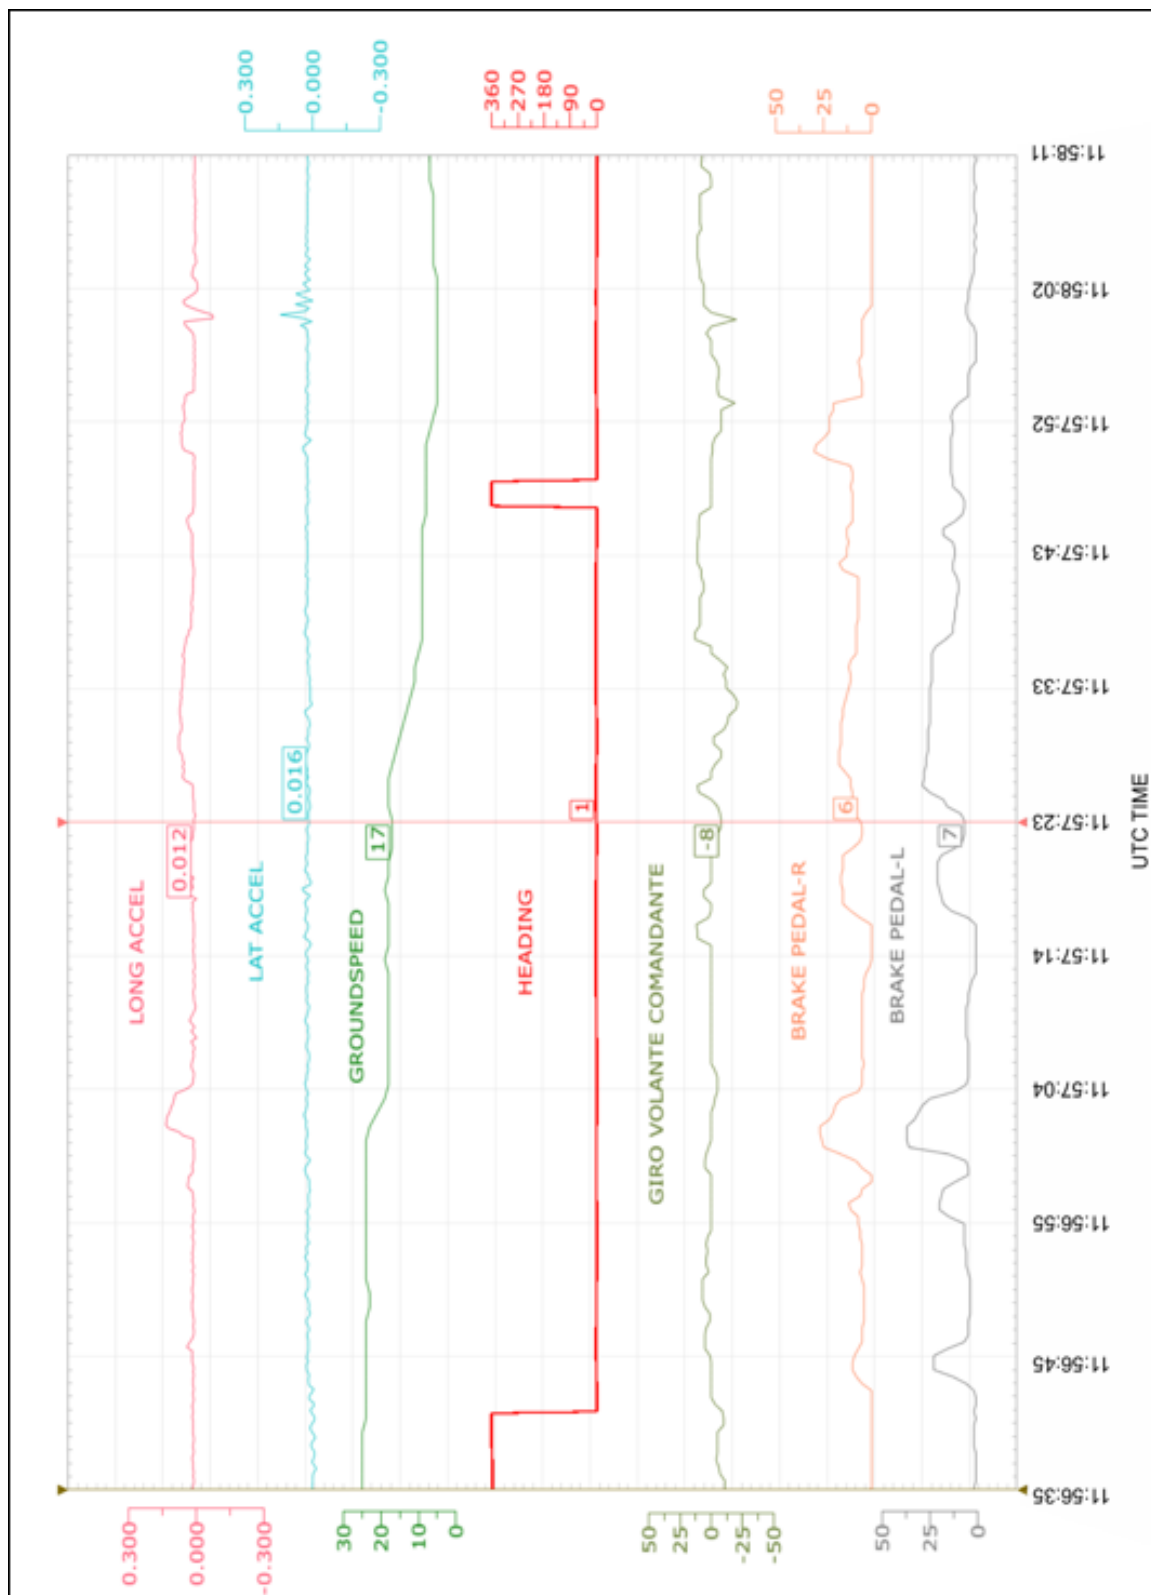
Figure 11. Graph with several parameters from aircraft EC-LZX

The graph in Figure 11 shows the captain's inputs to the brake pedal, as well as the trend in the aircraft's speed, from 11:56:39 until 11:58:11, which was 12 seconds after the collision.

At 11:57:59, another increase in lateral acceleration was recorded, peaking at 0.145 g.

The brake pedals were not activated at any time during the period from 11:57:54 and 11:58:31.

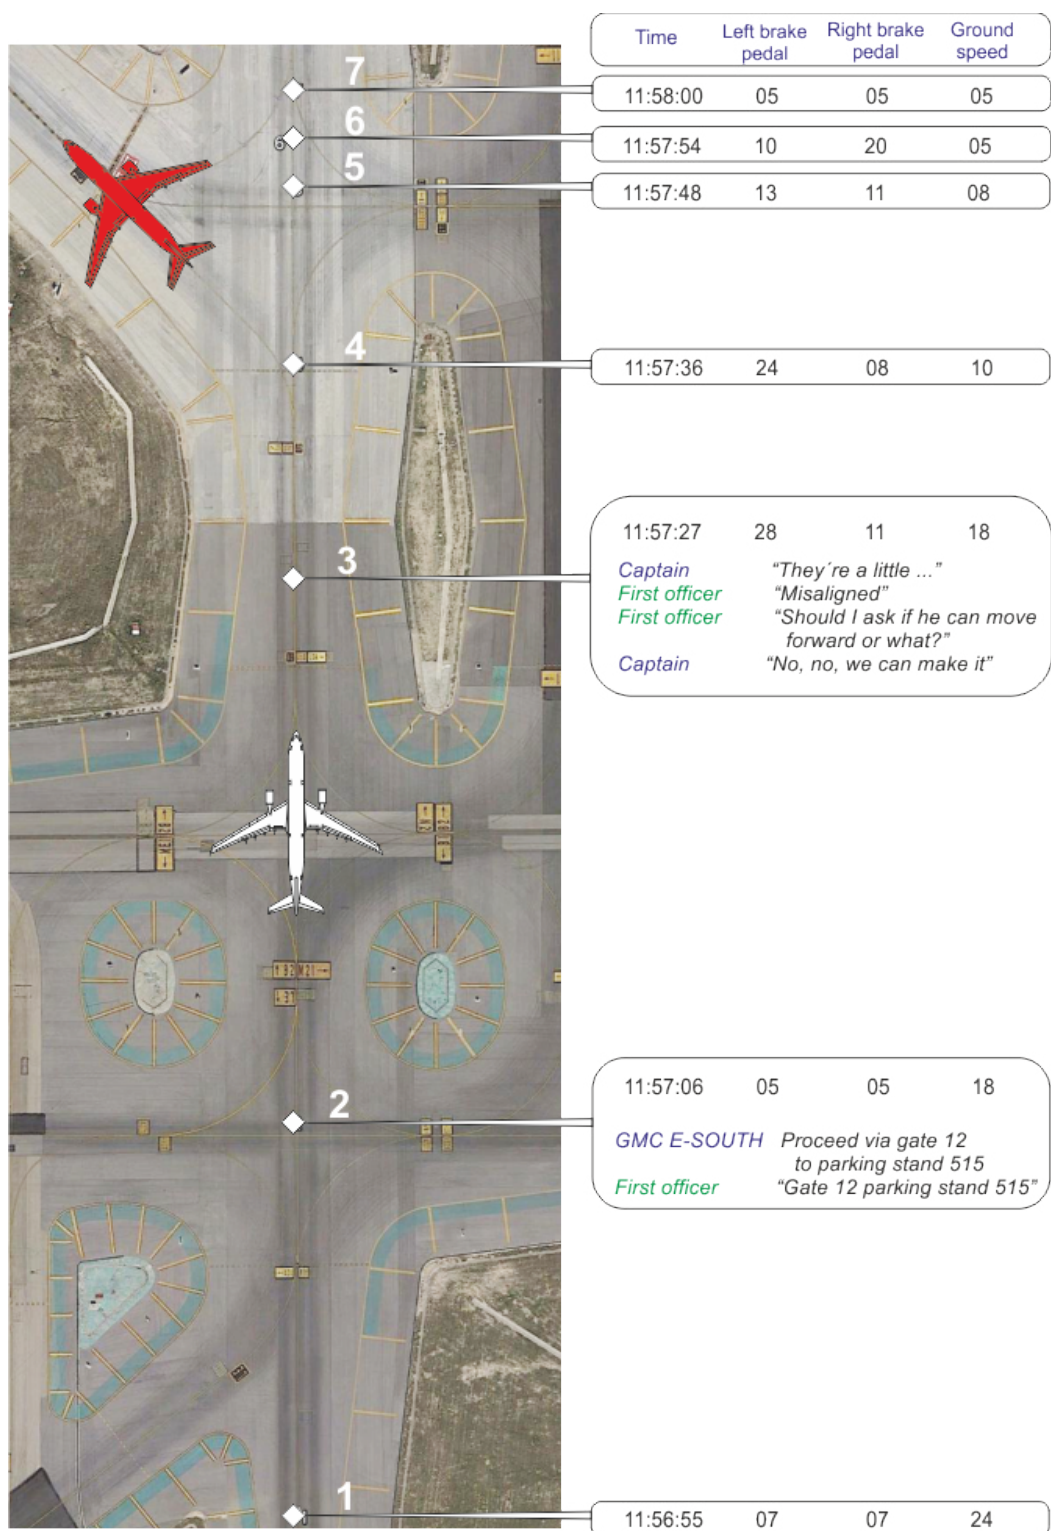
Figure 12. Detail from taxi phase of aircraft EC-LZX on taxiway B

Figure 12 shows the position of the aircraft at different times as it was taxiing on runway B. For each time, the table shows the degree of deflection for each brake pedal, the aircraft's speed and the conversations in the cockpit.

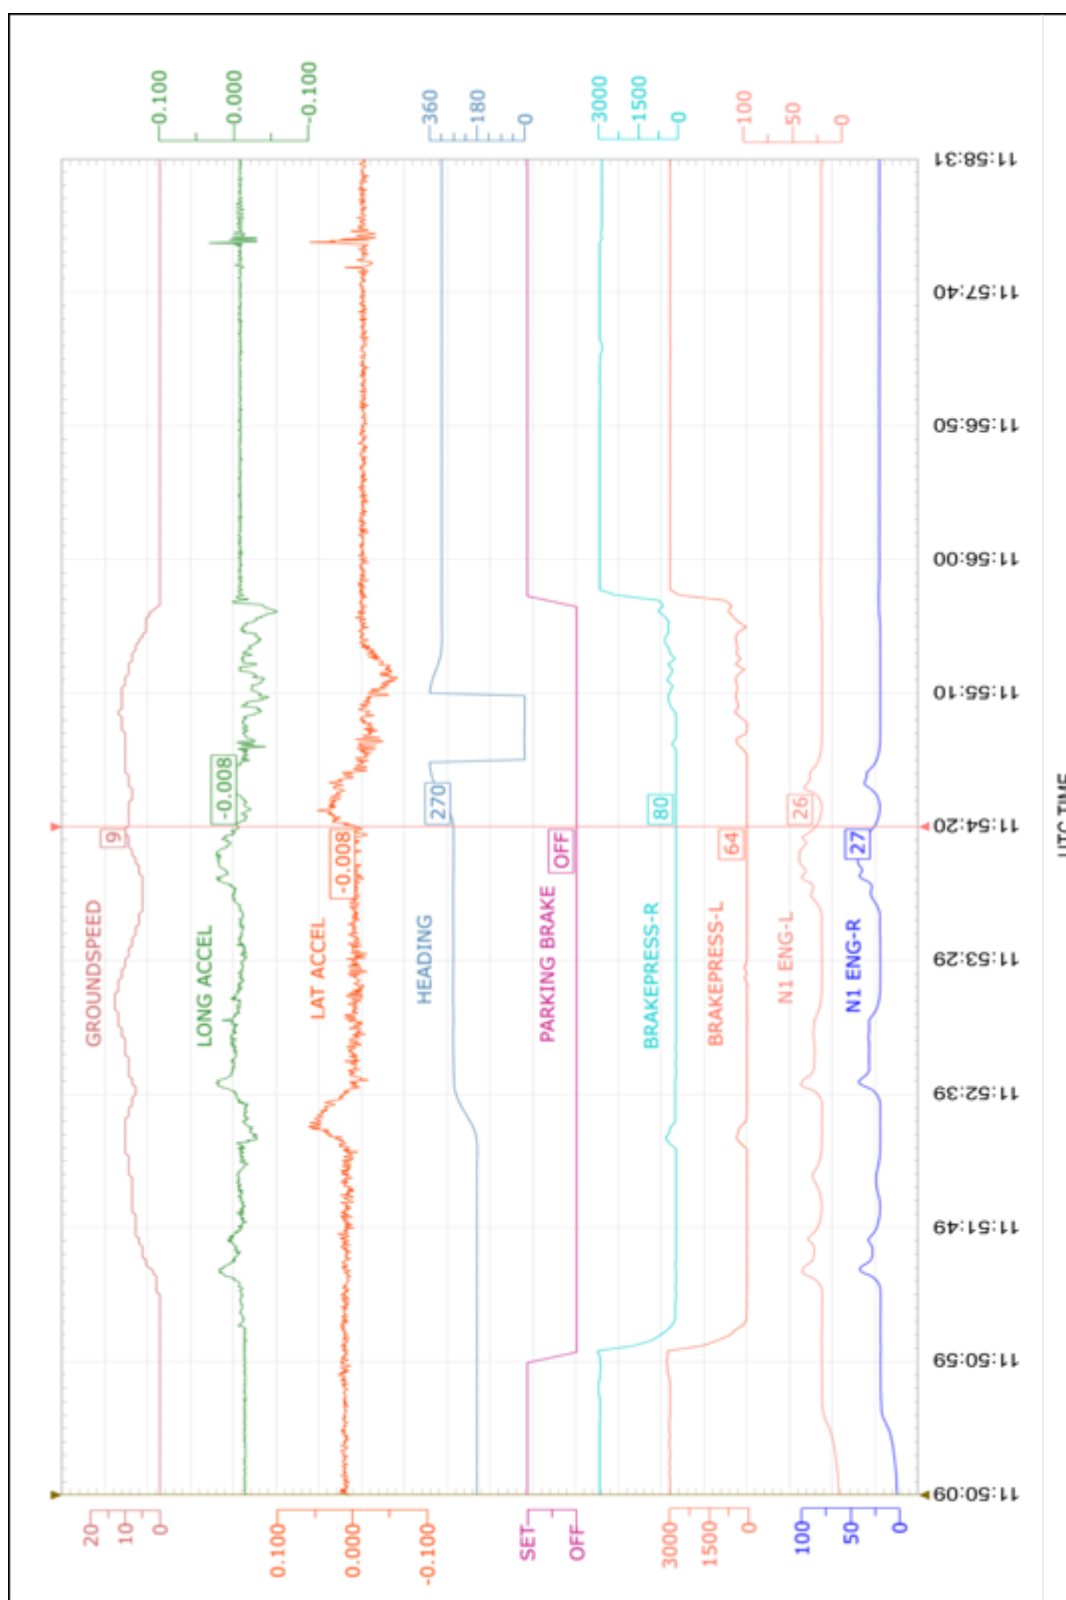
Figure 13. Graph of several parameters for aircraft N758AN, from 11:50:09 to 11:58:31 UTC

Figure 13 shows a graph with the trend for several parameters: ground speed, longitudinal and lateral accelerations, heading, parking brake, brake pressure (left and right) and engine speed (N1), spanning from 11:50:59 until 11:58:31 UTC.

At 11:55:10, the aircraft started a left turn to course 314°. The aircraft continued on this heading until 11:55:43, when it stopped.

At 11:57:51, a slight increase in the longitudinal acceleration was recorded, as was a larger increase in the lateral acceleration, which peaked at 0.025 g (see Figure 13).

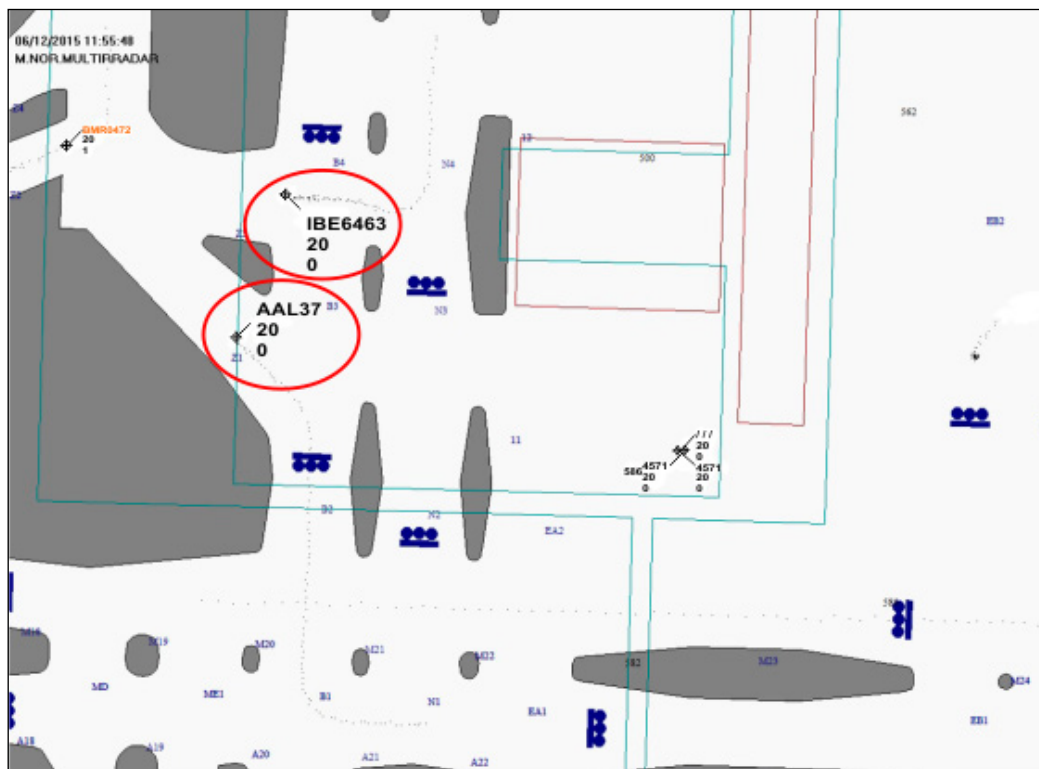
Figure 17. Multilateration radar image from 11:55:48

At 11:55:48, aircraft AAL37 stopped inside taxiway Z1. It did not move until after the incident. Aircraft IBE6463 was still stopped at the entrance to taxiway Z3.

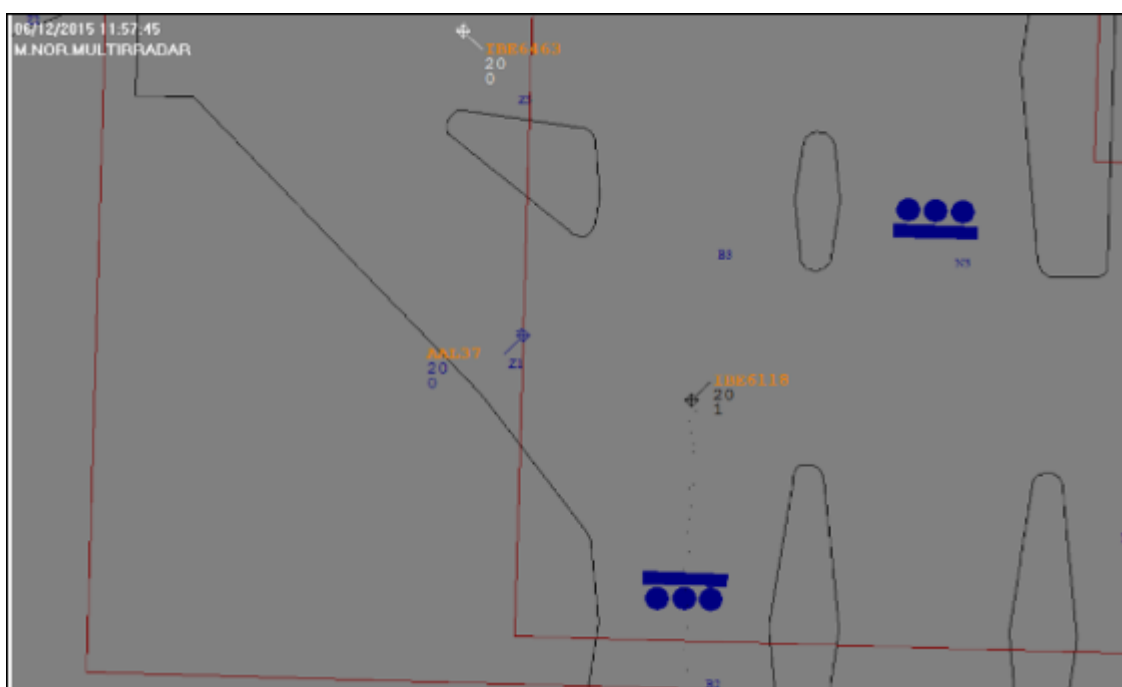
Figure 18. Multilateration radar image from 11:57:45

The image in Figure 19 shows a section of the radar screen from 11:57:45 UTC, which is practically the same time when the event occurred. This image shows that aircraft IBE6463 was closer to runway 18R-36L than aircraft AAL37 was.

In his statement, the captain indicated that he stopped the aircraft at that position in Z1 far enough away to ensure safe separation with another aircraft that was at Z3, and which preceded them in the takeoff order. The crew are not heard making any comments in this regard in the cockpit voice recorder. In addition, the multilateration display (Figure 18) shows that AAL037 reached point Z1 before IBE6463 reached holding point Z3.
