**COMISIÓN DE
INVESTIGACIÓN
DE ACCIDENTES
E INCIDENTES DE
AVIACIÓN CIVIL**

Report A-006/2016

Accident involving a Cessna 172 P,
registration EC-LSY, in Las Muelas,
Segura de la Sierra (Jaen, Spain)
on 9 February 2016

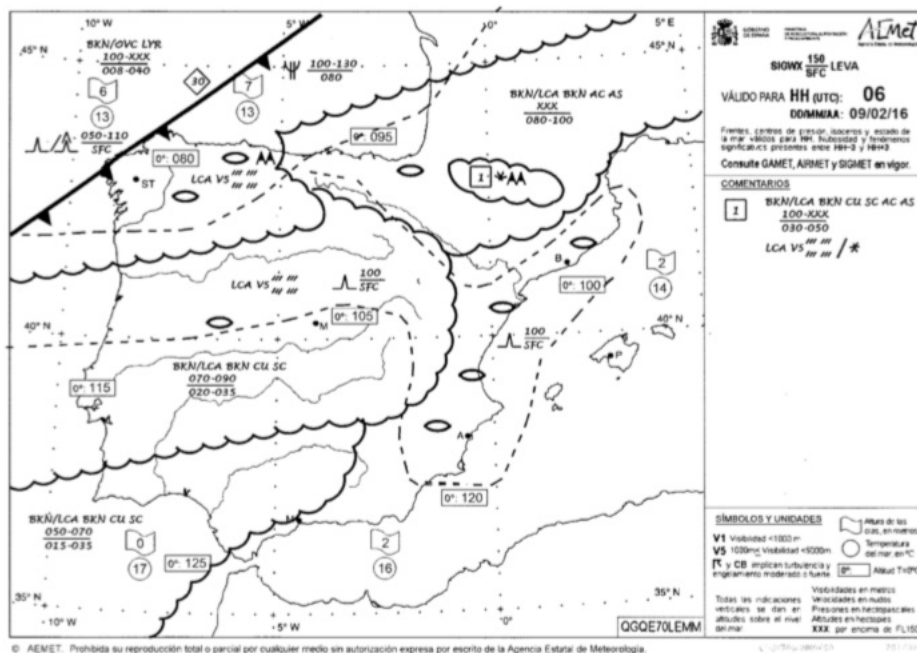
All of these conditions are detailed in the 06 UTC, 12 UTC and 18 UTC low-level maps, which also forecast orographic or mountain waves³ in the east of Spain, that is, the area where the flight was taking place.

Figure 1. Low-level map for 07:00 local time

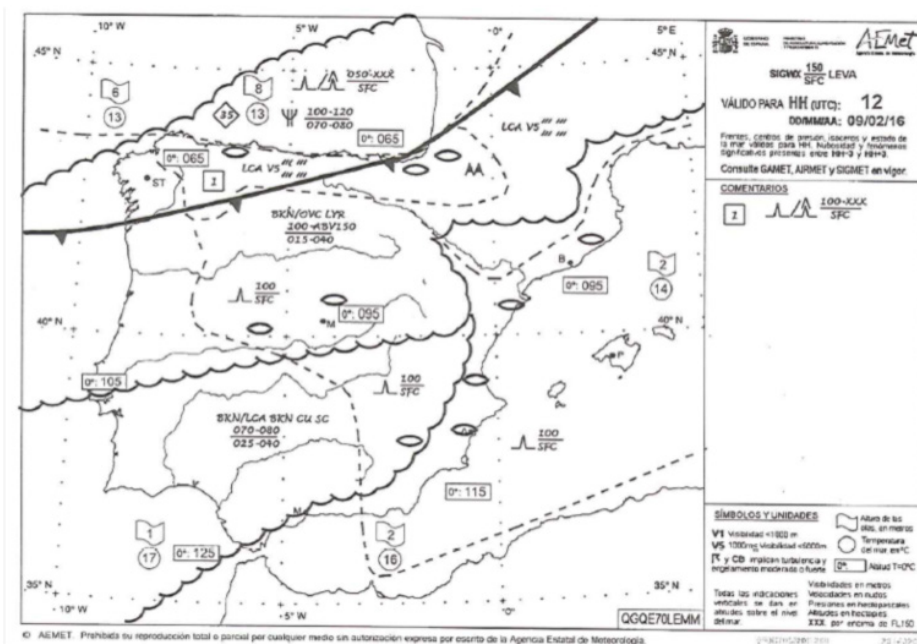
Figure 2. Low-level map for 13:00 local time

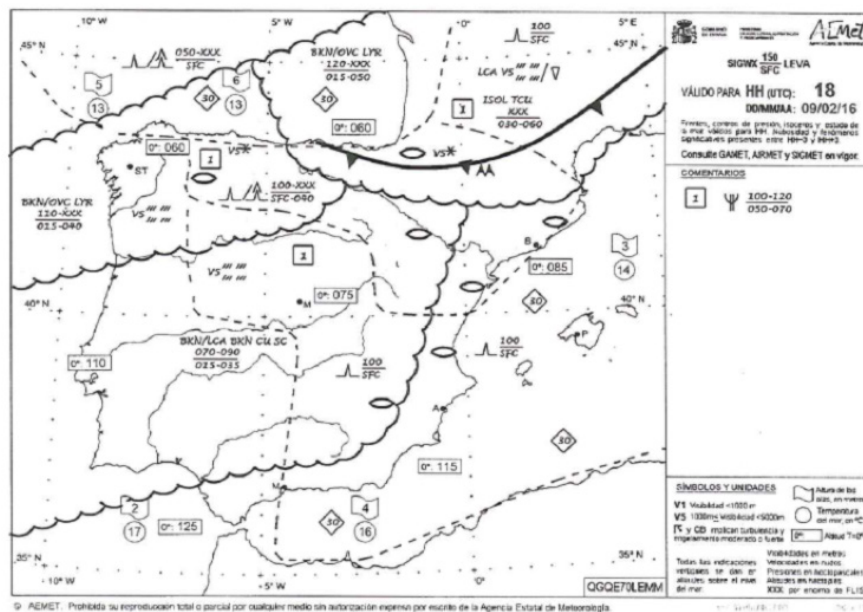
Figure 3. Low-level map for 19:00 local time

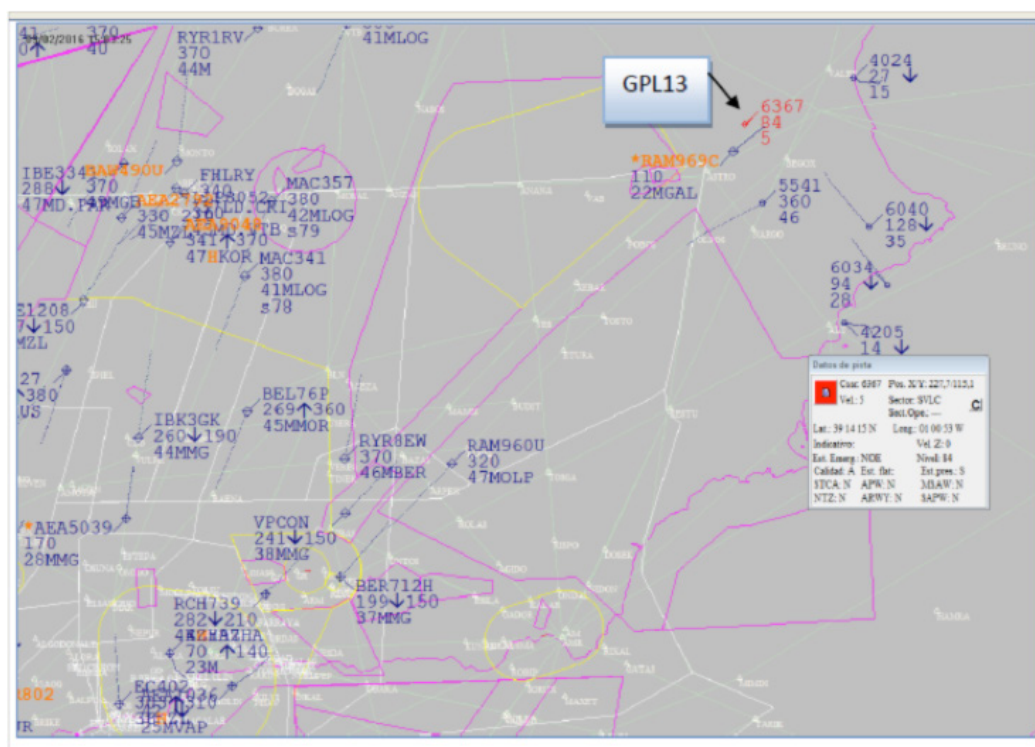
At 16:03:25, the aircraft, after taking off from the Valencia airport, was flying at an altitude of 8,400 ft at a ground speed of 50 knots.

Figure 4. Aircraft's position at 16:03:25

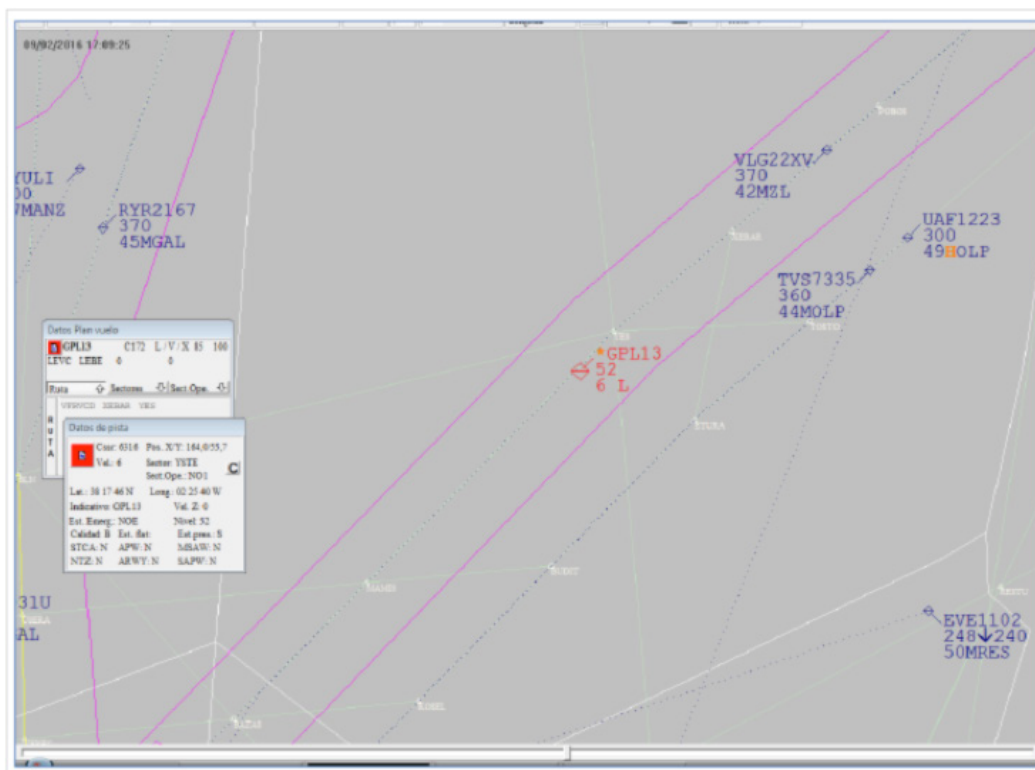
At 18:09:25, the aircraft was at flight level 52 with a ground speed of 60 knots.

Figure 5. Aircraft's position at 18:09:25

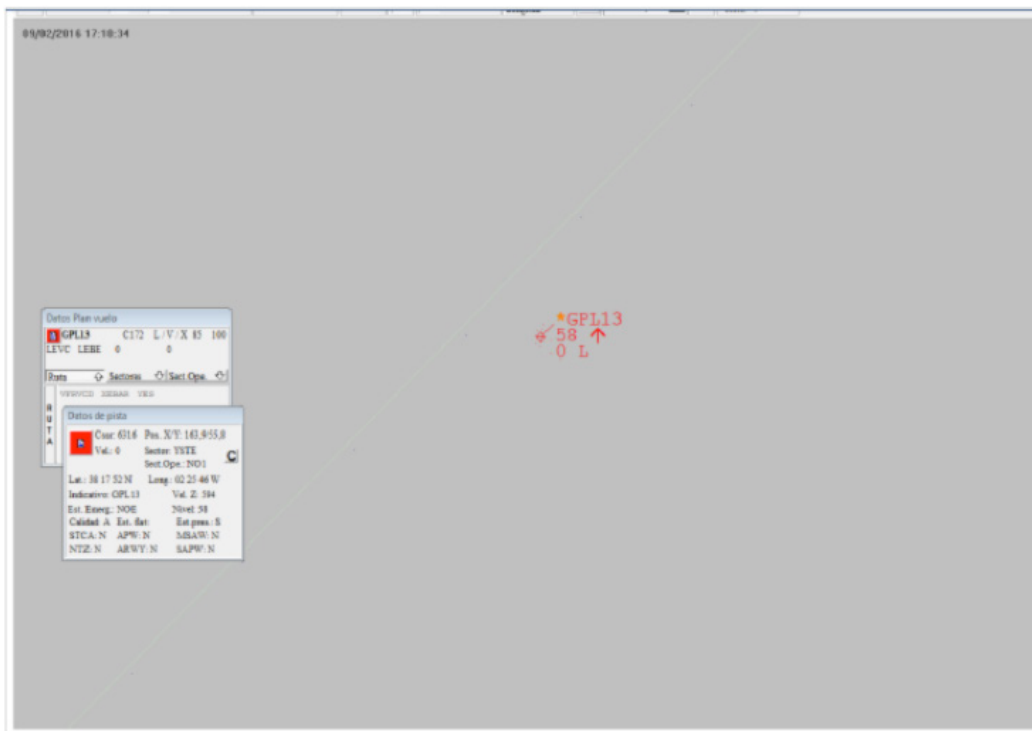
At 18:10:34, its ground speed was 0 knots.

Figure 6. Aircraft's position at 18:10:34

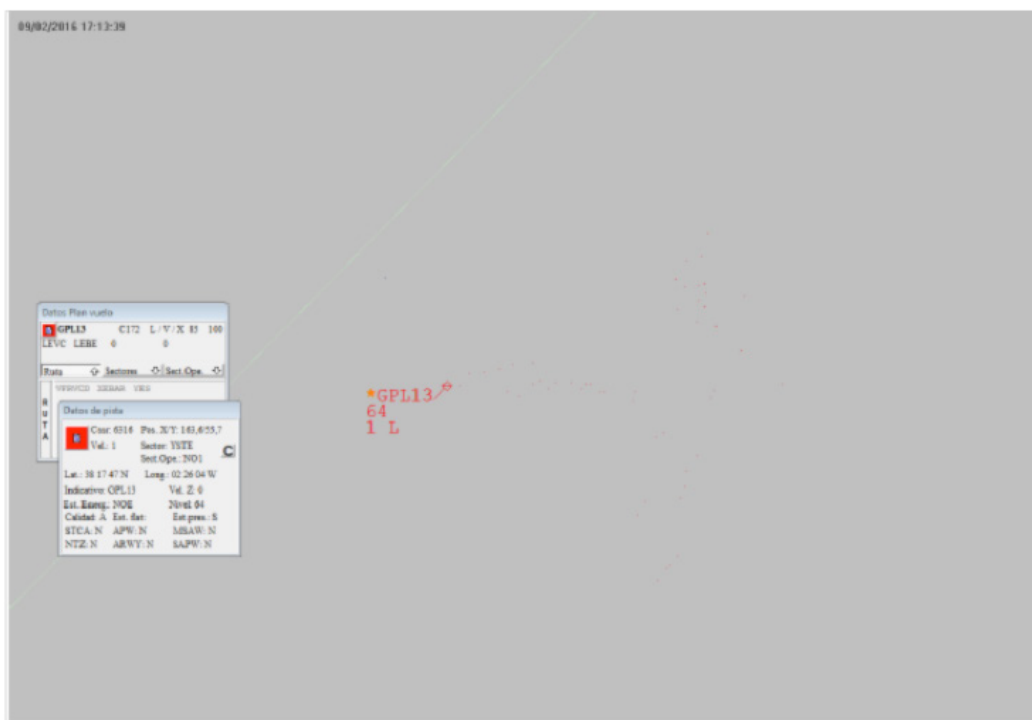
At 18:13:39, the aircraft's speed was 10 knots.

Figure 7. Aircraft's position at 18:13:39

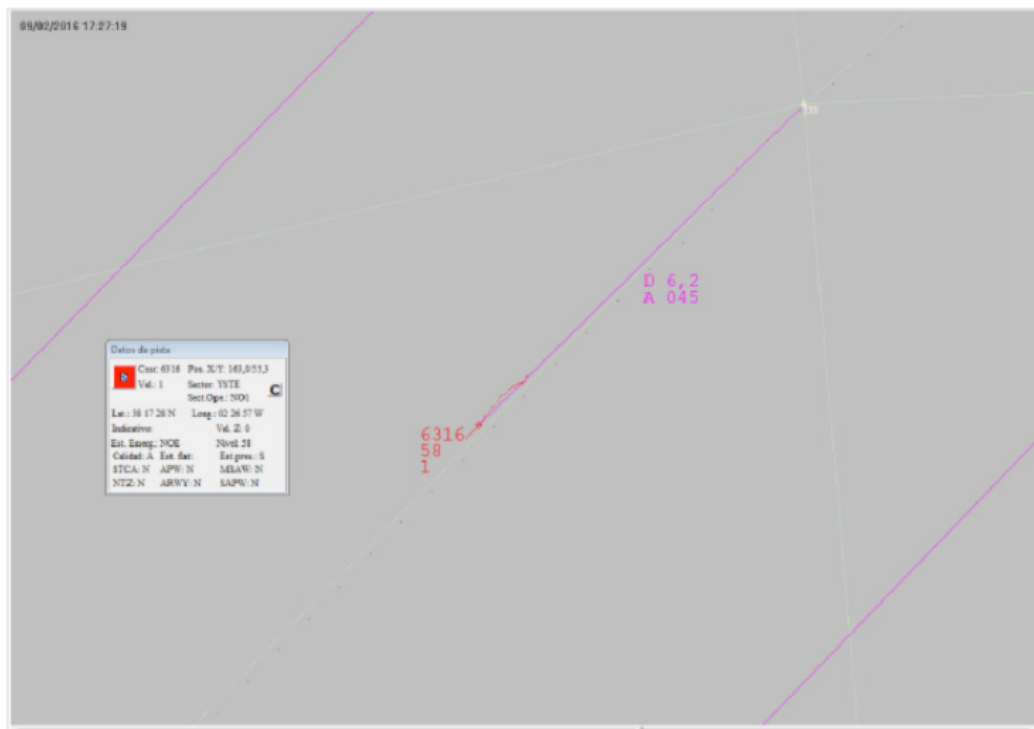
At 18:27:19, the aircraft's speed was still 10 knots.

Figure 8. Aircraft's position at 18:27:19

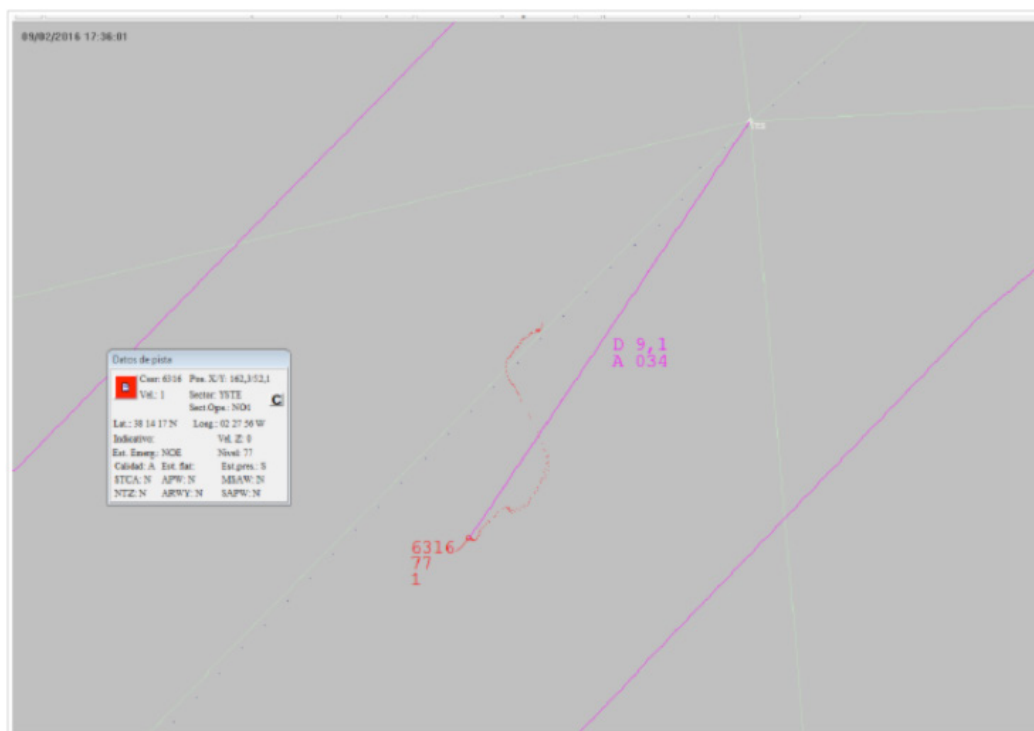
At 18:36:01, the aircraft's ground speed was still 10 knots.

Figure 9. Aircraft's position at 18:36:01

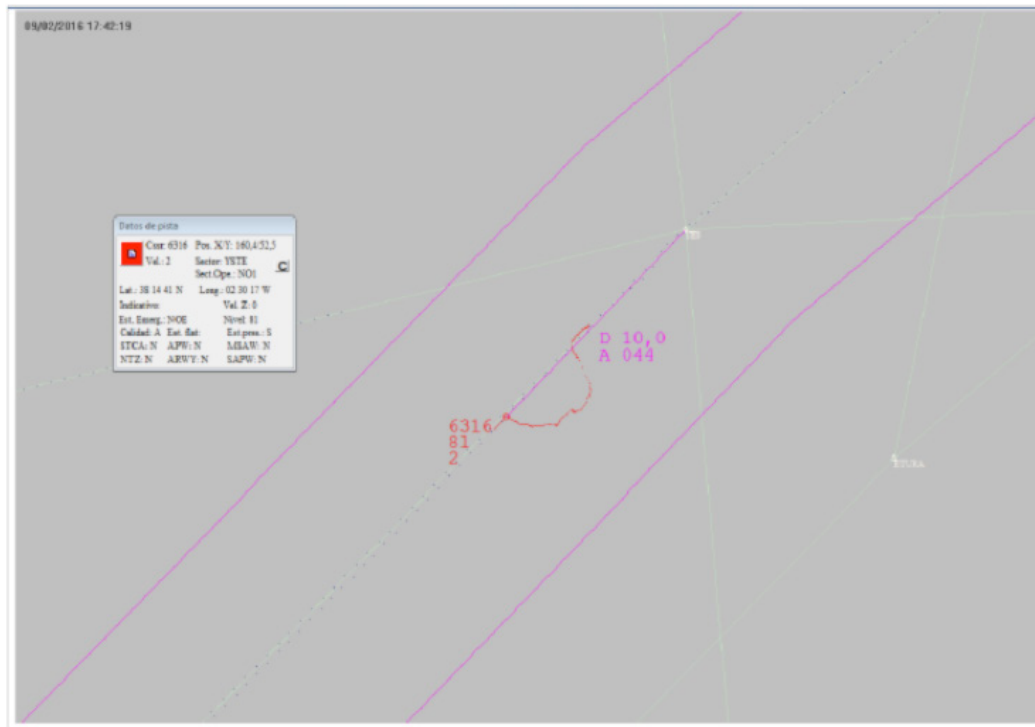
By 18:42:19, the aircraft's speed had started to increase and was on the order of 20 knots.

Figure 10. Aircraft's position at 18:42:19

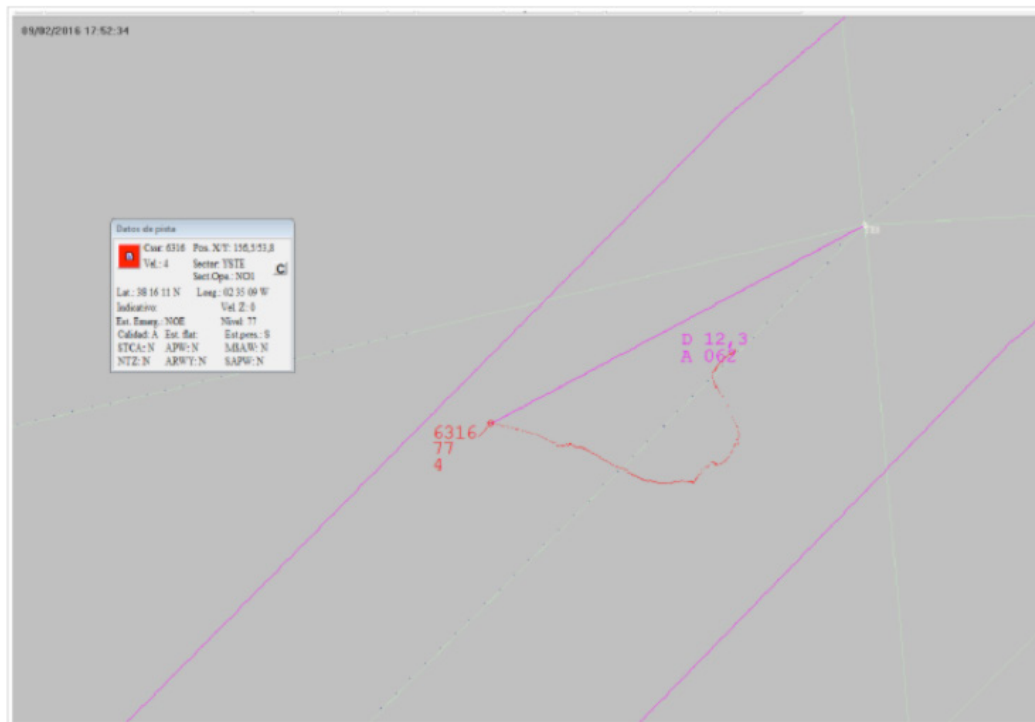
At 18:52:34, the aircraft's speed was continuing to increase, this time to 40 knots.

Figure 11. Aircraft's position at 18:52:34

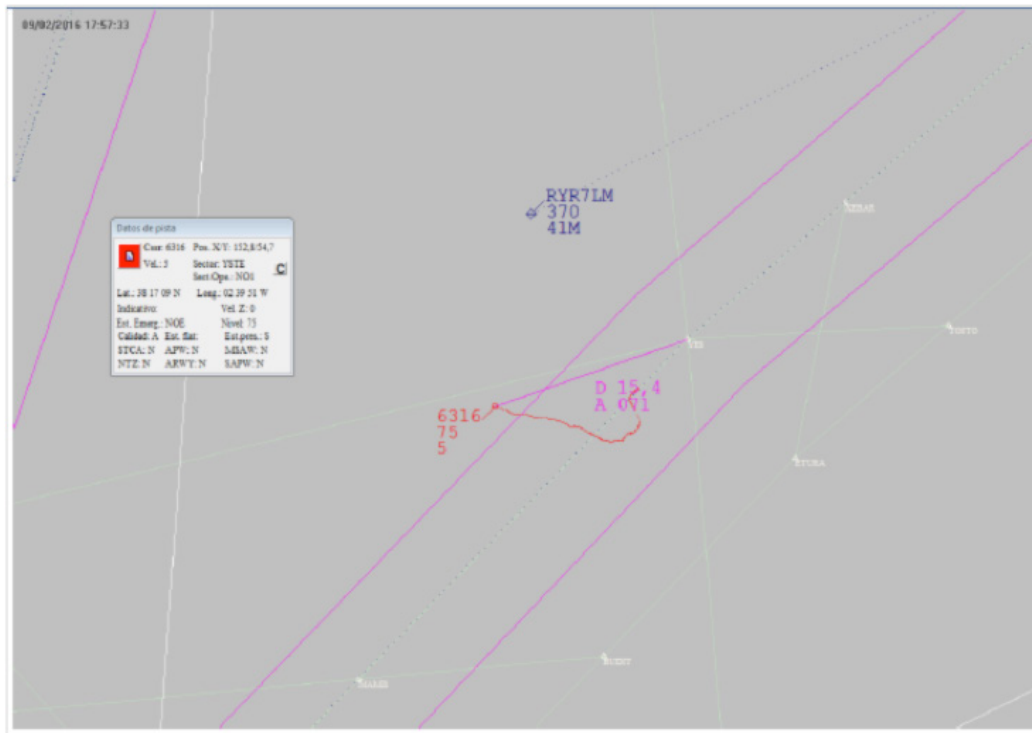
By 18:57:33, the aircraft's speed was 50 knots.

Figure 12. Aircraft's position at 18:57:33

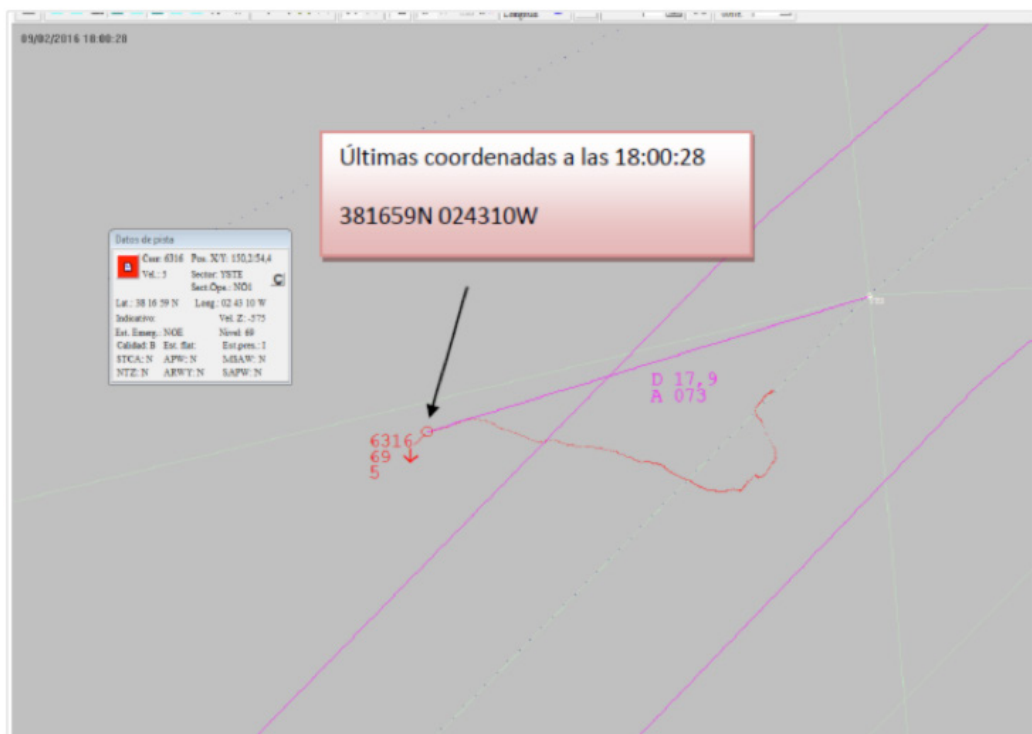
At 19:00:28, with the aircraft flying at flight level 69, descending and a speed of 50 knots, the radar track was lost.

Figure 13. Aircraft's position at 19:00:28

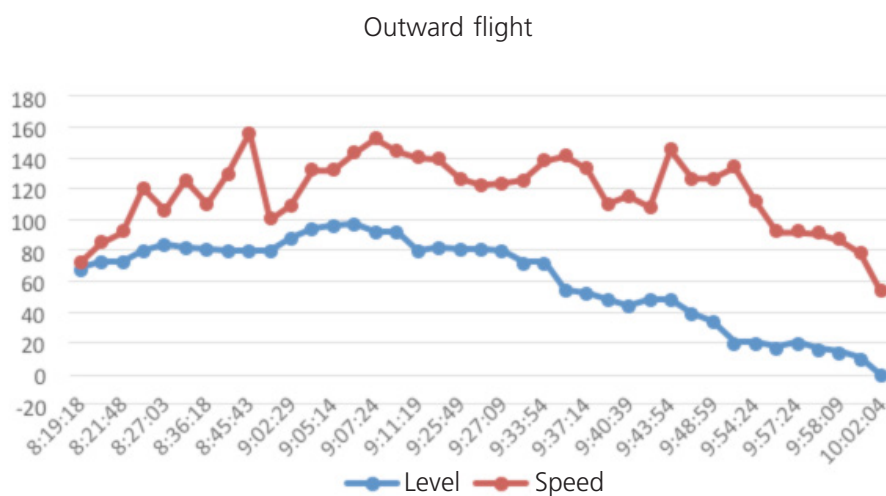
The level and speed, in knots, for the outward flight from the Granada to Valencia airports are provided in the figure below. The graph shows the flight profile between 08:19:18 and 10:02:04 local time.

The average cruise speed was 120 knots, higher than the 100-kt cruise speed indicated in the flight plan.

Figure 27. Flight level and speed on the outward flight
