## **Report IN-012/2016**

Incident involving a Boeing  
737-700 aircraft, registration  
PH-XRZ, operated by Transavia  
Airlines at the Barcelona-El Prat  
Airport (Spain) on 17 April 2016

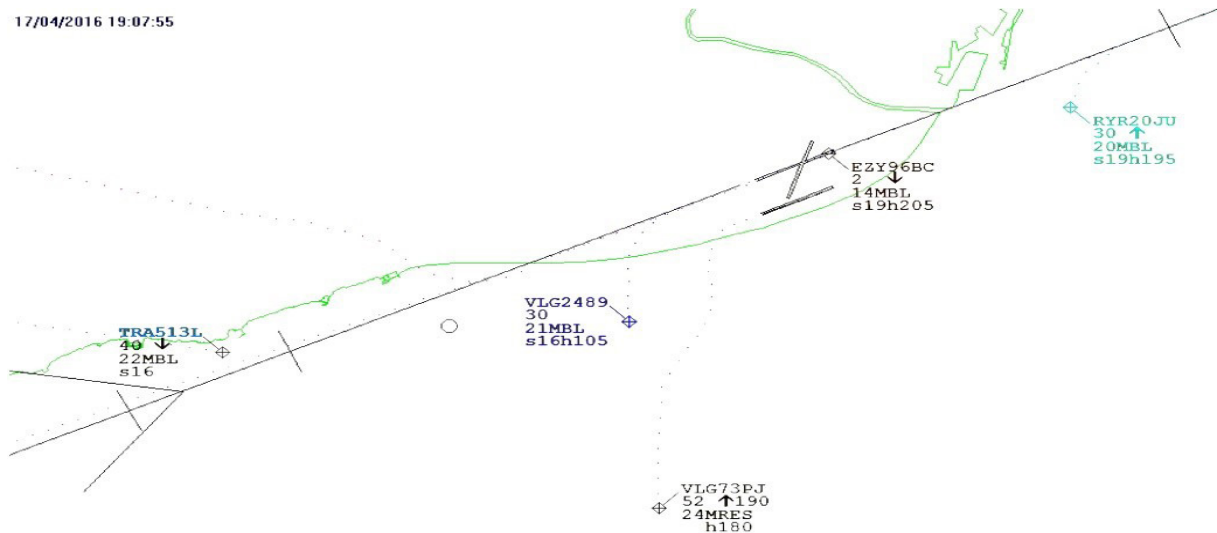
17/04/2016 19:07:55

At 19:08:23, the approach controller for sector T4 asked the Transavia crew to confirm intercepting the runway 07L localizer and instructed them to maintain 3000 feet, since there was an aircraft executing a go around at the opposite threshold. By then the aircraft had already descended below the specified altitude, and so the crew stopped the descent and climbed back to 3000 feet.

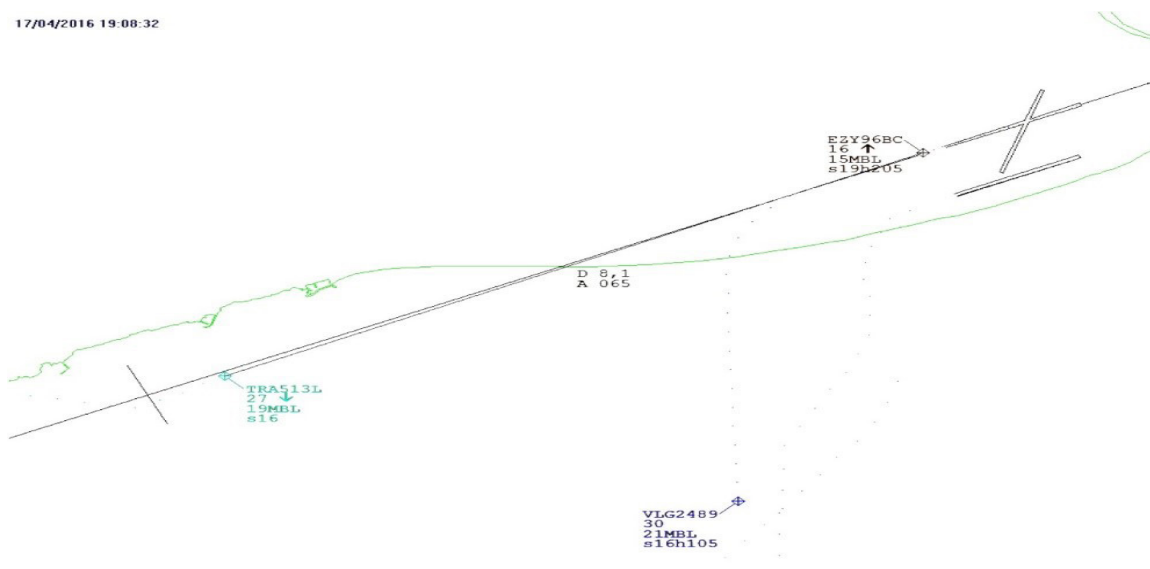
17/04/2016 19:08:32

At 19:08:29, the approach controller for sector T4, noticing that the EasyJet aircraft was going around, asked the local arrivals controller to immediately transfer the traffic, which the latter confirmed had already been transferred. At the same time, the Transavia crew reported returning to 3000 ft. At that point there was a moment of uncertainty as the two aircraft were facing each other and it was unclear which controller had the EasyJet on the frequency. The controller for sector T3 also asked the local arrivals controller to turn the traffic going around to the south, but the latter replied that it was no longer on his frequency.

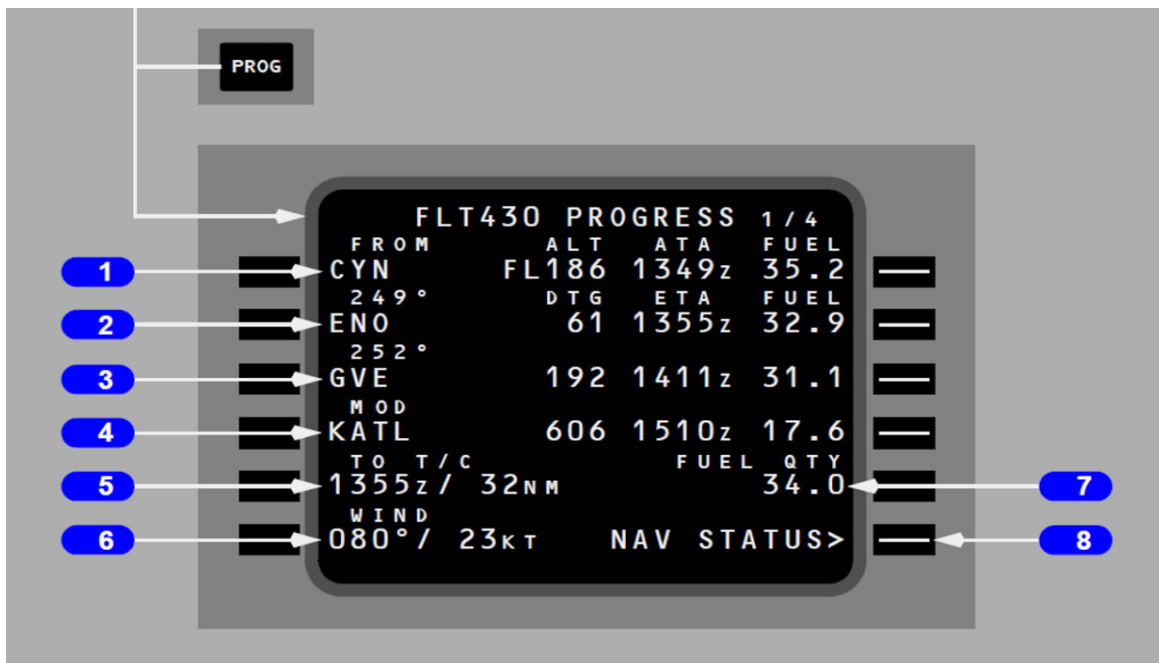
Figure 1. FMC PROGRESS page

The amount of fuel shown on the FMC is provided in wholes and tenths of a tonne on the PROGRESS page. Figure 1<sup>4</sup> shows the how the amount of fuel remaining onboard is displayed (no. 7) and the fuel estimated until the next waypoints and until landing.
