**COMISIÓN DE
INVESTIGACIÓN
DE ACCIDENTES
E INCIDENTES DE
AVIACIÓN CIVIL**

Report IN-033/2016

Incident involving an Airbus A321-231, registration EC-MHS (operated by Vueling Airlines, S.A.) and an Airbus A320-214, registration G-EZTF (operated by Easyjet Airline Company LTD), in the vicinity of point ASTEK, intermediate approach fix for runway 07L at the Barcelona-El Prat Airport (Spain) on 7 August 2016

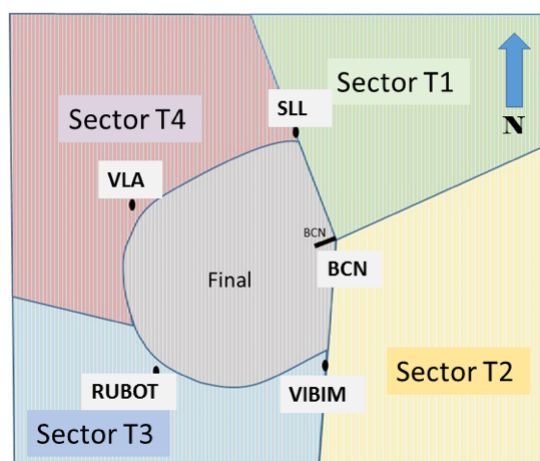
Figure 1. Locations of the sectors

In this configuration, the initial approach sectors that feed the Final approach are Sector T3, which includes Initial Approach Fixes (IAF) RUBOT and VIBIM, and Sector T4, with the SLL and VLA IAFs. Sector T3 handles traffic inbound from the South (S) of the airfield, and Sector T4 handles traffic approaching from the North (N).

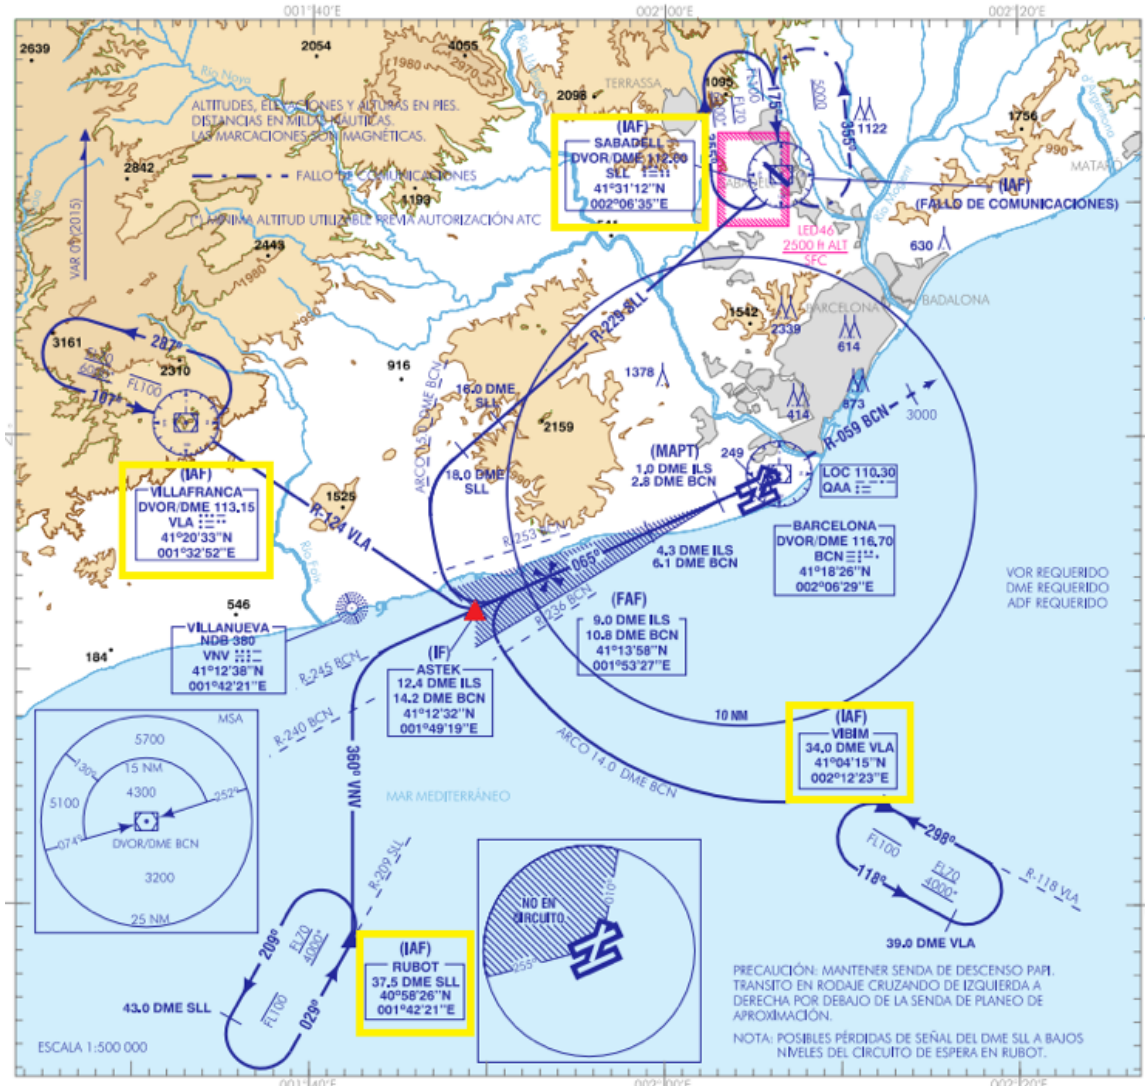
Figure 2 shows the approach chart for the LOC RWY 07L at LEBL, and the locations of the initial approach fixed (boxed in yellow), as described in point 1.1 and Figure 1.

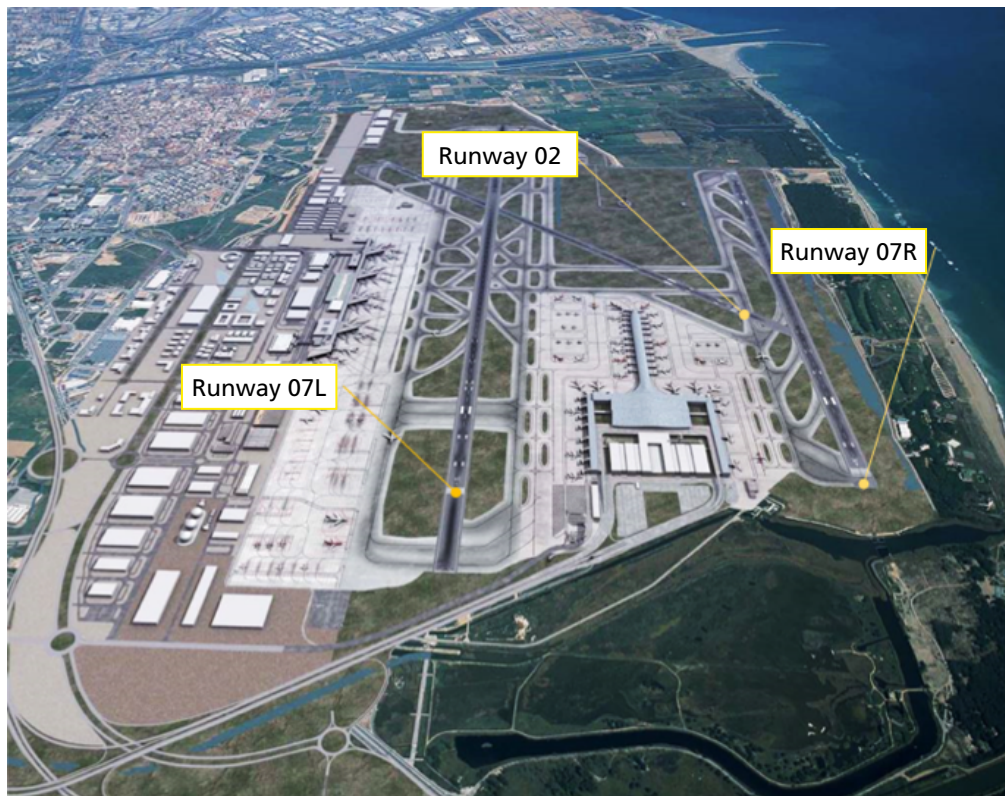
Figure 10. Barcelona-El Prat Airport

Figure 10 shows the airport's configuration during the accident.

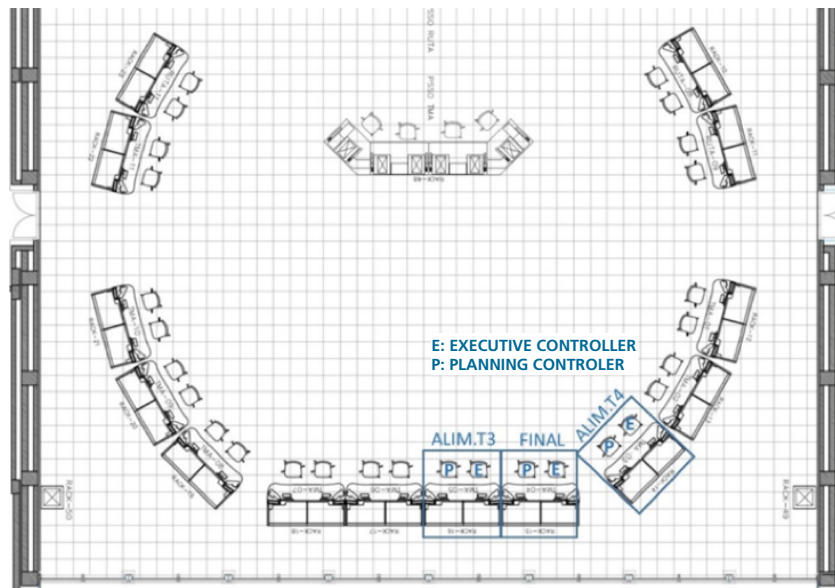
Figure 11. Posts occupied by the controllers on the day of the incident

The control room was visited during the investigation to inspect the posts occupied by the controllers on the day of the accident. It was noted that the approach posts are next to one another, with the Final approach post being between the T3 and T4 feeder sectors. It was also noted that, as a general rule, the planning controller is seated to the right of the executive controller. The posts in which the controllers were seated on the day of the incident are shown in Figure 11.

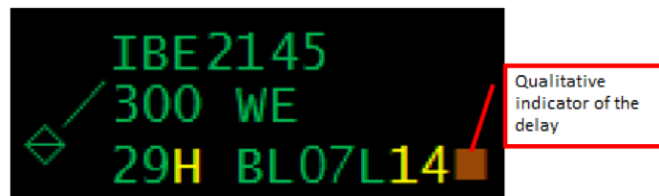
Figure 13. Radar label for an inbound aircraft with a changed sequence number

The information on the sequence and any changes are displayed to the remaining controllers on the basic flight labels, such that the sequence number is the same color as the label if it has not been assigned manually (the QM has not validated the sequence), and yellow if it has been assigned and validated manually (see Figure 13).
