**COMISIÓN DE
INVESTIGACIÓN
DE ACCIDENTES
E INCIDENTES DE
AVIACIÓN CIVIL**

Report A-036/2016

Accident involving a Piper
PA-28-161 Warrior II aircraft,
registration EC-JCI, at the Seville
Airport (Seville, Spain) on 9
September 2016

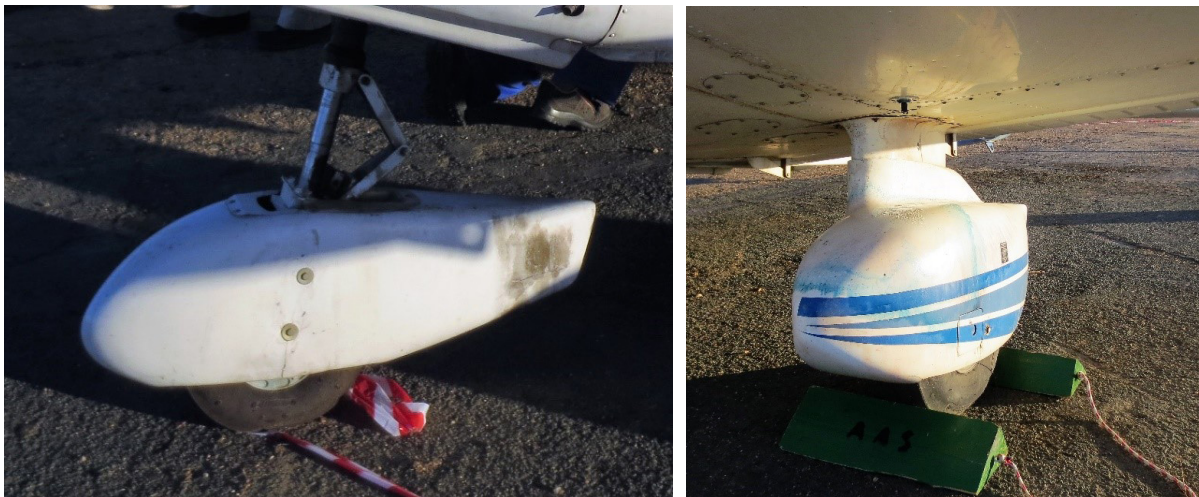
Photographs 2 and 3: Landing gear fairings

The arrangement of the fairings on the landing gear wheels on the accident aircraft is shown in photographs 2 and 3.

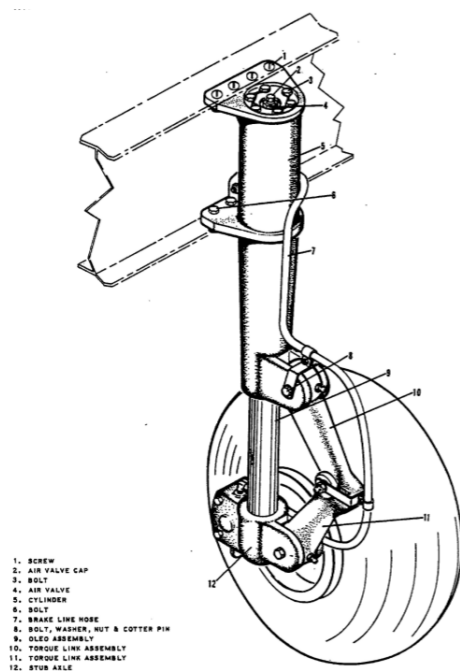
Figure 5. Main components of the main gear leg

1. Improper operation with excessive use of the brakes instead of using the throttle lever during the long taxi route, and improper inputs made to the pedals by not providing steering controls, but using them exclusively to apply the brakes, could have caused the brakes to overheat excessively. As a result, the turn to the left, in the opposite direction to that desired by the pilot, as per his statement, could have been due to unbalanced braking of the main gear wheels. This means that the brake system was more effective braking the left wheel than the right, which probably did not brake, thus causing the aircraft to turn left. The wheel on this side would have braked, which resulted in the undesired taxiway excursion of the aircraft to the left. Based on the evidence gathered during the inspection of the wreckage, the brake system on both main gear wheels was verified to be in very bad condition,

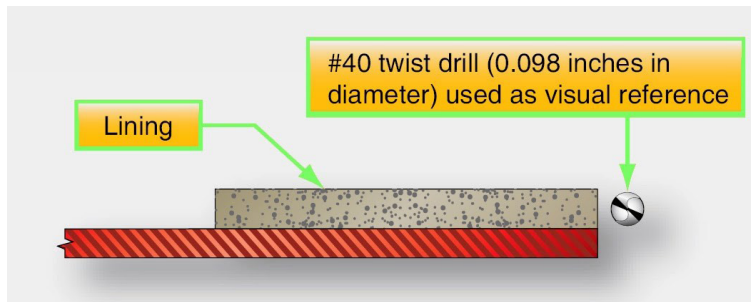
Figure 6. Thickness check of friction lining

On this aircraft, a Piper PA-28-161, the manufacturer specifies the use of Cleveland brakes. The wear of the friction lining on these brakes can be measured directly by the pilot or by the maintenance technician, since part of the lining is accessible. On the accident aircraft, the brakes were

If worn or damaged parts are identified during an inspection, they must be replaced in order to keep the aircraft airworthy, followed by a check to verify their operation.

The check is carried out while the aircraft is taxiing. The braking action on each main gear wheel must be the same if equal pressure is applied to each pedal. The pedals must be firm, not mushy or spongy, when depressed. When the pressure is released from the pedal, the brake must release with no sign of resistance.
