## **Report IN-037/2016**

Incident involving a Gulfstream G200 aircraft, registration EC-KBC, at the Barcelona-El Prat Airport (LEBL, Spain) on 26 September 2016.

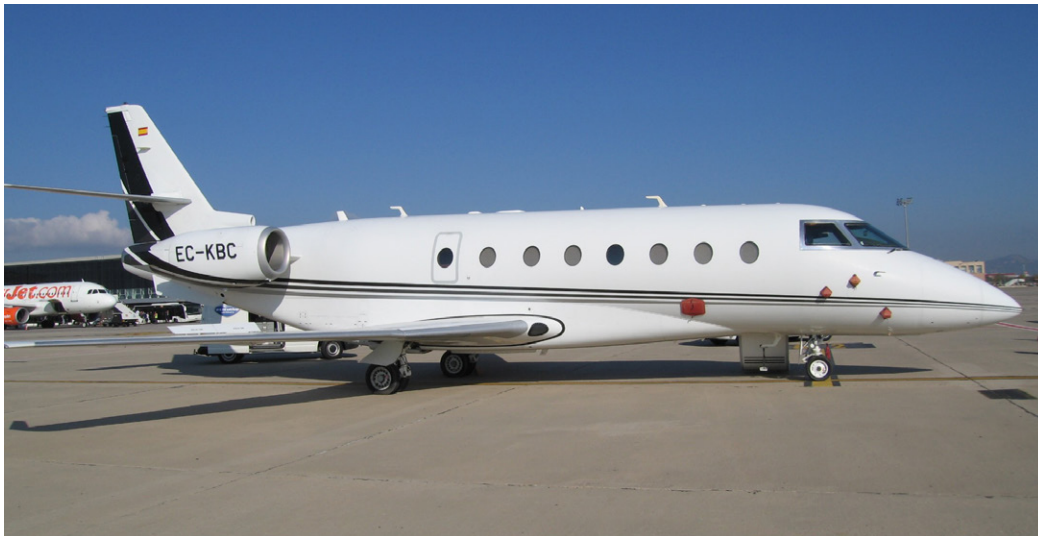
Photograph 5: Photo of the aircraft

The aircraft was inspected after it was removed from the incident site (see Photograph 5). Due to the circumstances of the incident, special attention was paid to the systems used to steer the aircraft: the main landing gear and brakes, the nose wheel and handwheel, the rudder and the reversers. No signs or damage were found beyond those indicated in **Section 1.3 Damage to aircraft.**

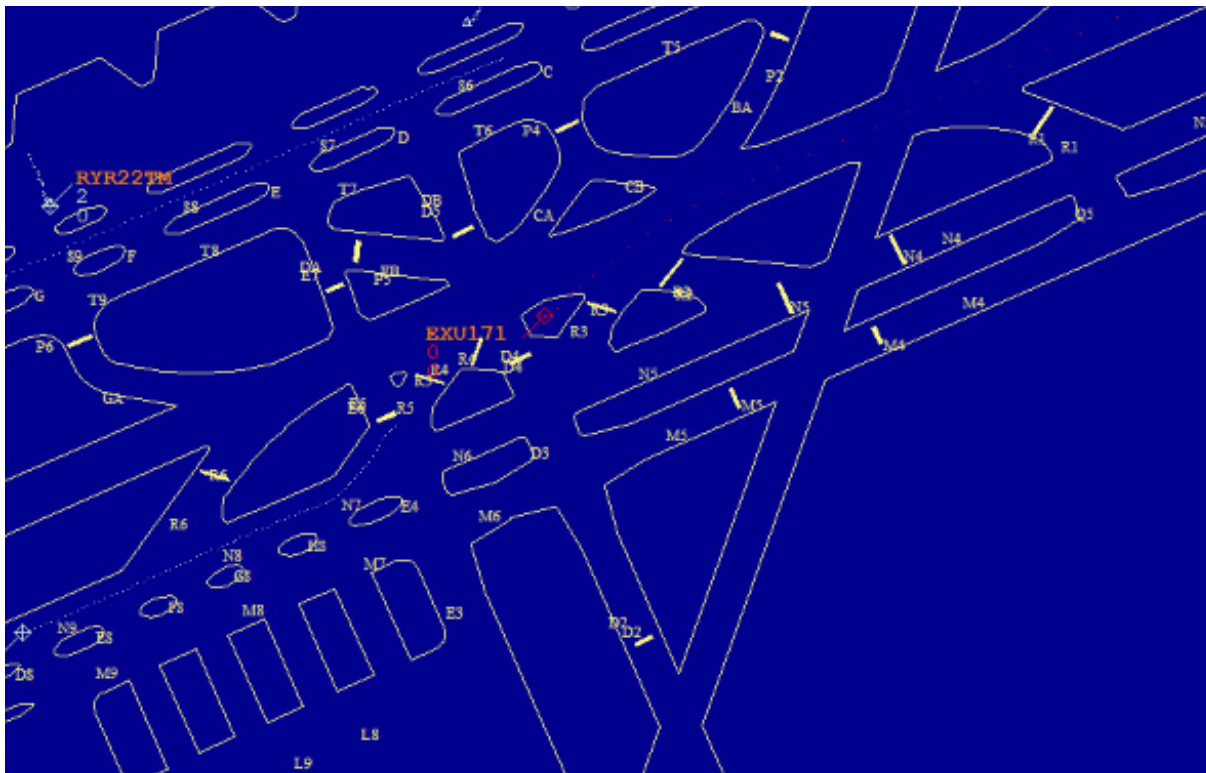
Figure 4: Final position of the aircraft after runway excursion.

According to information on the radar track provided by the control services provider (ENAIRE), the aircraft is seen making the approach and landing lined up with the runway before subsequently deviating to the left and eventually coming to a stop at an island located off the left shoulder.

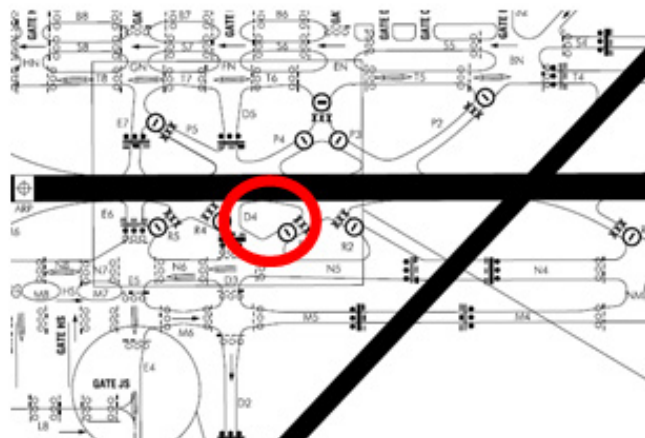
Figure 5: Location of aircraft's final position after runway excursion.

at the island located between rapid exit taxiways R3 and R4 (see Figure 5 and Photograph 10 below).

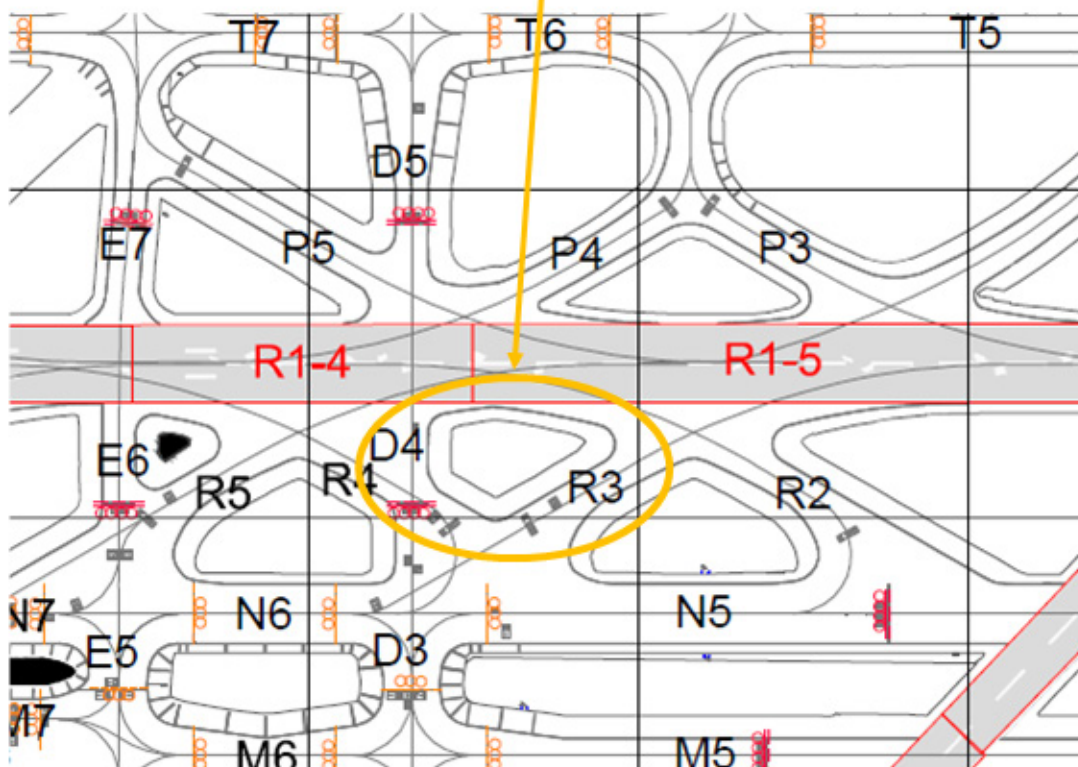
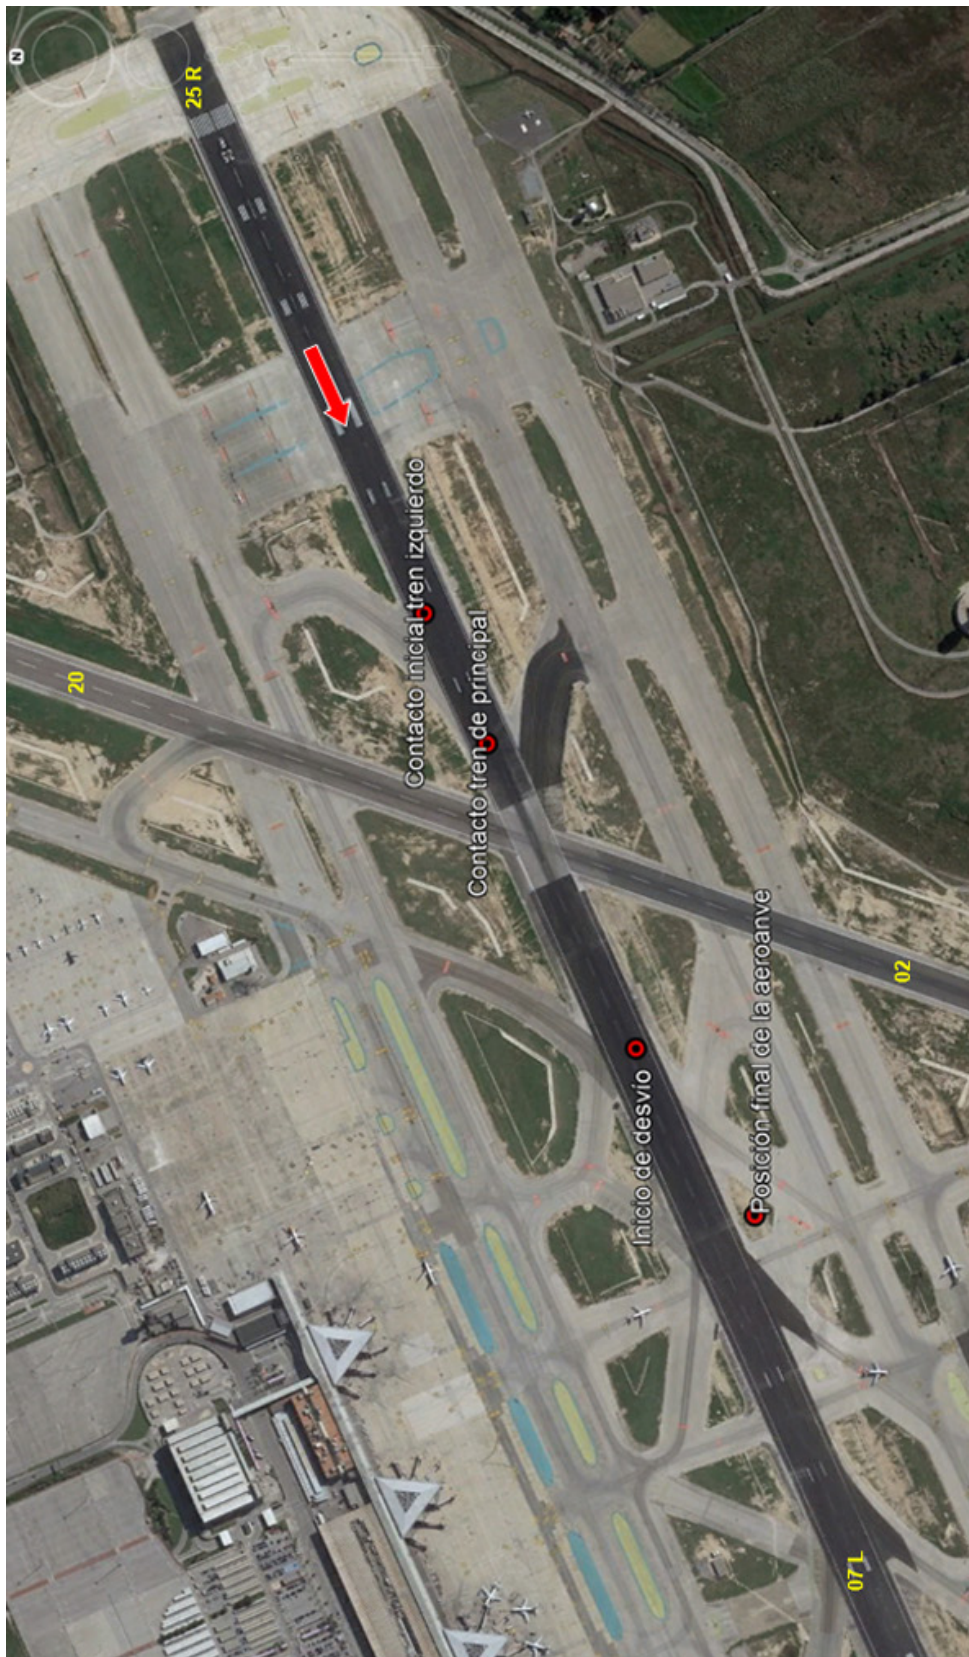
Aerial photograph of the airport with the aircraft's direction of motion and final position  
Image taken from Google Earth

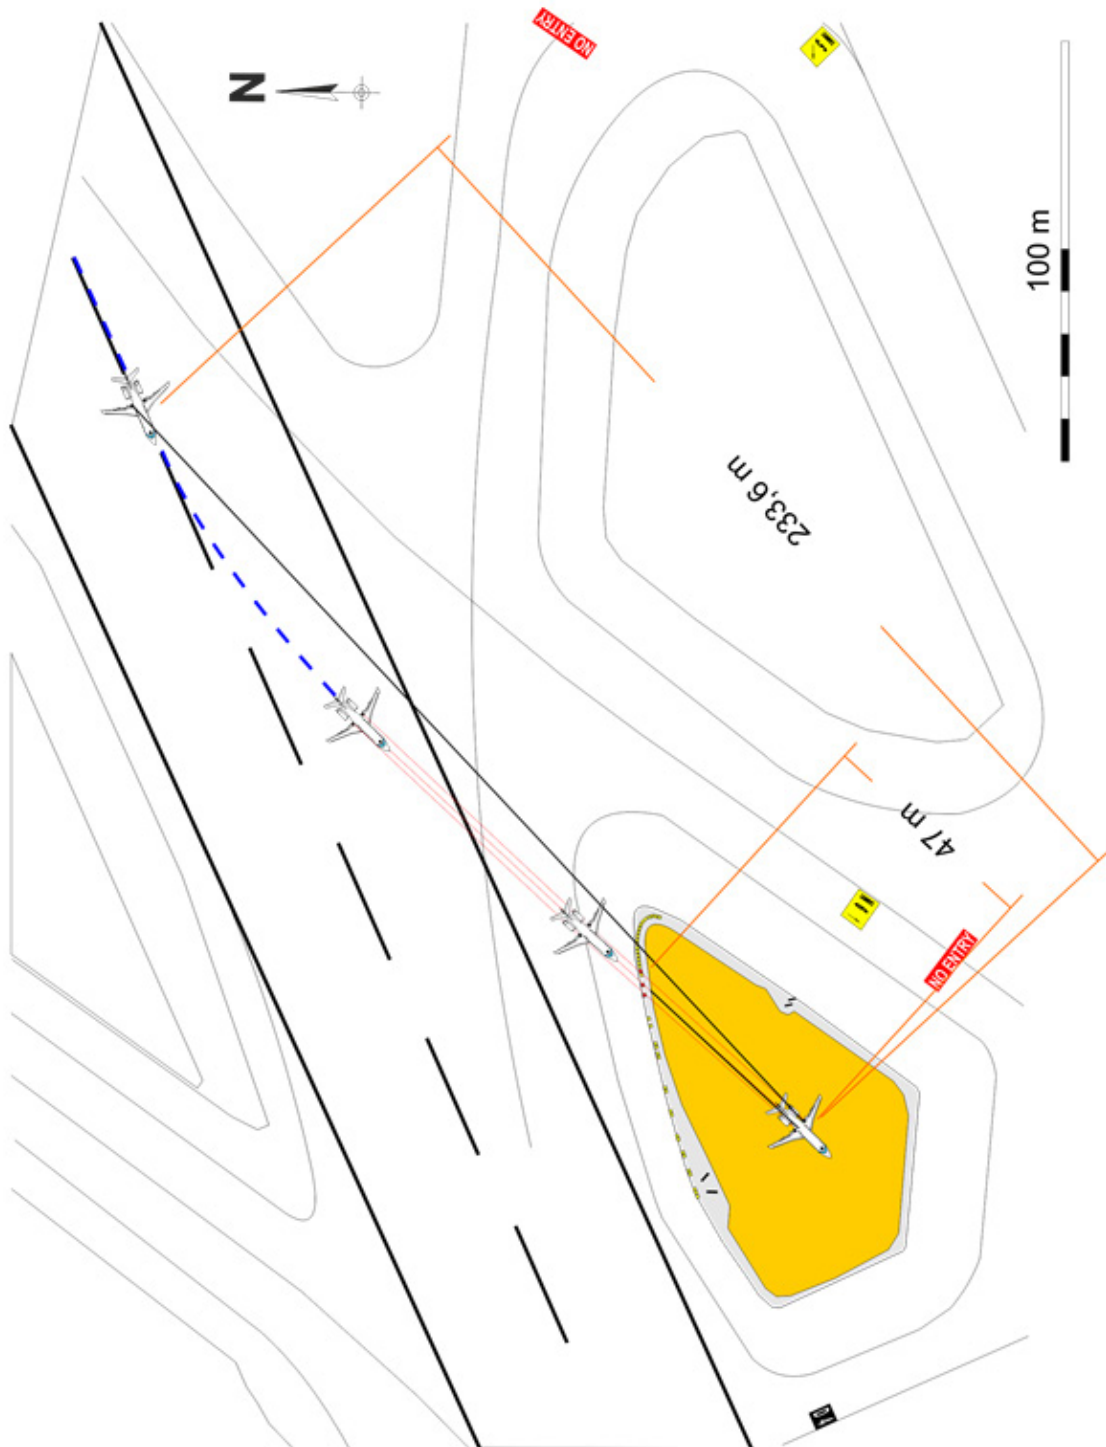
Diagram of the path taken by the aircraft and its track
