**COMISIÓN DE
INVESTIGACIÓN
DE ACCIDENTES
E INCIDENTES DE
AVIACIÓN CIVIL**

Report IN-038/2016

Incident involving a BOEING 737-400, registration SP-ENA, operated by ENTER AIR, and a CESSNA 172, registration EC-JOB, operated by BARCELONA FLIGHT SCHOOL, at the Barcelona TMA (Spain) on 28 September 2016

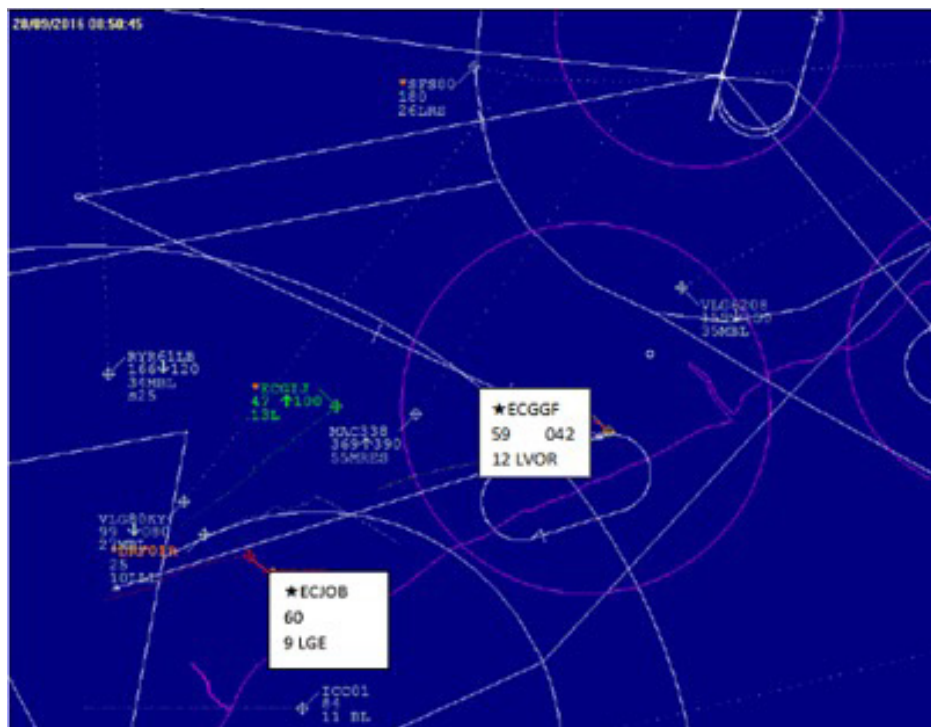
Figure 6. Aircraft EC-GGF on approach to LEGE (08:50:45)

08:48:17 Aircraft EC-GGF, under IFR from LELL to LEGE, approaches CLE, holding at 6000 ft, and reports to sector T1. The ATCO in the sector tries to communicate with the Girona TWR, to no avail. The traffic is instructed to descend to 4200 ft and complete the VOR/DME approach to runway 02 at Girona.

08:50:45 The ATCO in sector T1E transfers EC-GGF to the Girona TWR. On the same route (SLL-CLE) is aircraft EC-JOB, flying under IFR, which is also going from LELL to LEGE at 6000 ft.

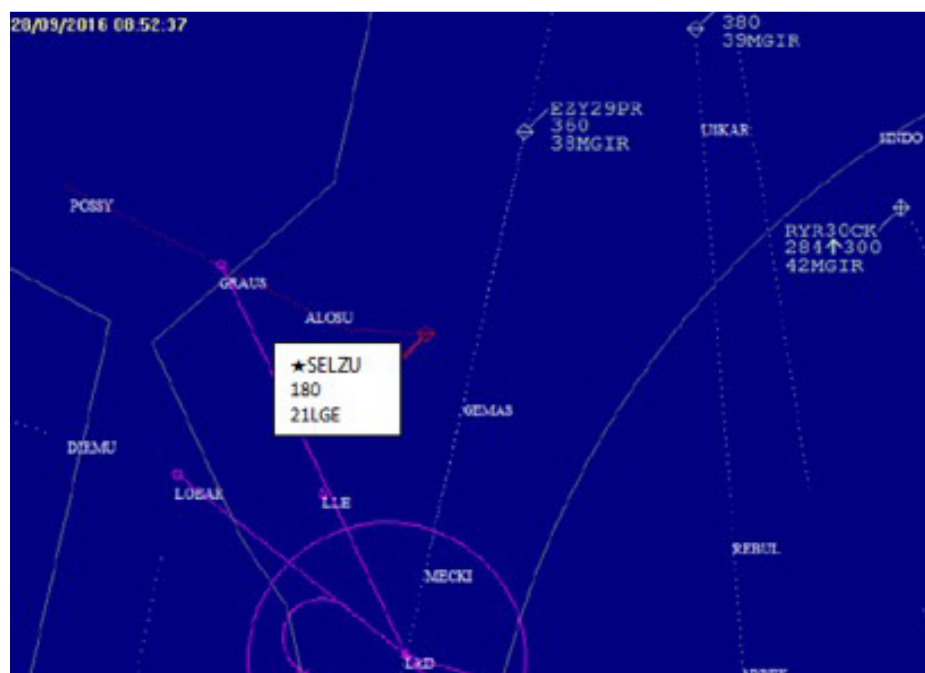
Figure 7. SELZU aerial work traffic (08:52:37)

08:52:37 The sector T4 ATCO informs the ATCO in T1E of the presence of an aircraft at FL180 that is doing aerial work near GEMAS (visible in Figure 7, with callsign SELZU).

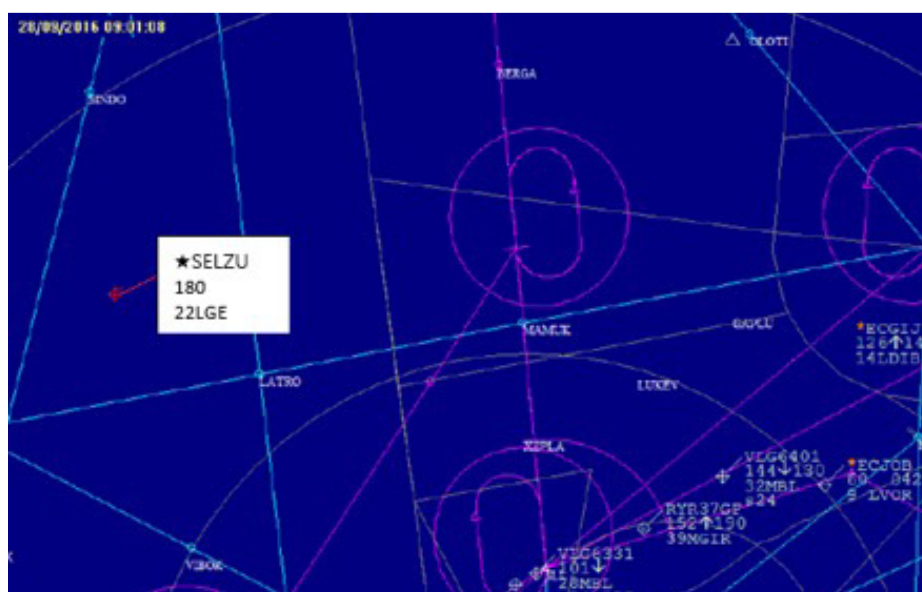
Figure 10. Traffic SELZU transferred to D1E (09:01:08)

09:01:01 Sector T4E transfers aircraft SELZU to sector D1E.
